# ***Wetland Delineation Report***

***Spirit Lake Sediment Site  
Former U. S. Steel Duluth Works  
St. Louis River  
Duluth, Minnesota***

***Prepared for  
U. S. Steel and  
U.S. EPA Great Lakes National Program Office***

***April 2013***

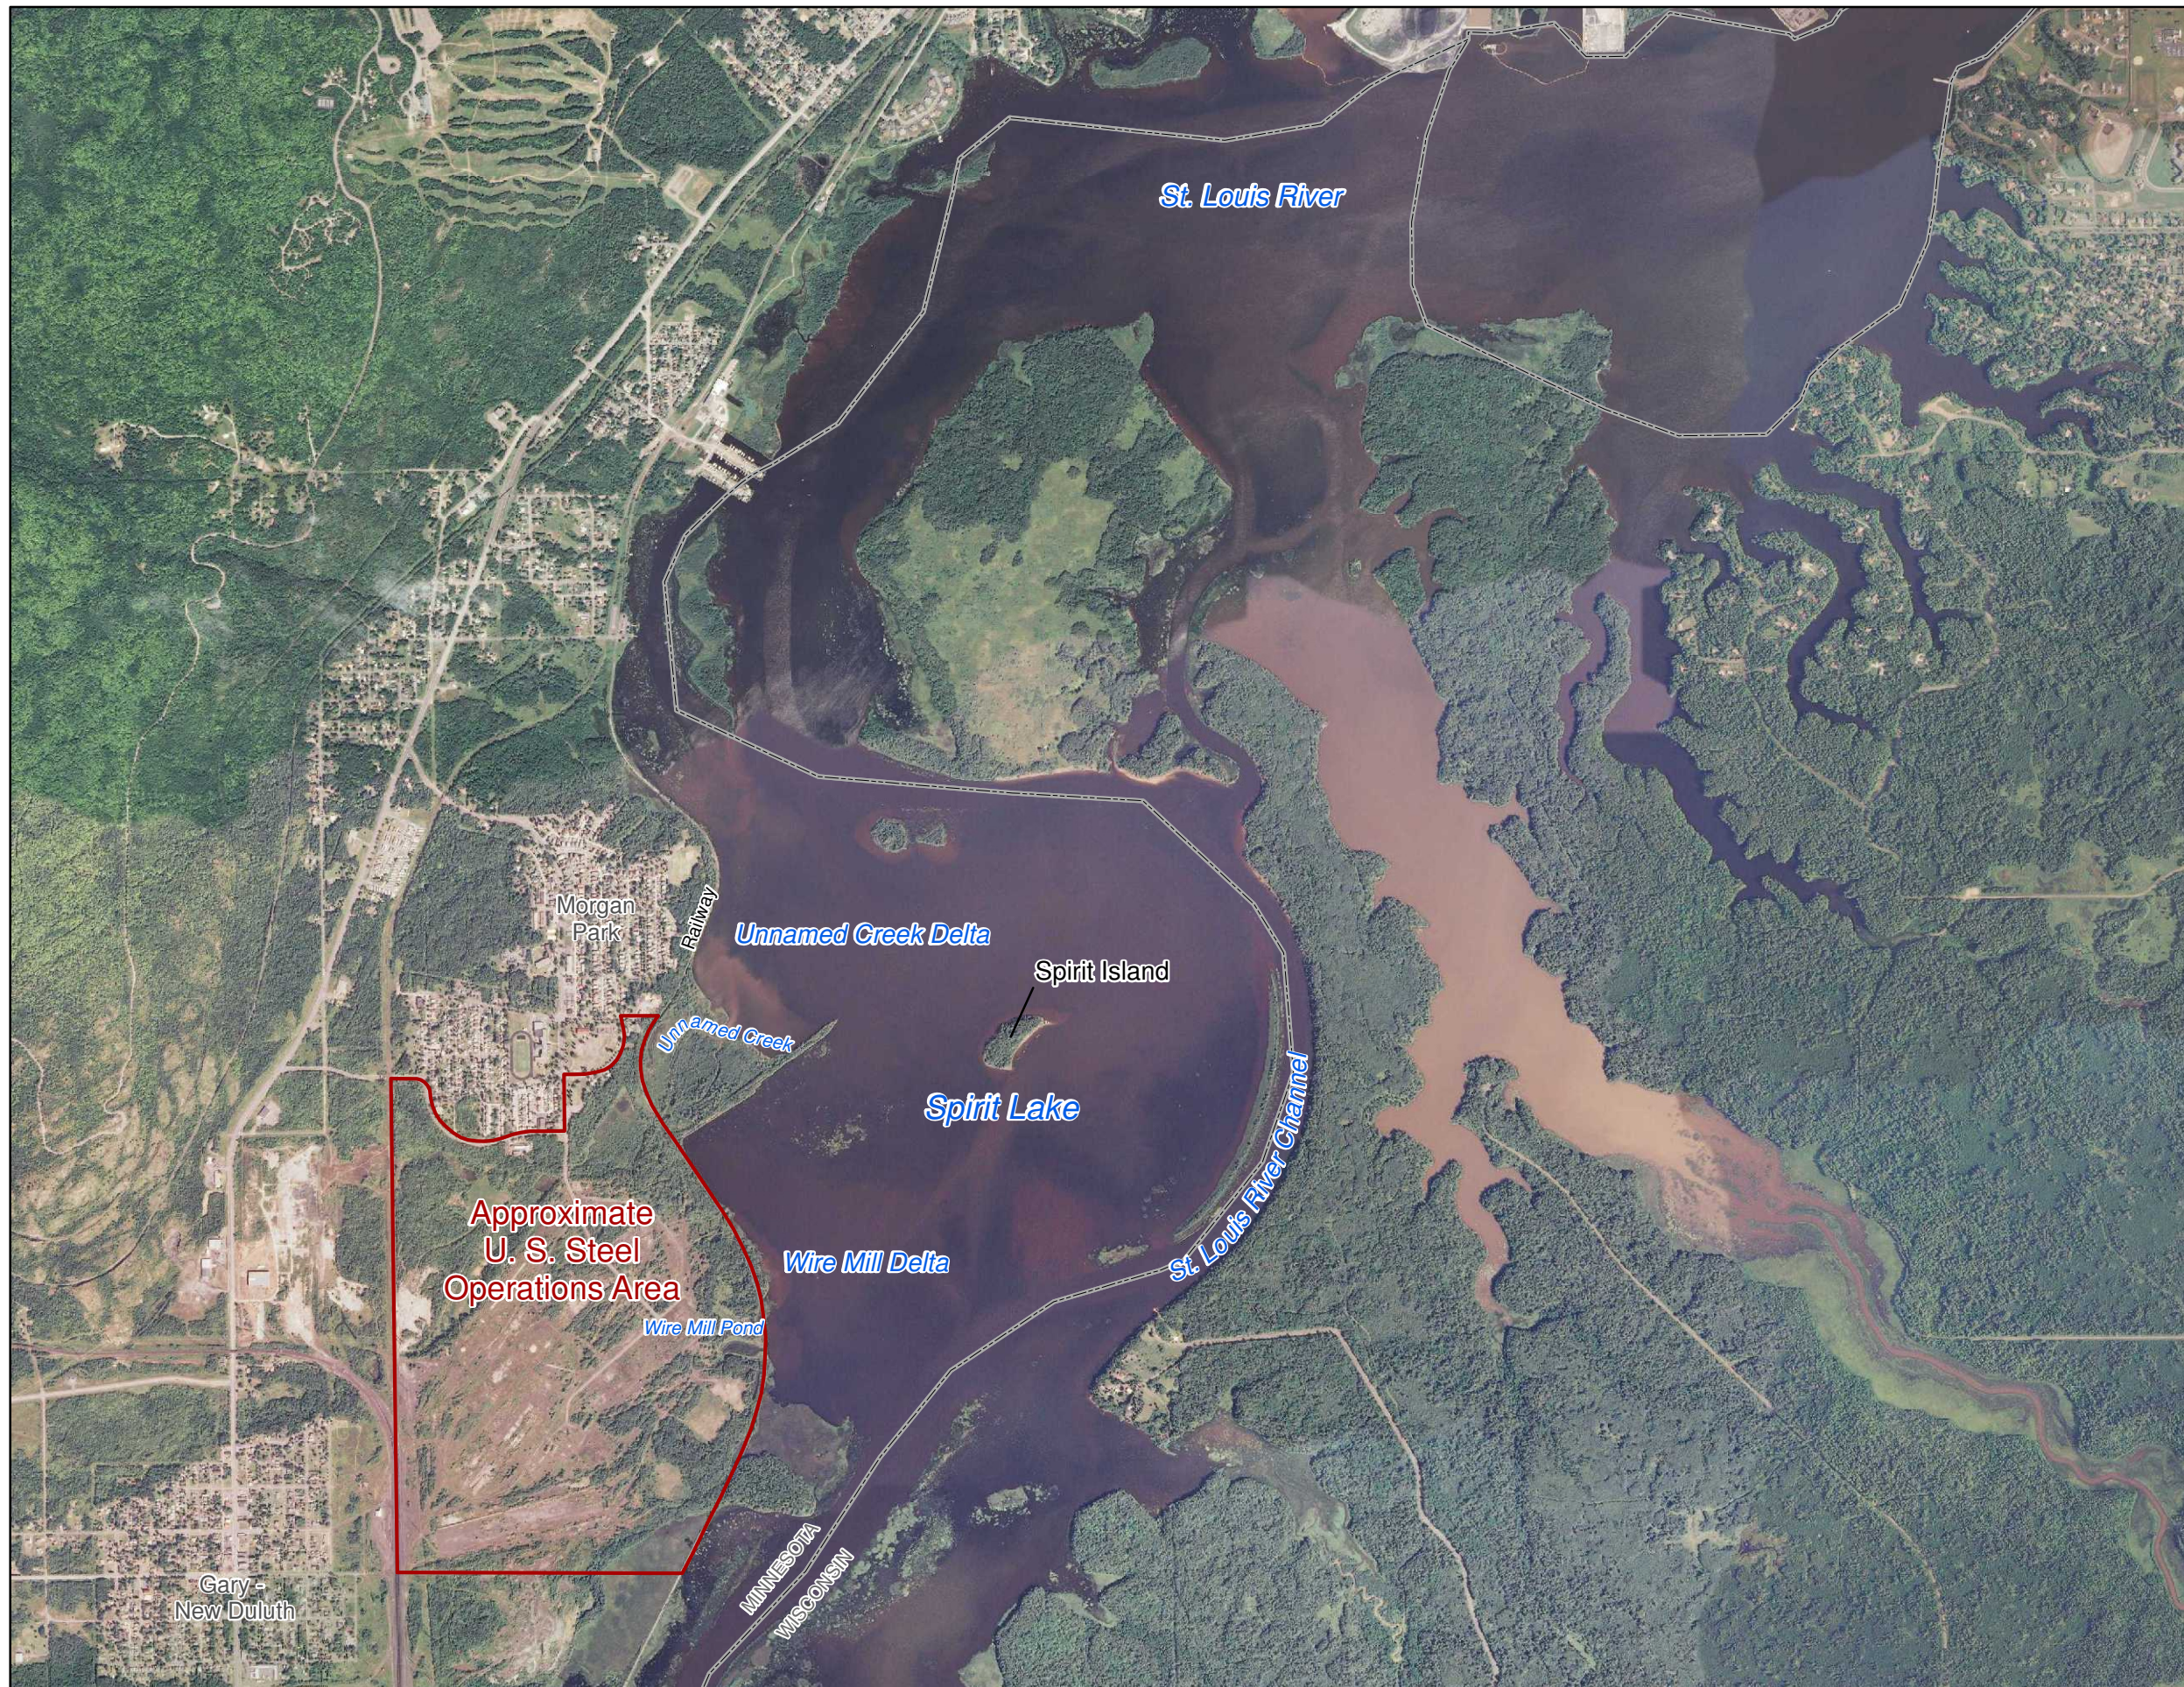
Figure D-1

**SITE LOCATION MAP  
FOR SPIRIT LAKE**  
Spirit Lake Sediment Site -  
Former U. S. Steel Duluth Works  
Saint Louis River  
Duluth, Minnesota

The Site is located in an open reach of the St. Louis River estuary referred to as Spirit Lake, near the Morgan Park neighborhood of Duluth, Minnesota (Figure D-1). The Site layout and relation to the former U. S. Steel Duluth Works are shown on Figure D-2.

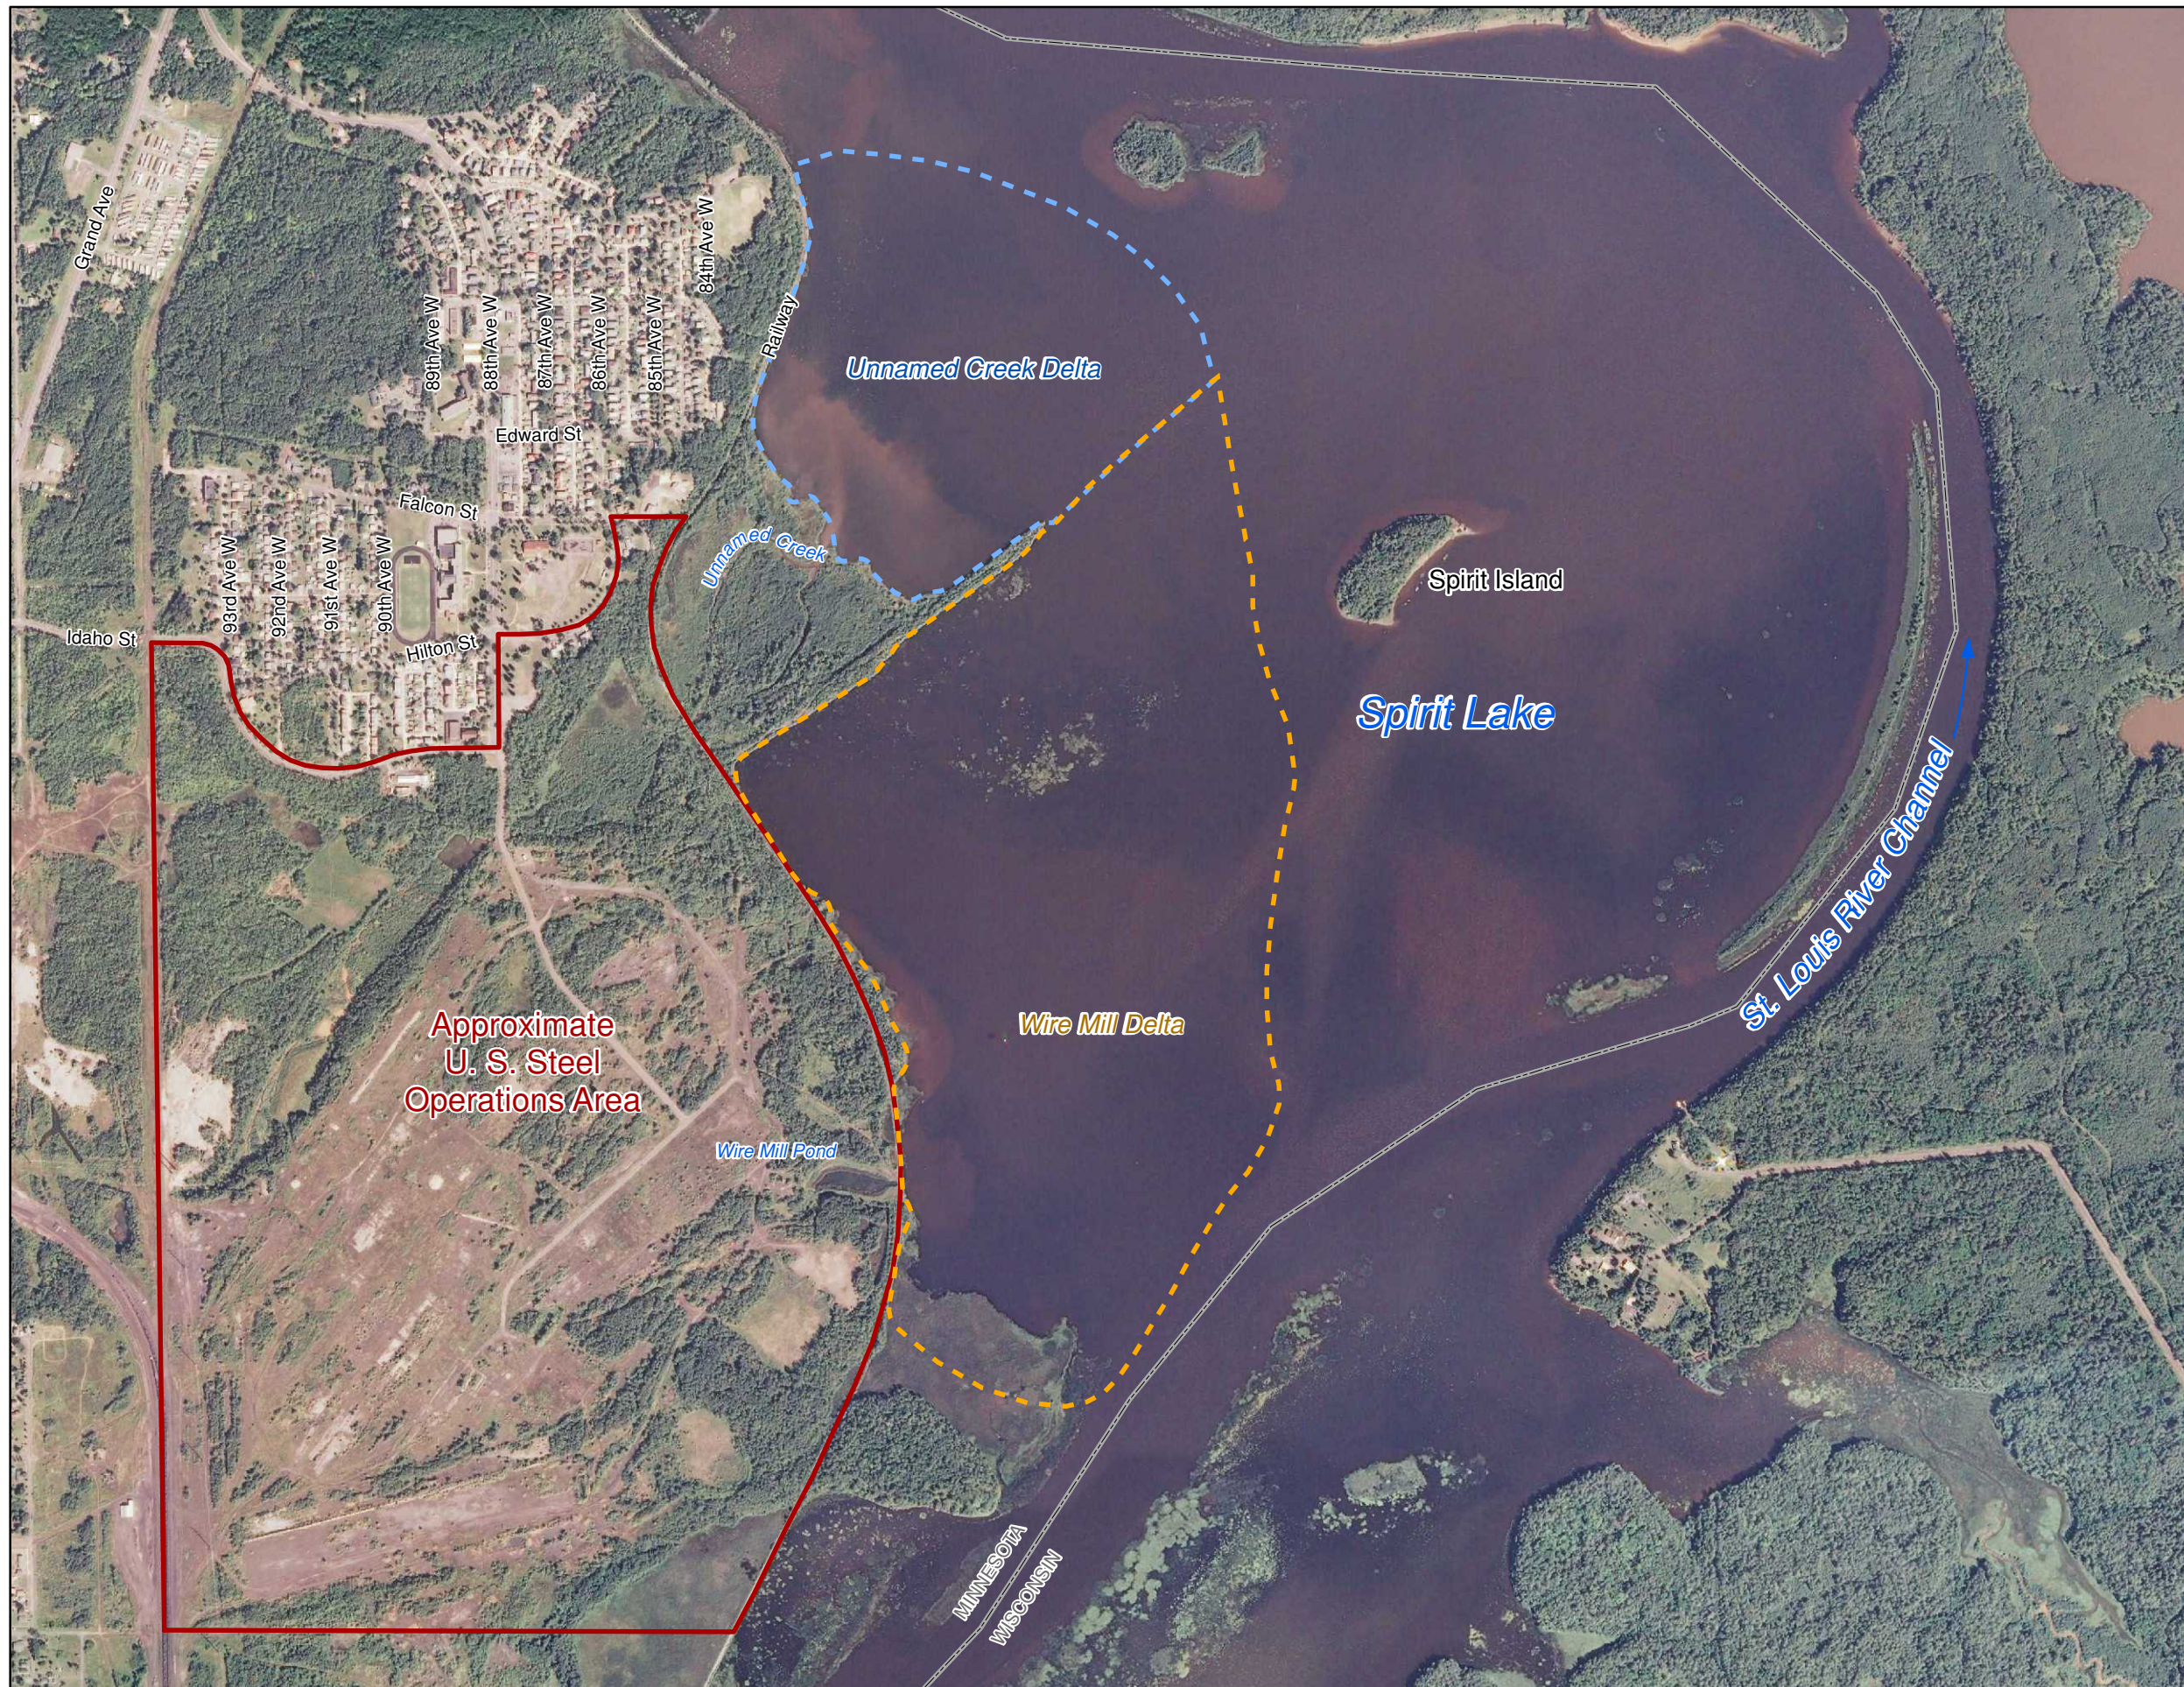
**SITE LAYOUT**  
 Spirit Lake Sediment Site -  
 Former U. S. Steel Duluth Works  
 Saint Louis River  
 Duluth, Minnesota

The Site is comprised of two main areas along the western shore of Spirit Lake: the Wire Mill Delta and the Unnamed Creek Delta, as shown on Figure D-2. The Wire Mill Delta area is near the former discharge pond associated with the former Duluth Works Wire Mill operational area. The Unnamed Creek Delta is north of the Wire Mill Delta at the outlet of Unnamed Creek, where it empties into Spirit Lake. A man-made spit of land separates the two delta areas.

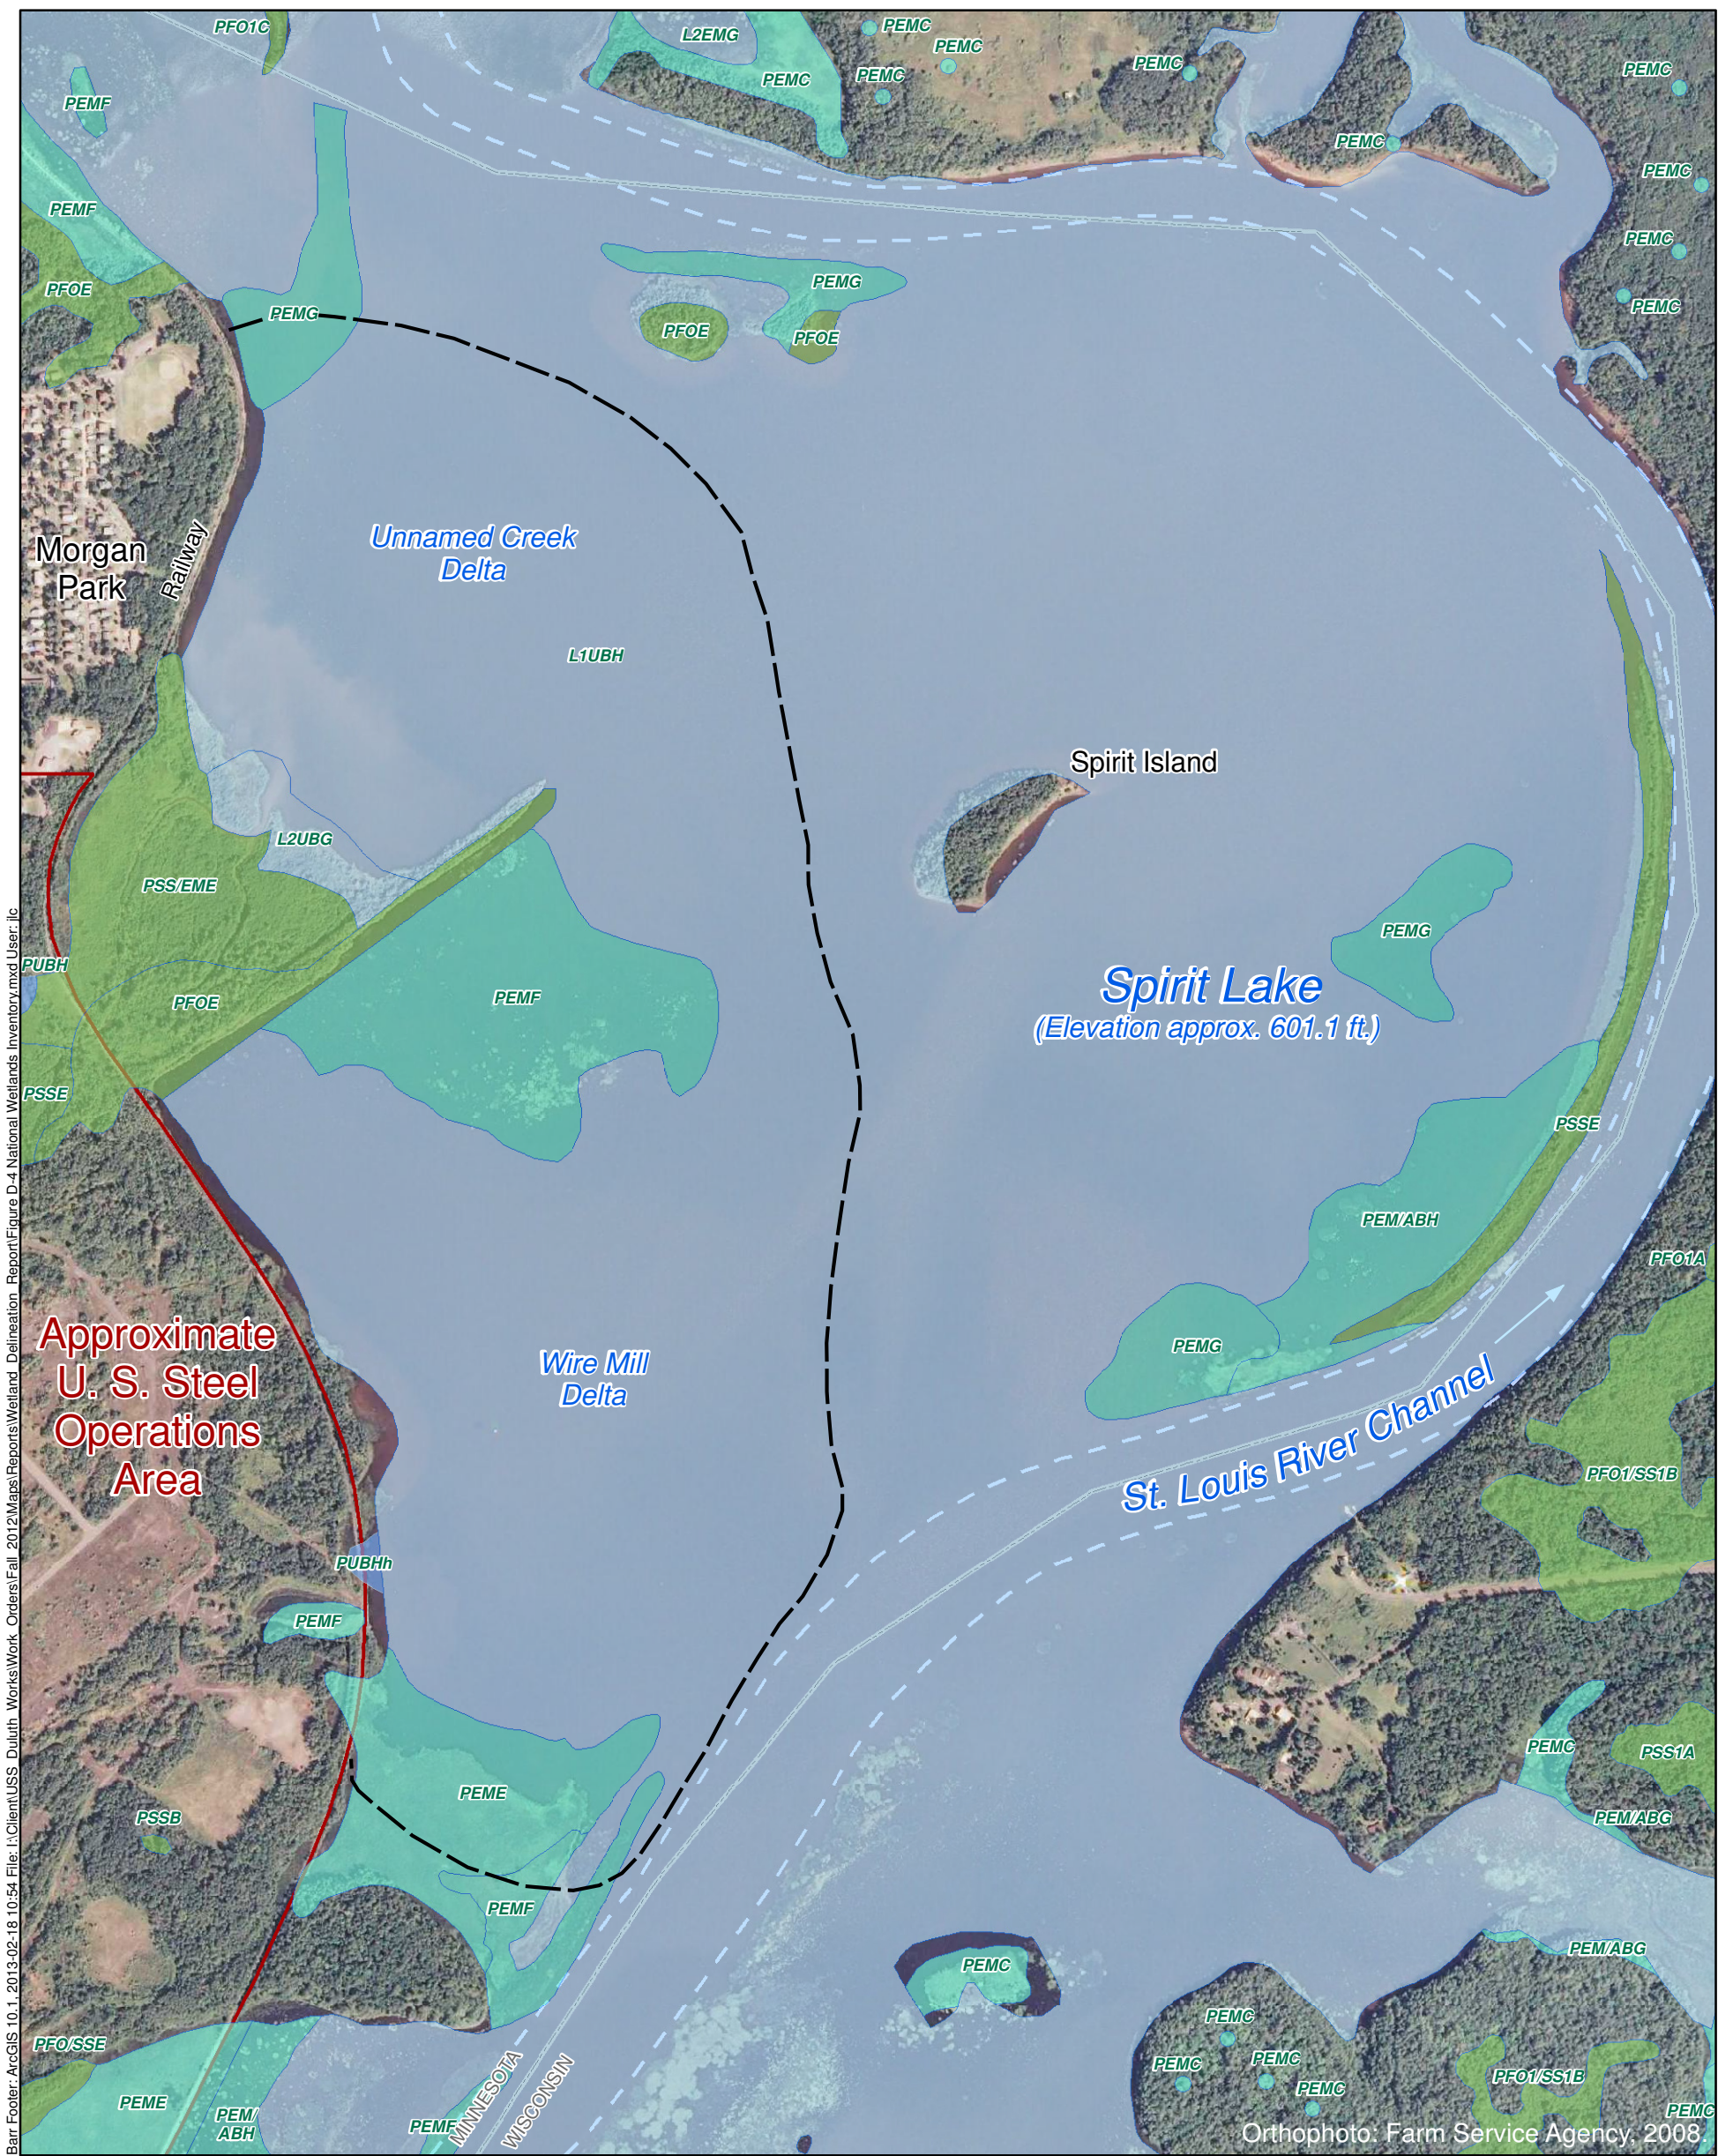
Figure D-4

**NATIONAL WETLANDS INVENTORY**  
 Spirit Lake Sediment Site -  
 Former U. S. Steel Duluth Works  
 Saint Louis River  
 Duluth, Minnesota

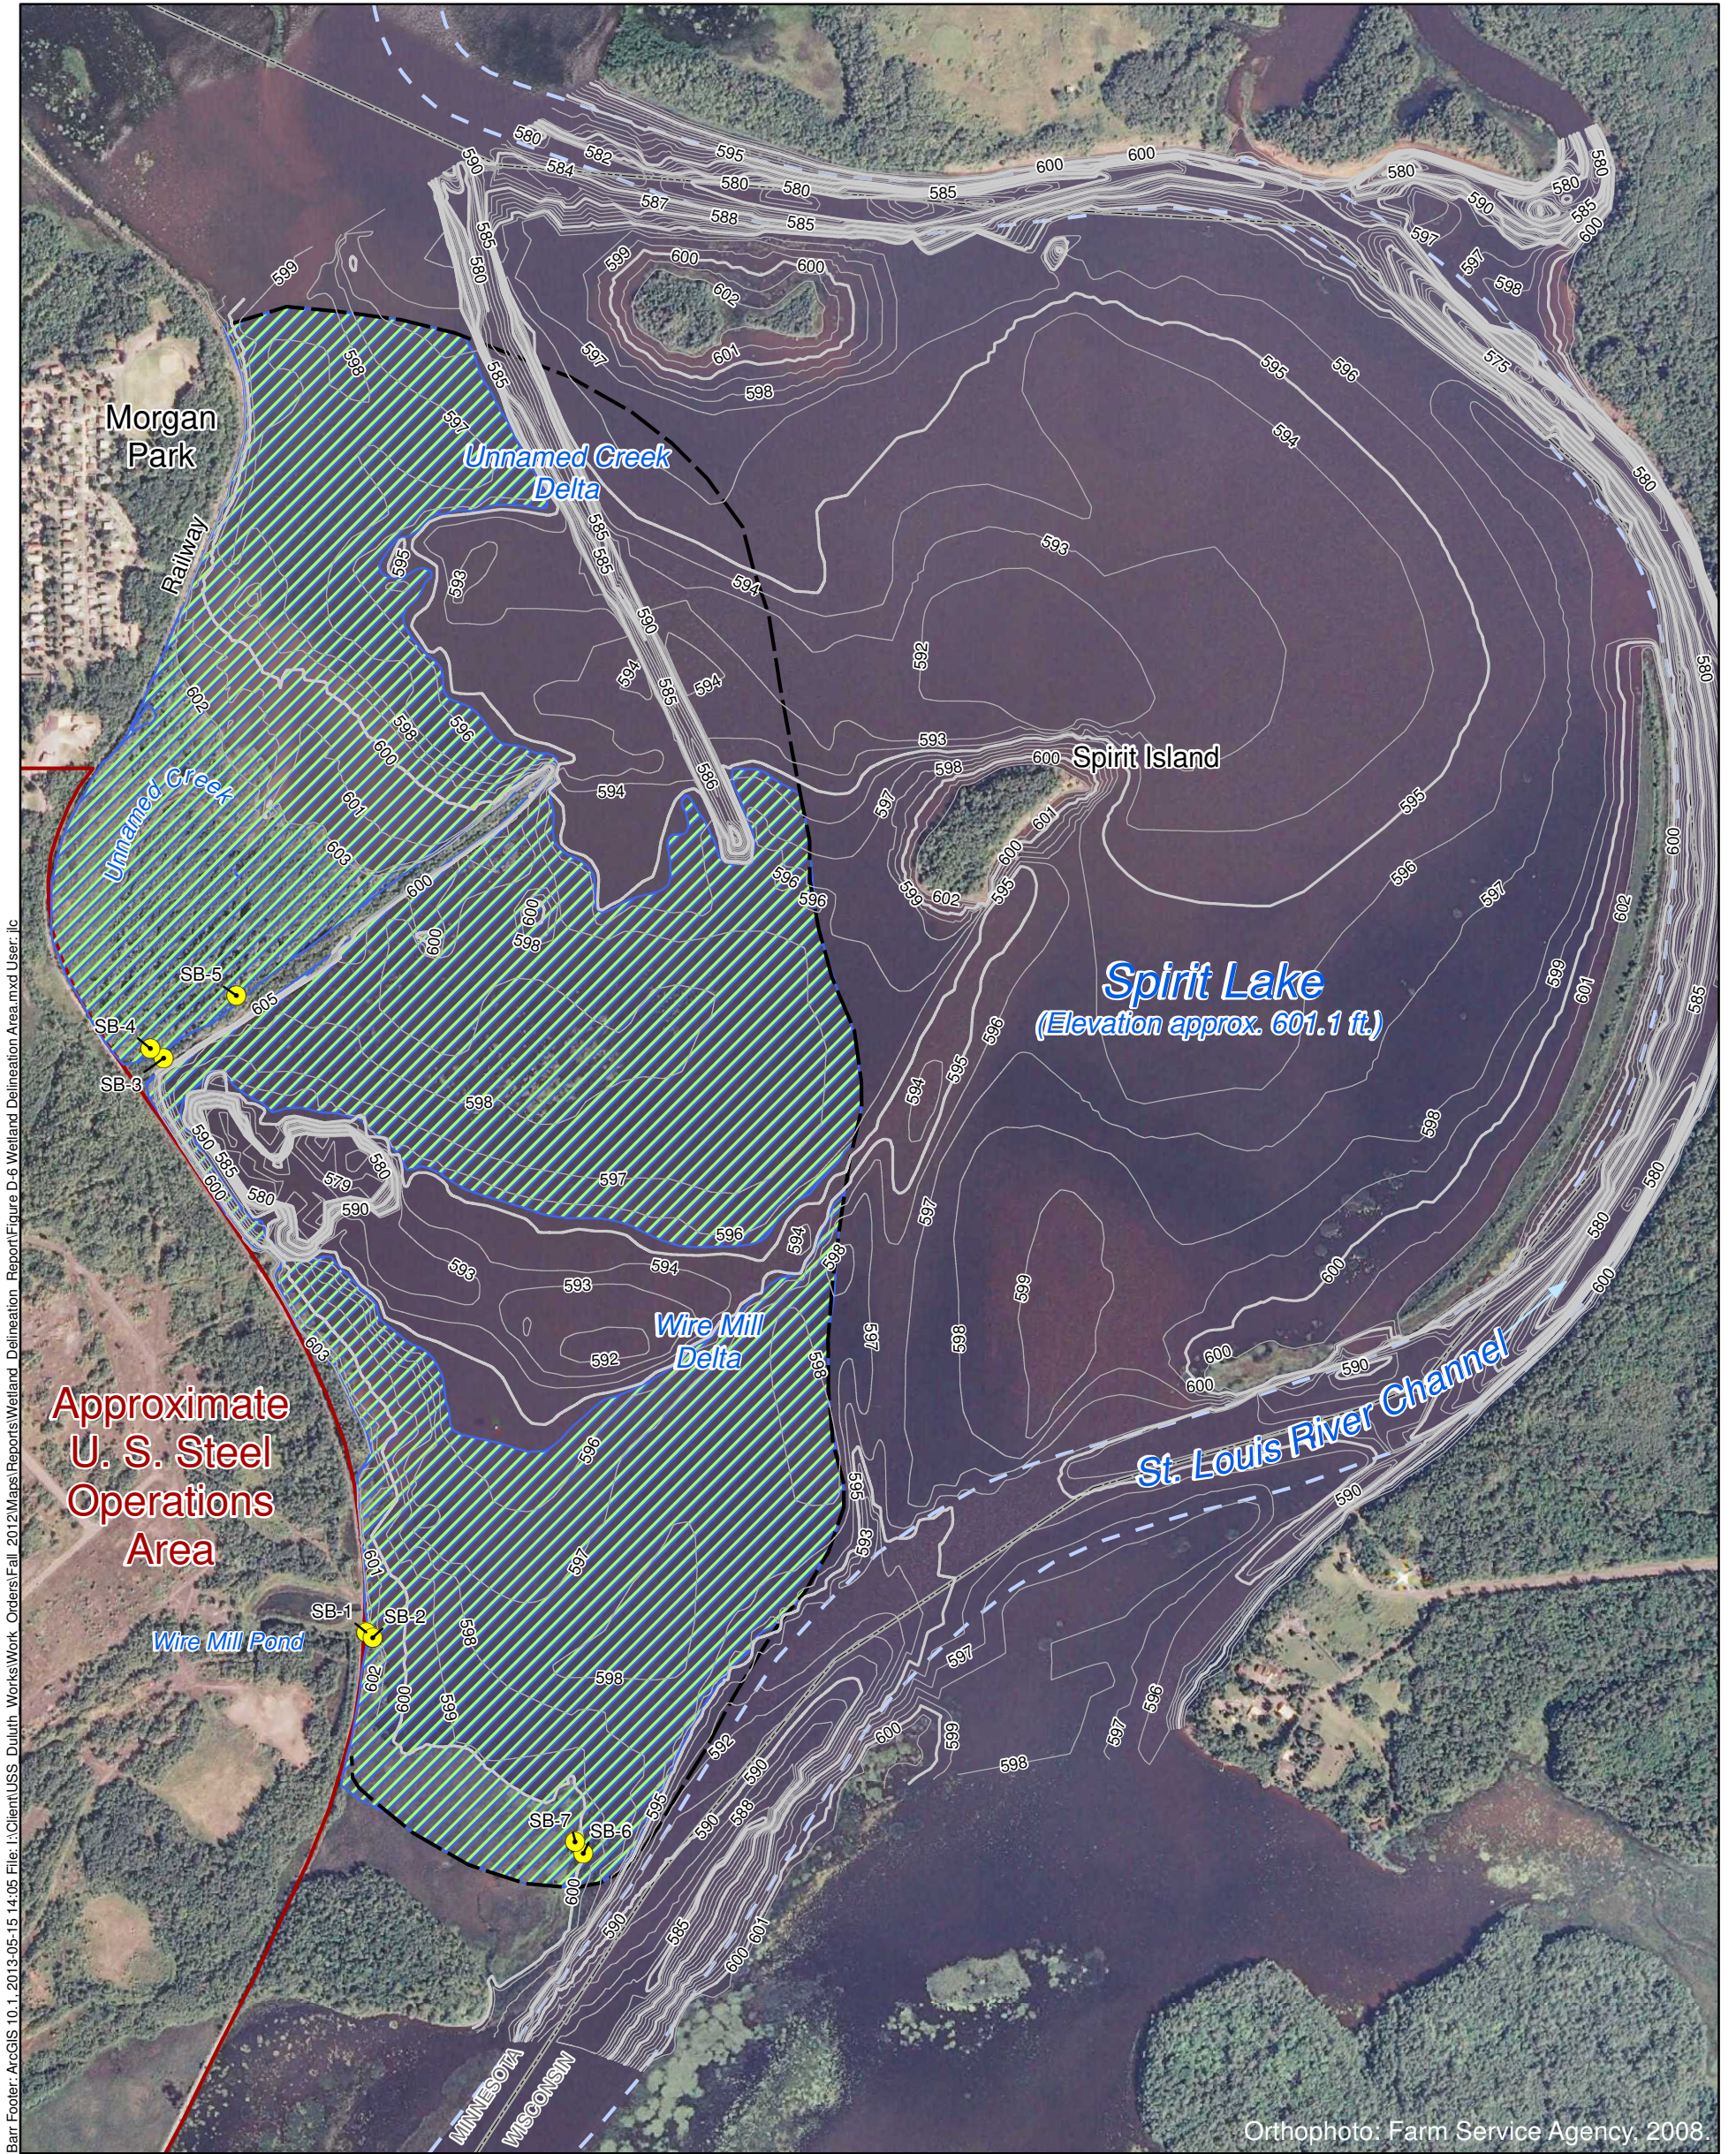
Figure D-6

**WETLAND DELINEATION AREA**  
 Spirit Lake Sediment Site -  
 Former U. S. Steel Duluth Works  
 Saint Louis River  
 Duluth, Minnesota

Soil borings were reviewed at data points shown in Figure D-6. Representative soil samples from each boring were examined for hydric soil indicators. Soil colors (e.g., 7.5YR 4/2, etc.) were determined with the aid of a Munsell<sup>®</sup> soil color chart and noted on the Wetland Data Forms (Appendix D-1).

All wetland areas delineated within the Site are shown on Figure D-6. A comparison of the total area of each wetland community is shown in Table 3. Table 4 summarizes vegetation found during the August 2012 site visit for each wetland community. Additional information on the field-delineated wetland, including dominant vegetation, soil type, and hydrologic information, is provided on the wetland data sheets in Appendix D-1.

One wetland complex was delineated within the Site. The portion of this wetland delineated within the Site is approximately 308 acres (Figure D-6). The wetland extends beyond the project Site boundary. Observed wetland communities within the delineated boundary were documented in the field and mapped on Figure D-8.

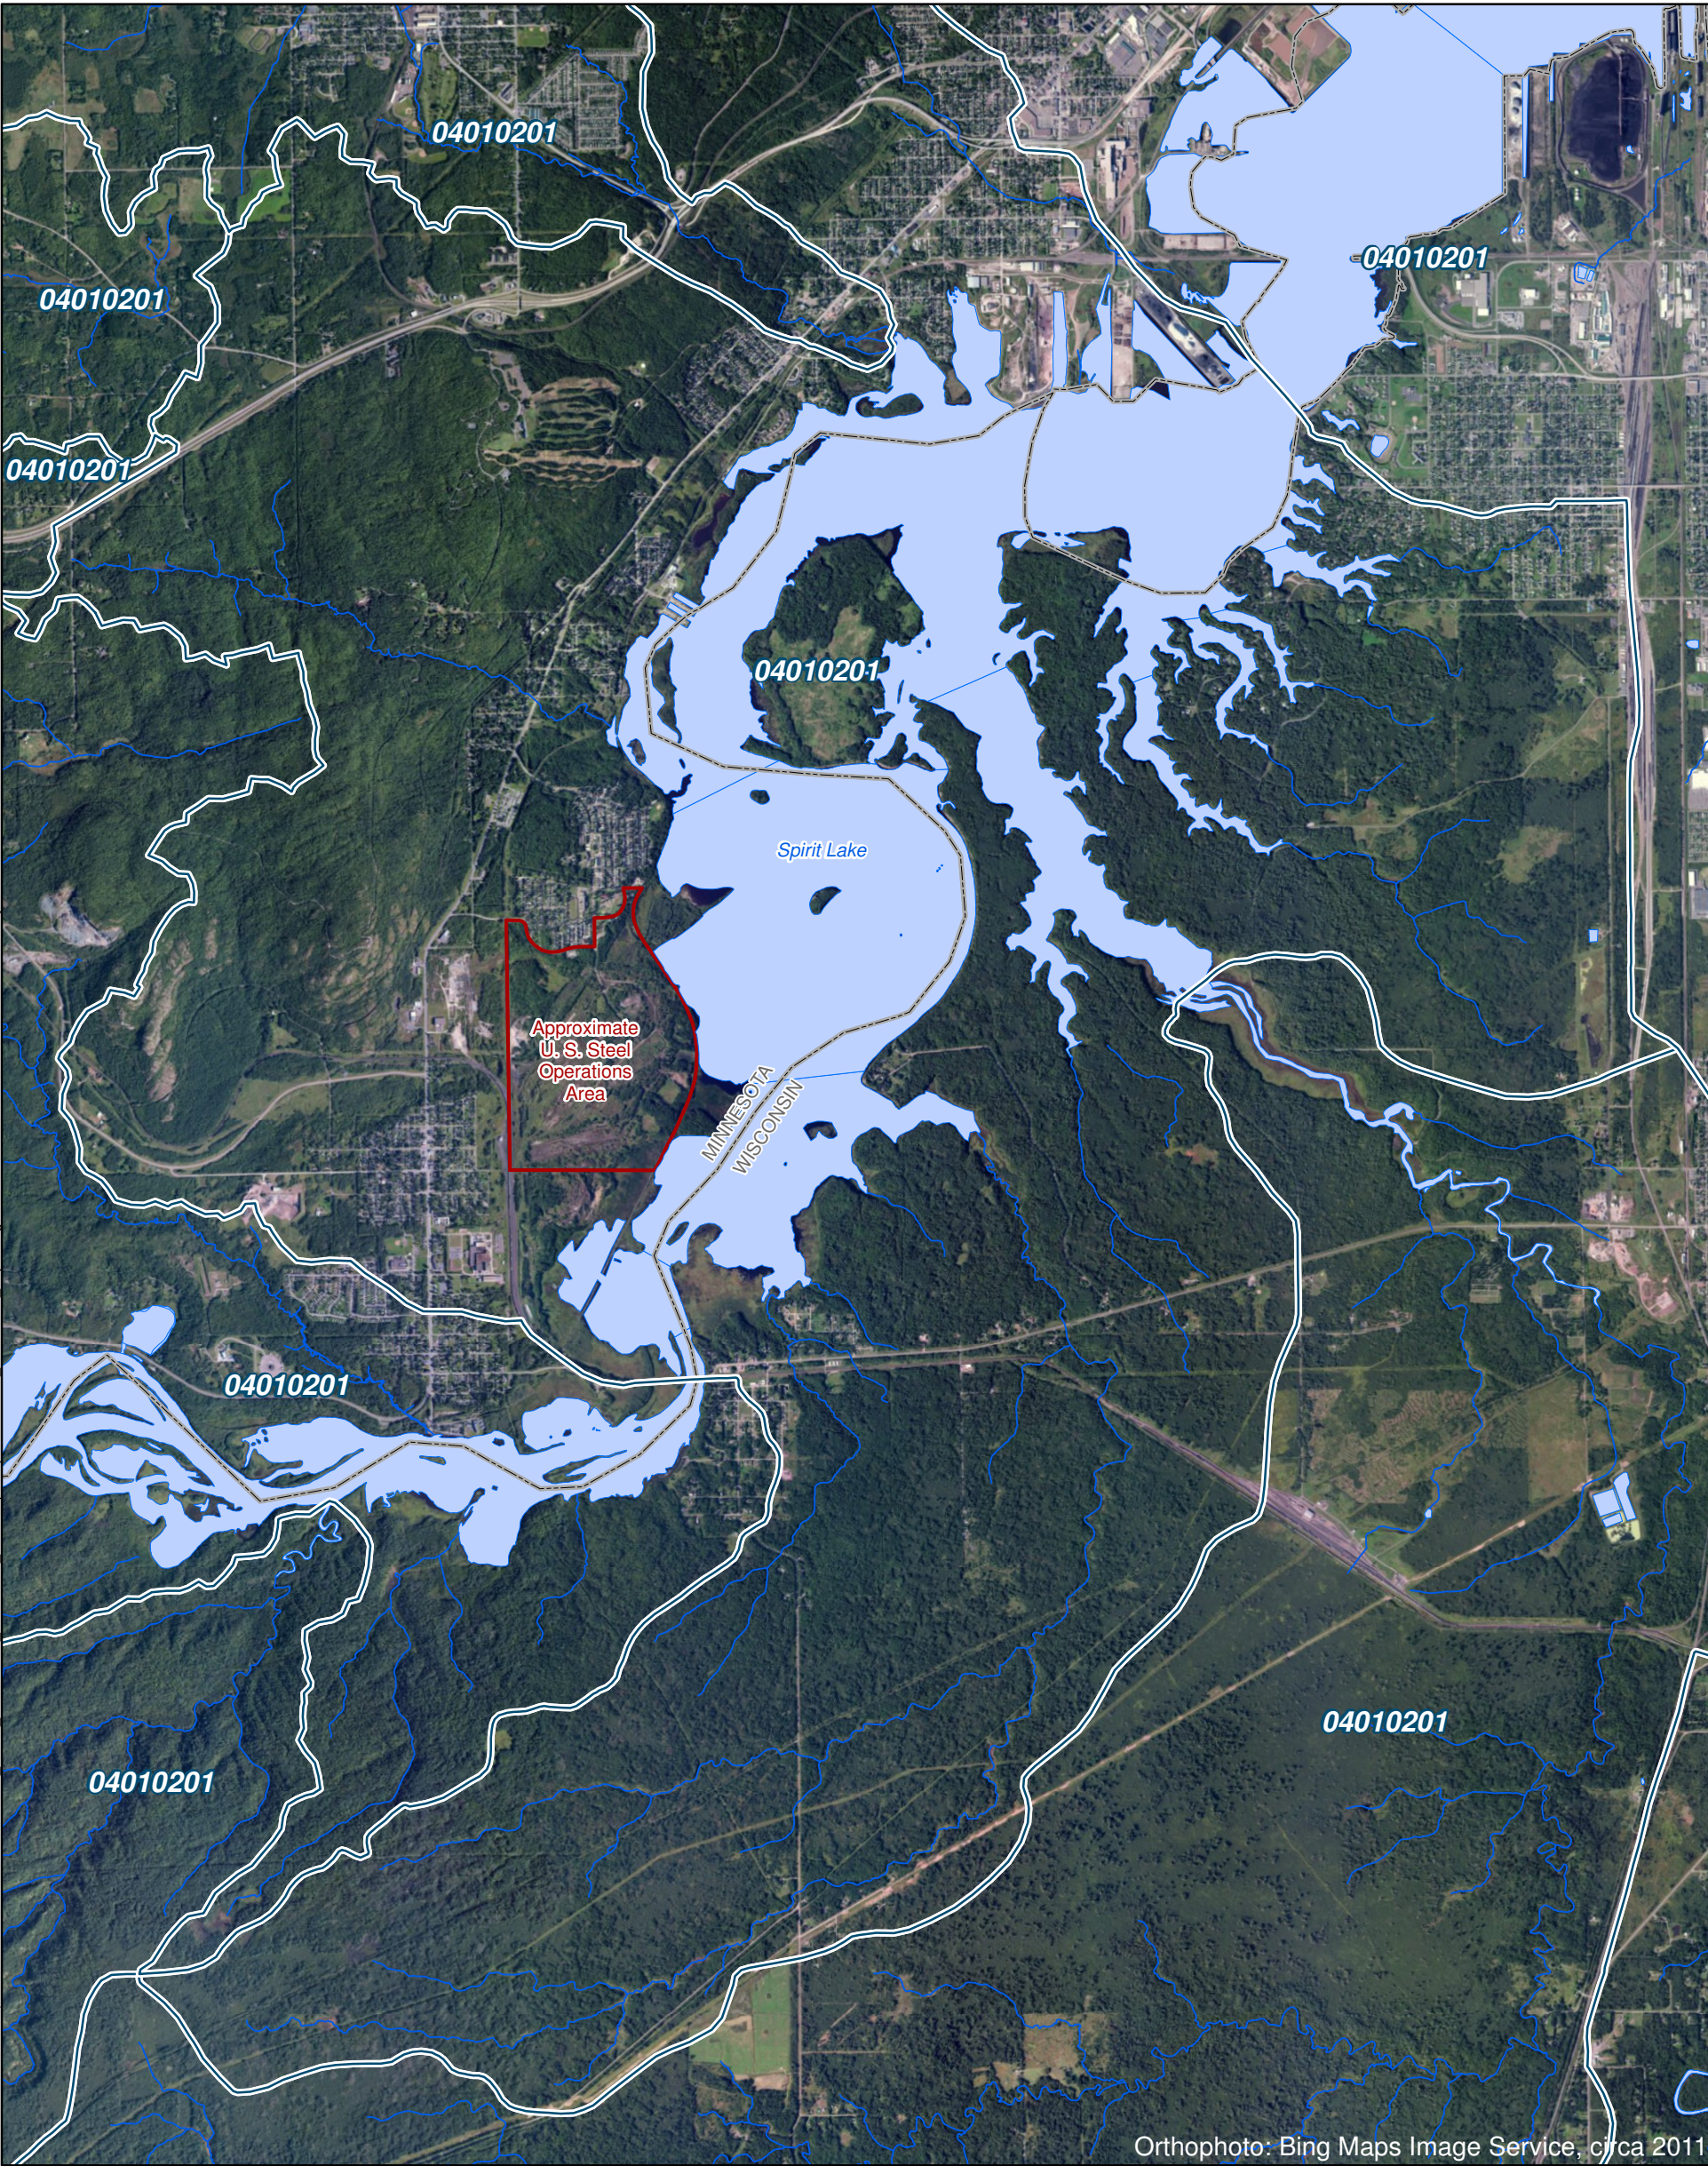
Figure D-7

**WATERSHEDS AND WATERBODIES**  
 Spirit Lake Sediment Site -  
 Former U. S. Steel Duluth Works  
 Saint Louis River  
 Duluth, Minnesota

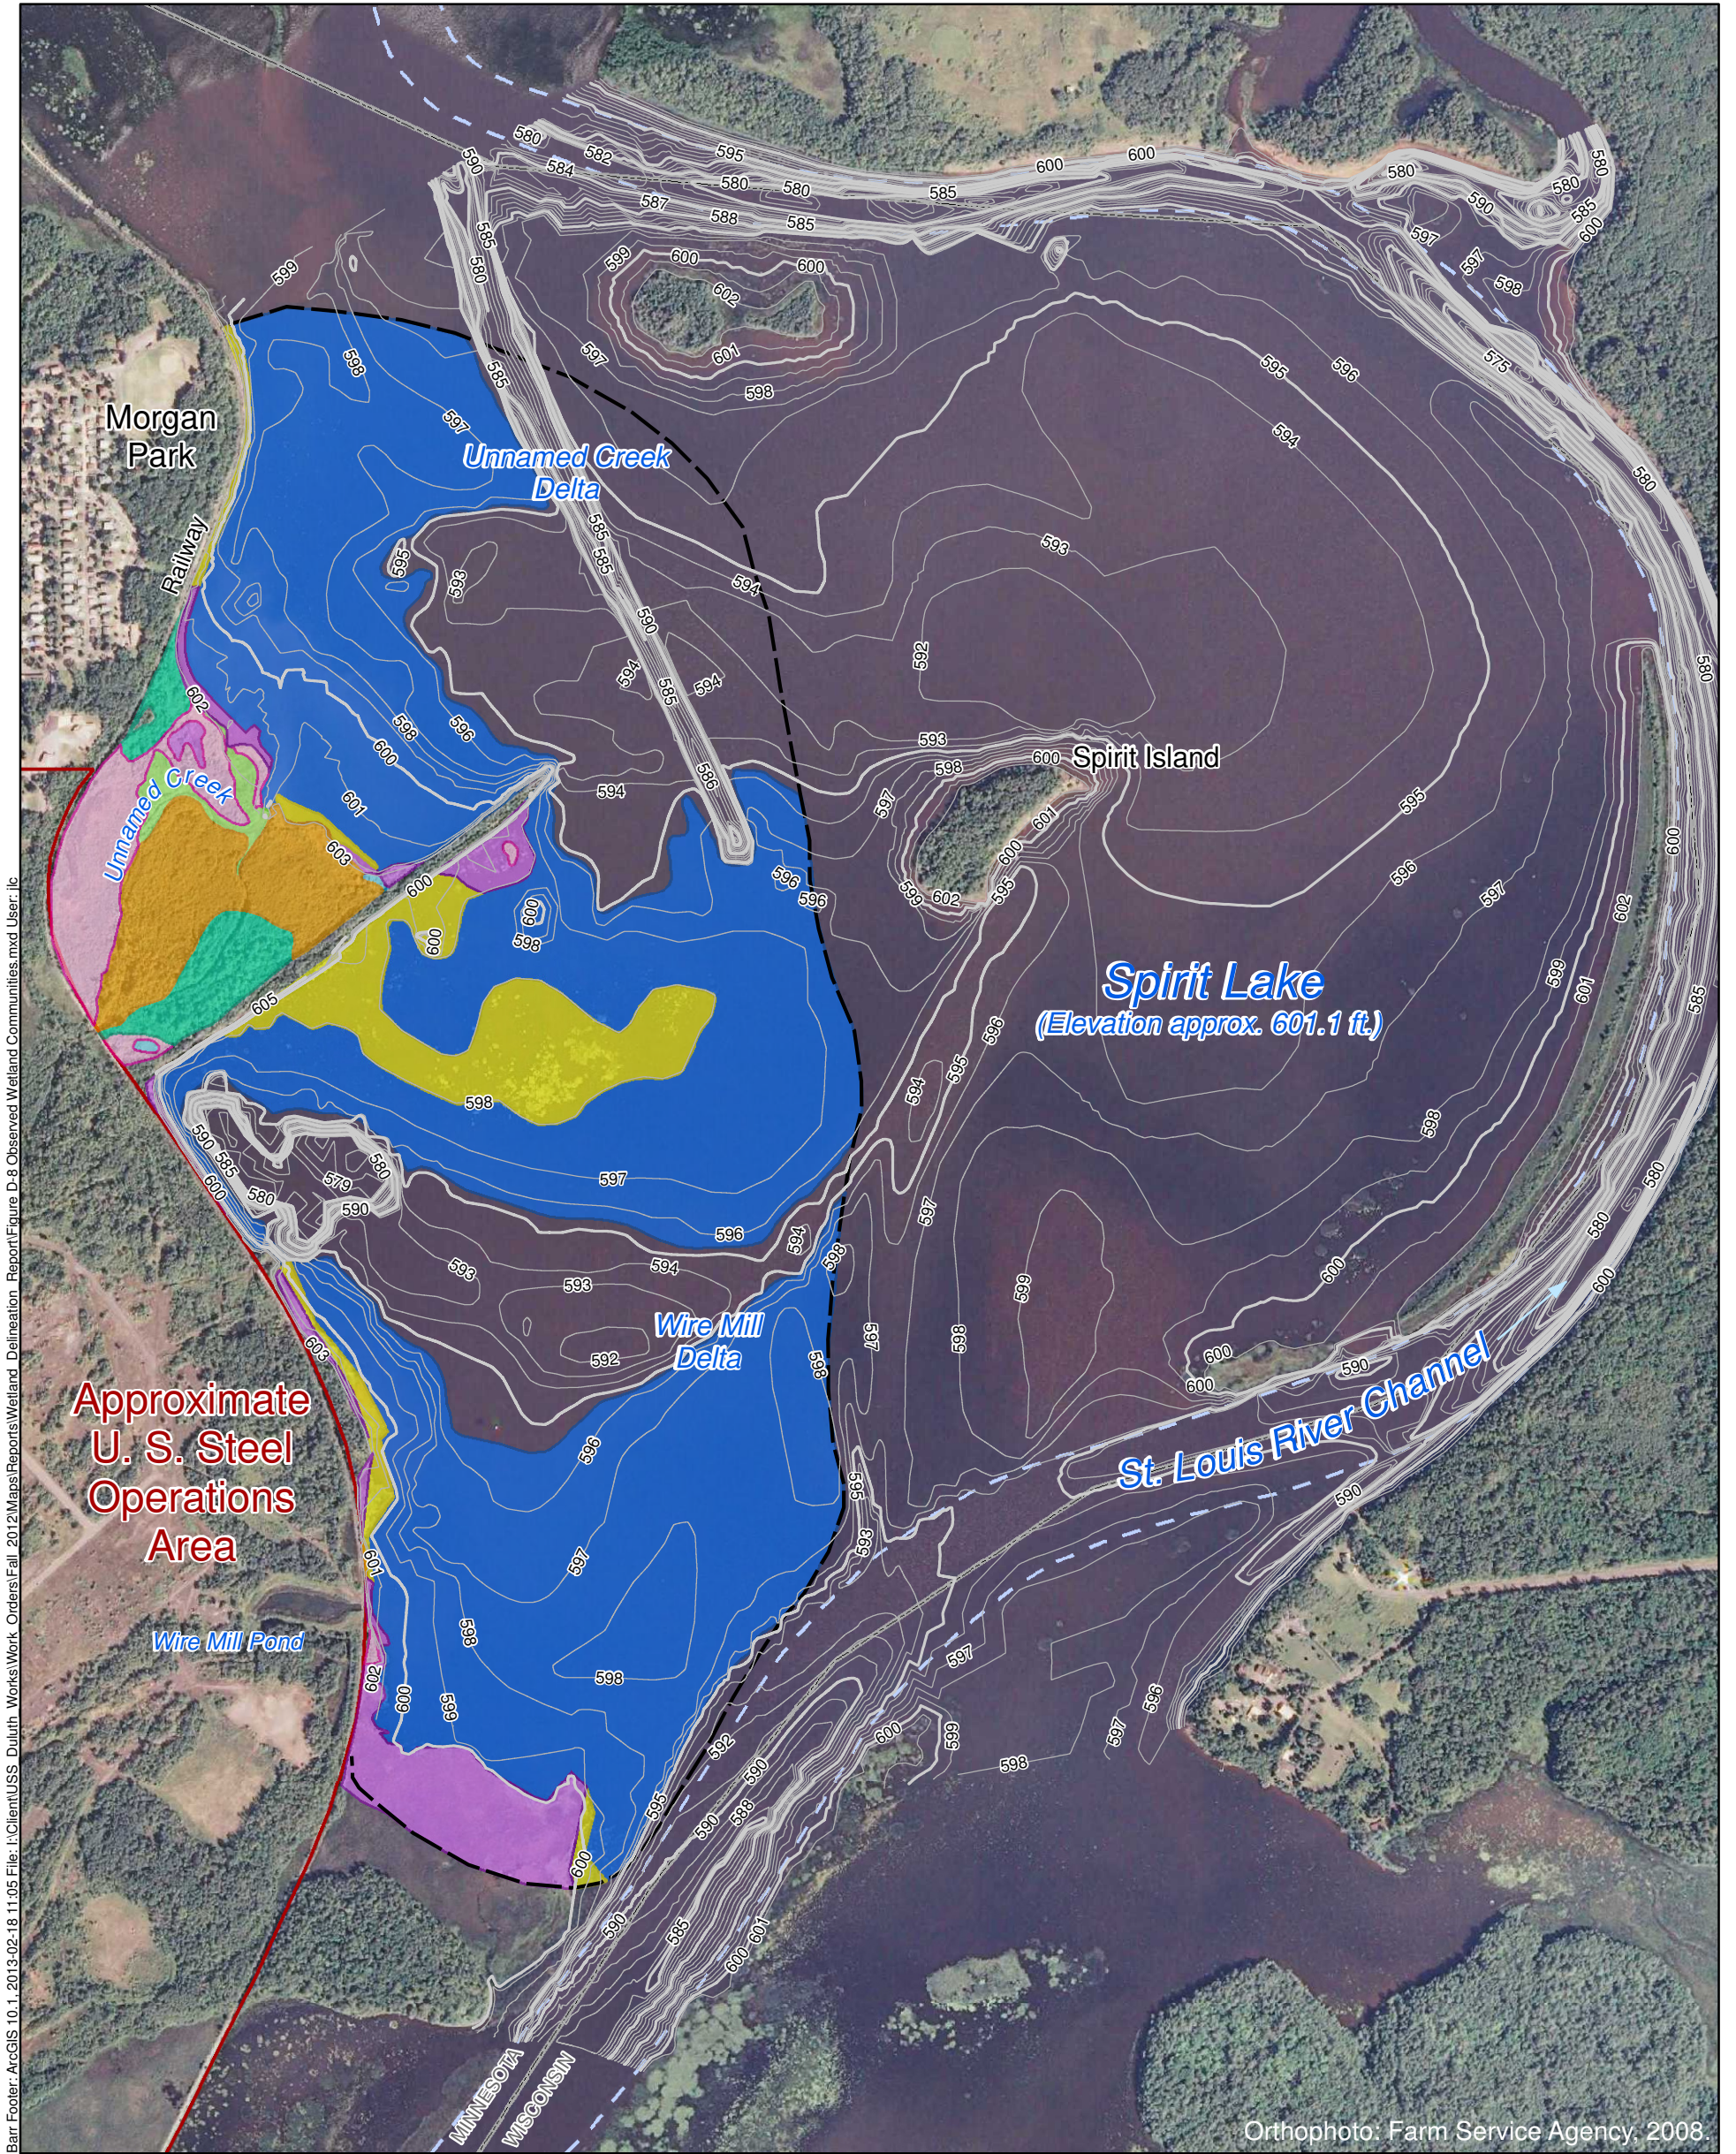
Figure D-8

**OBSERVED WETLAND COMMUNITIES**  
Spirit Lake Sediment Site -  
Former U. S. Steel Duluth Works  
Saint Louis River  
Duluth, Minnesota
