West Branch Grand Calumet River, Hammond and East Chicago, Indiana

The Great Lakes Legacy Act

Reach 1 and 2 River Dredging and Capping

Roxana Marsh Excavation and Restoration

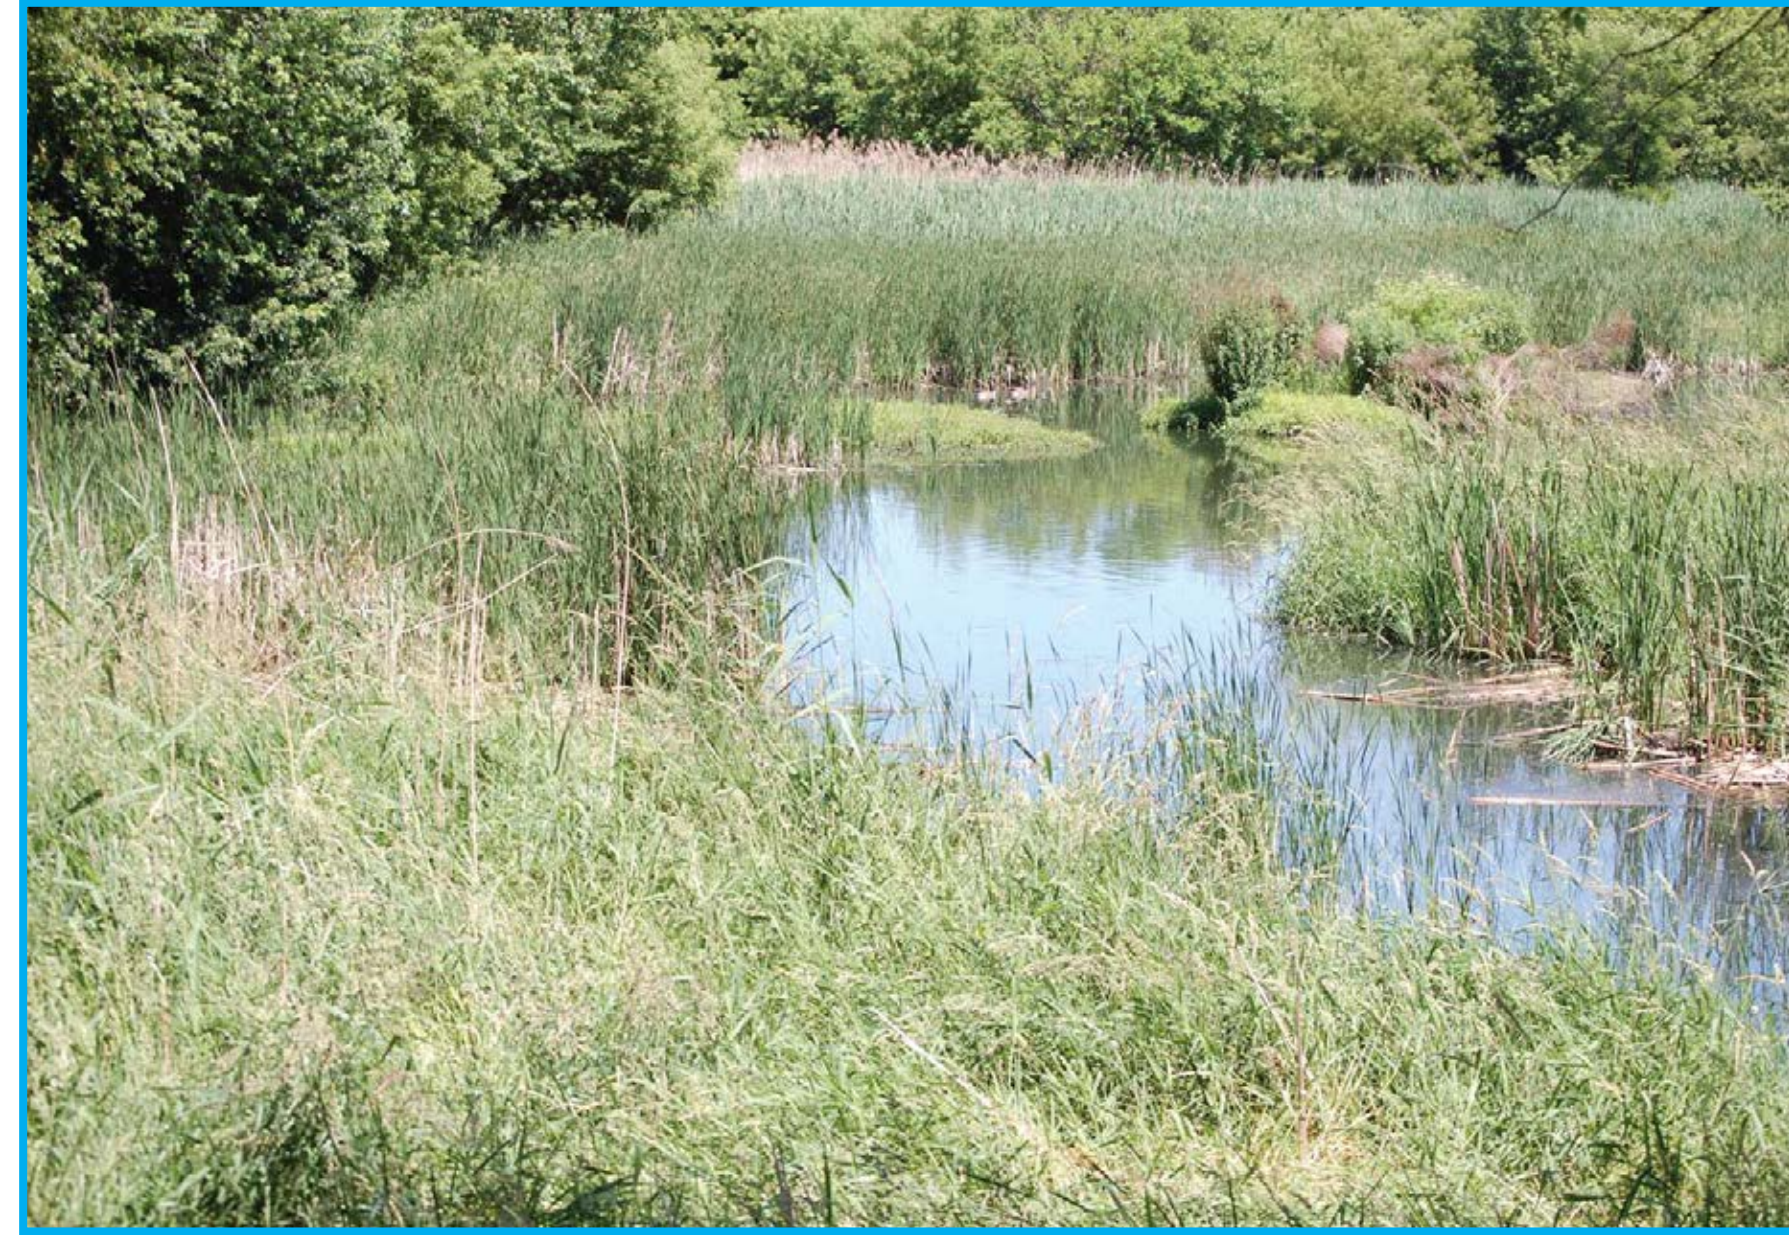
Existing Conditions

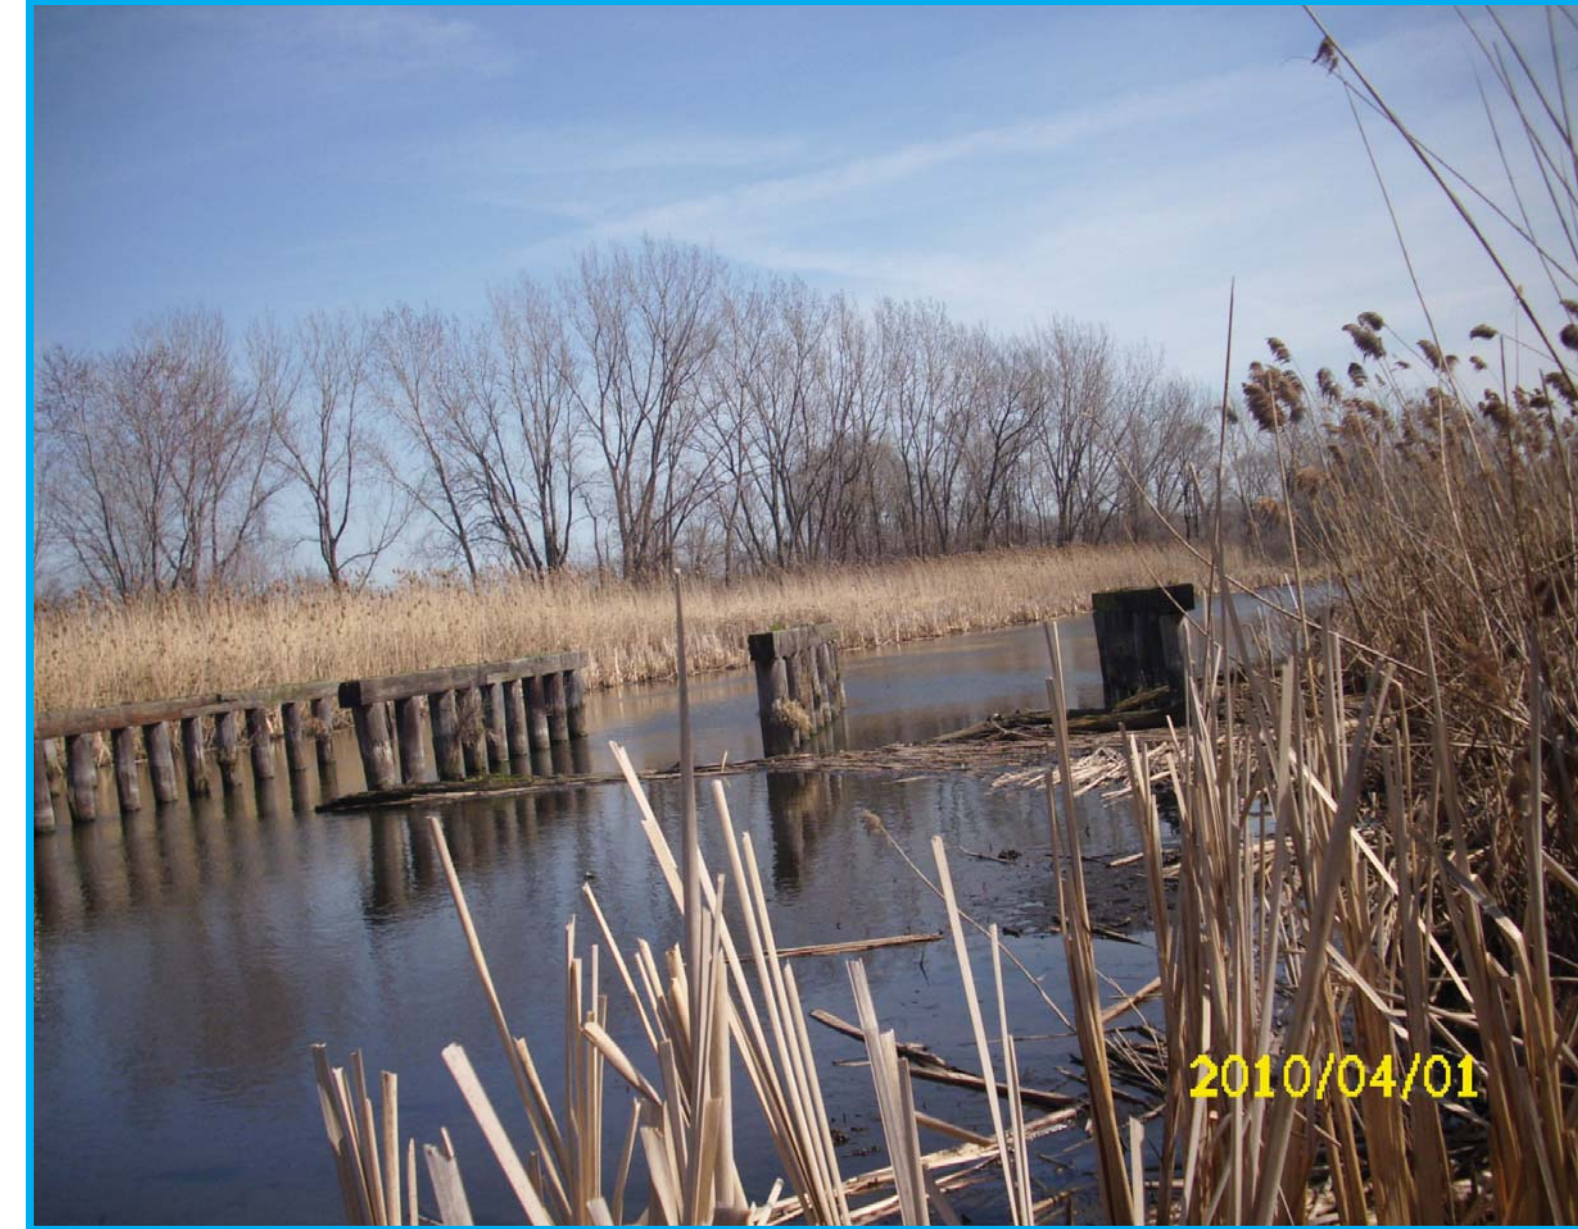
Removing Old Pilings from River

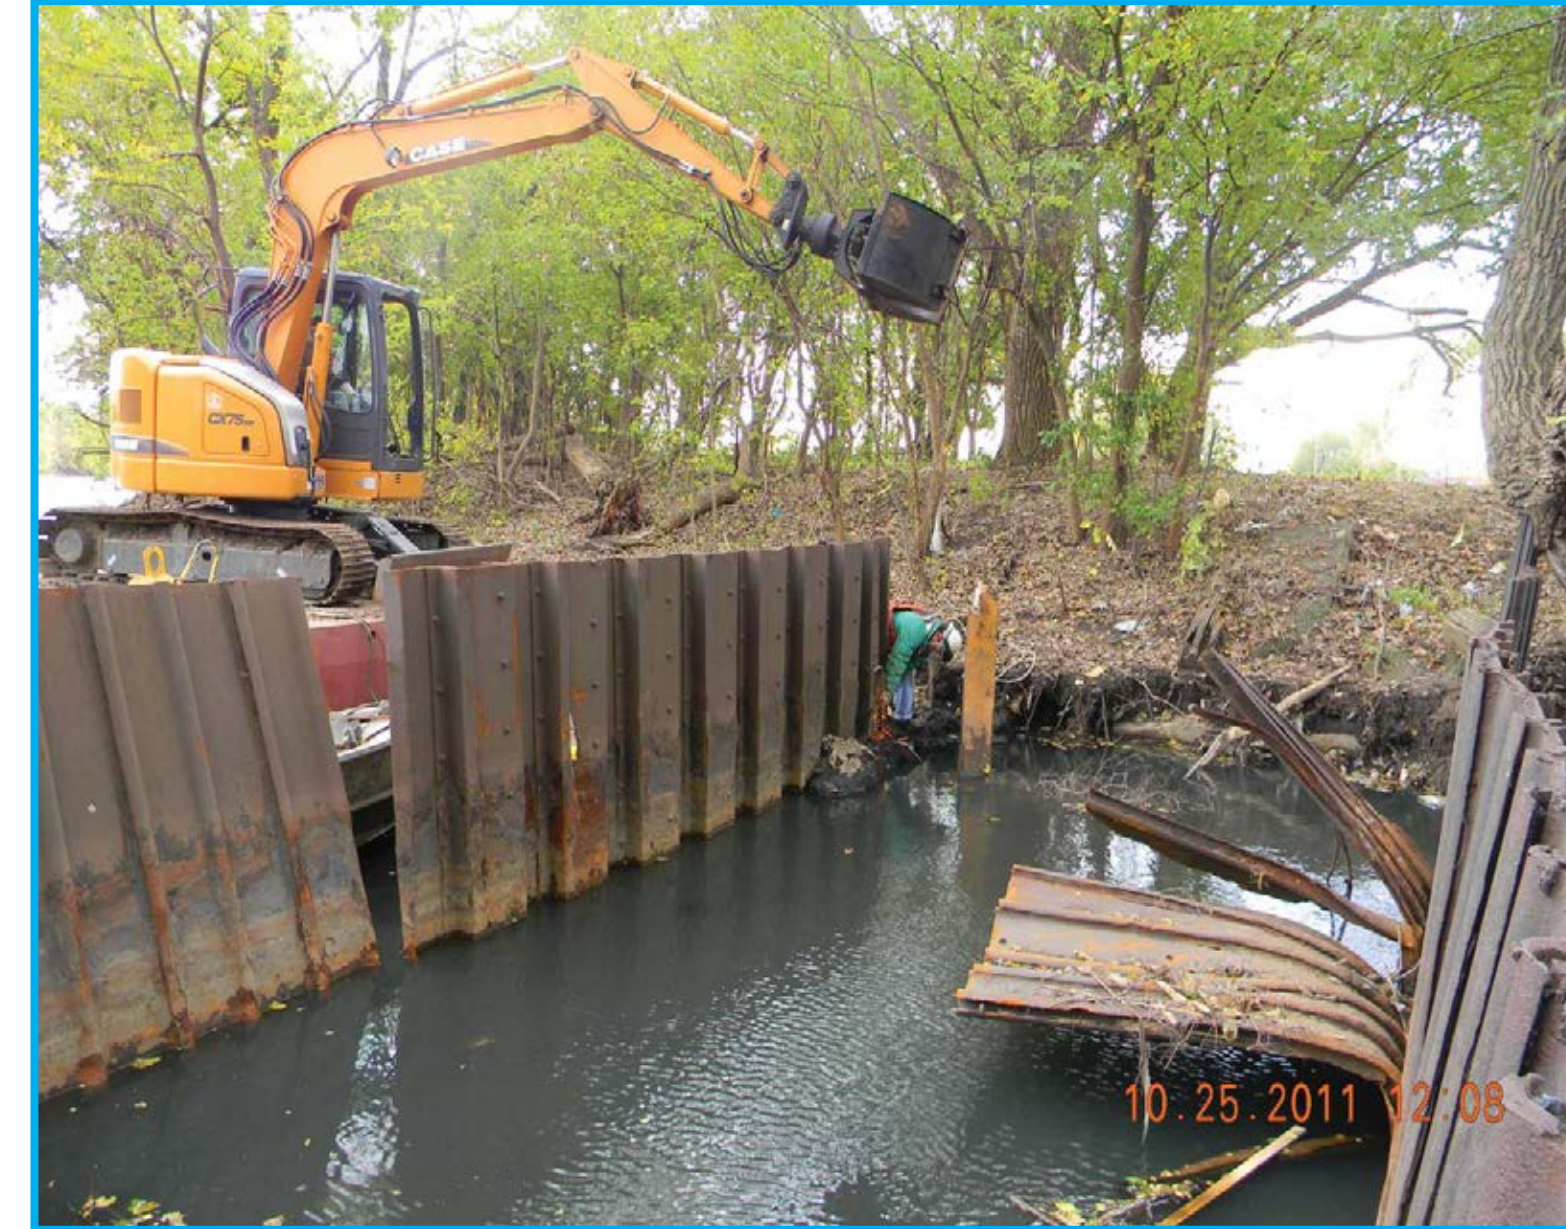
Removing Debris from Banks

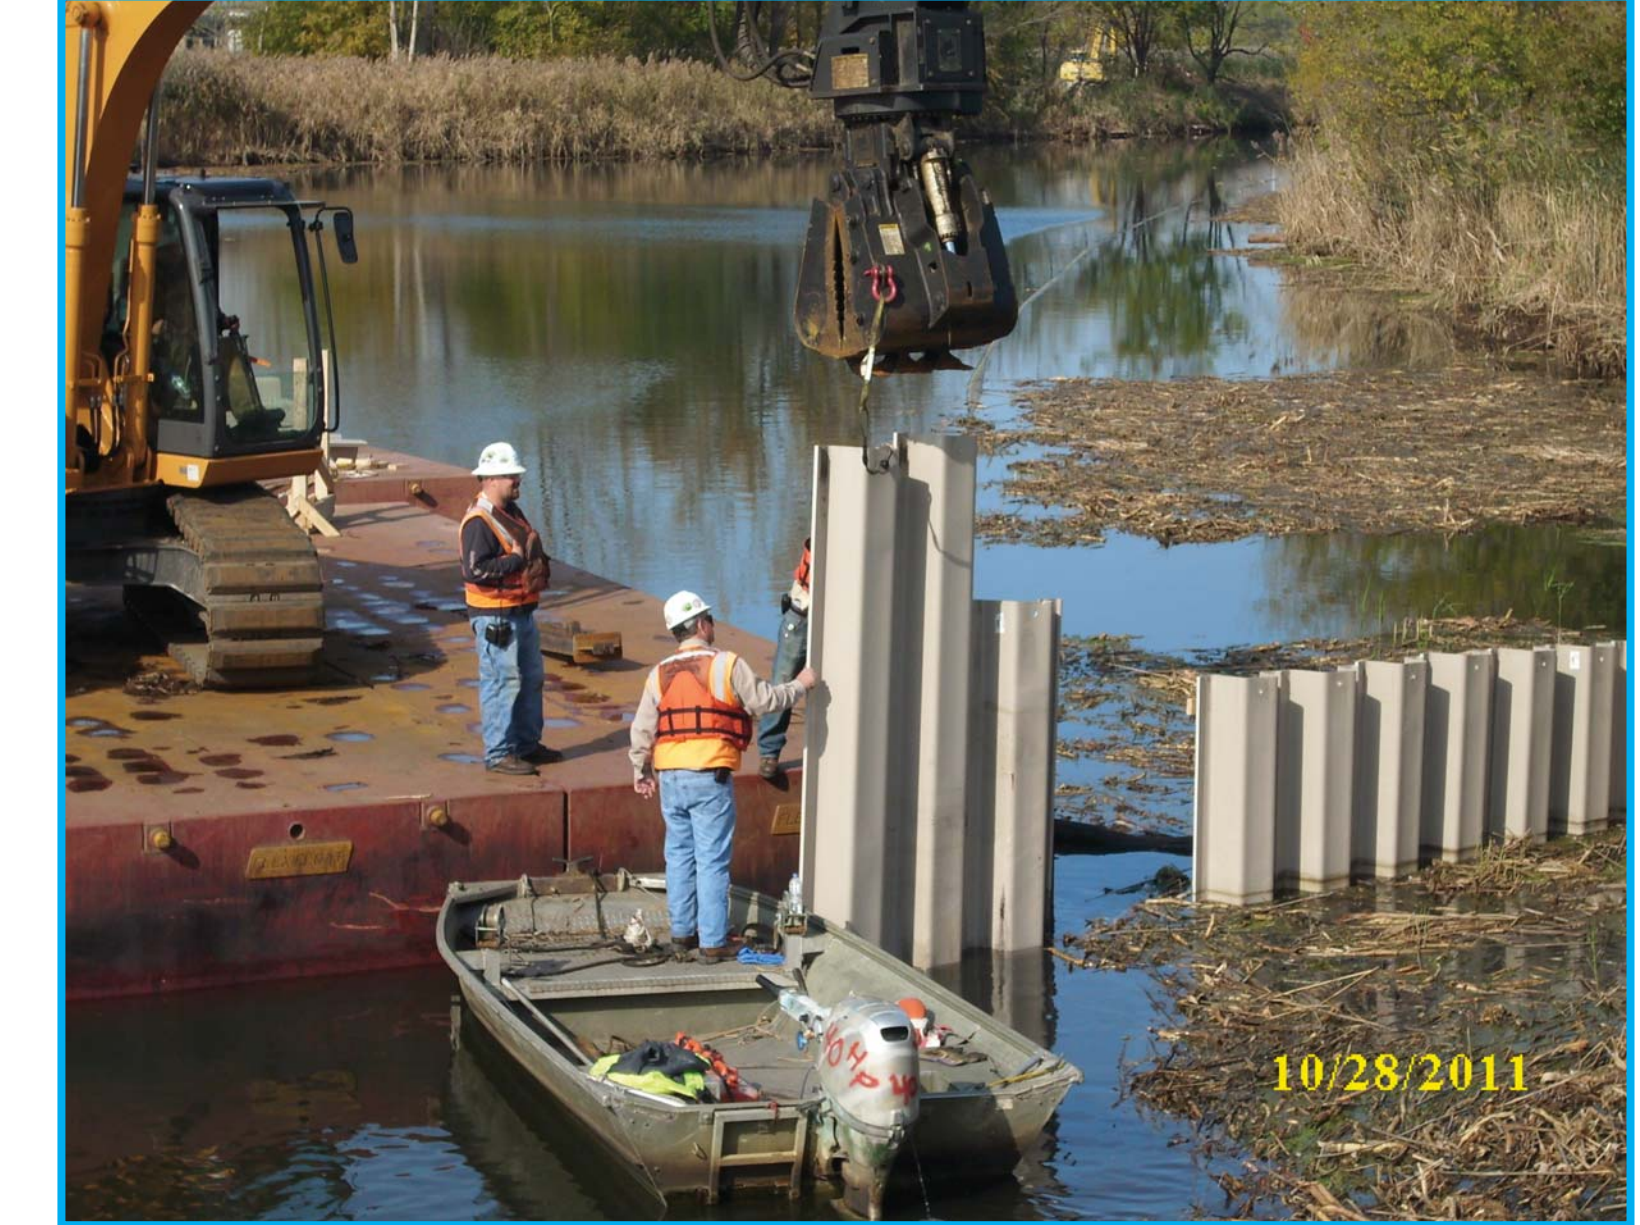
Installing Sheet Pile Weir

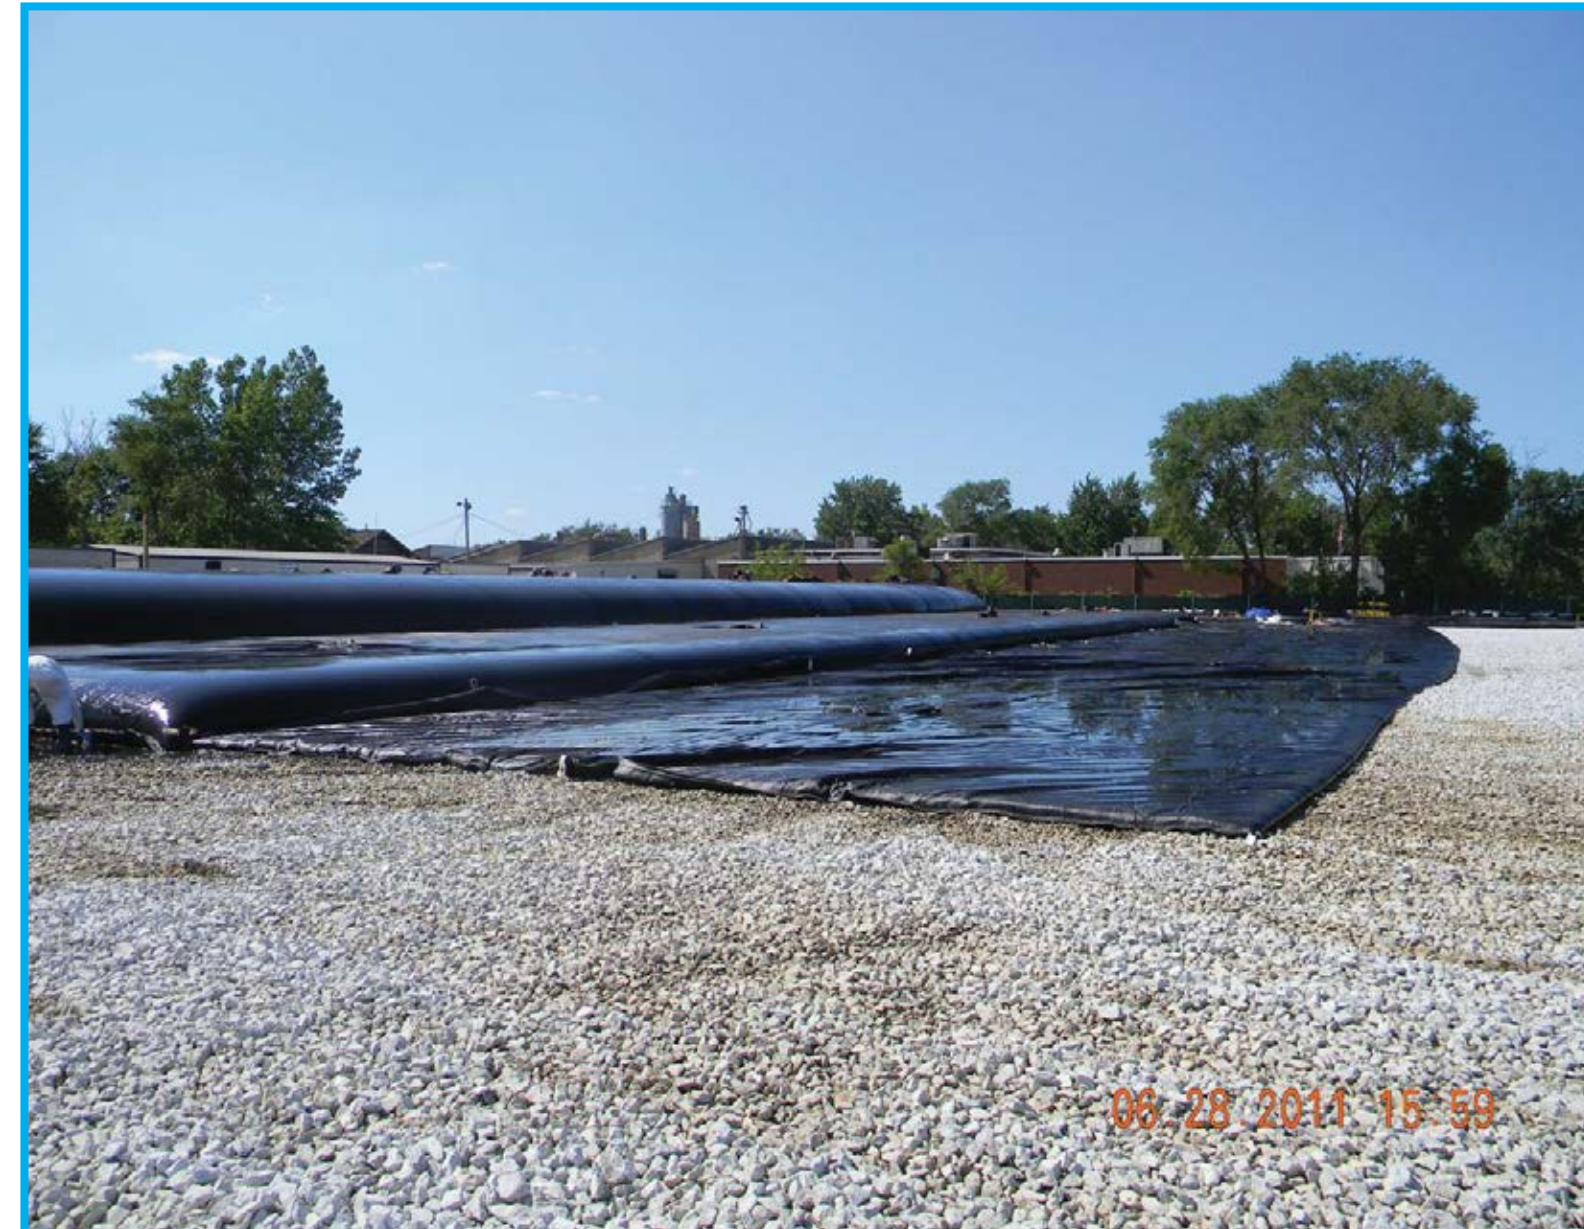
Unrolling Geotextile Tube

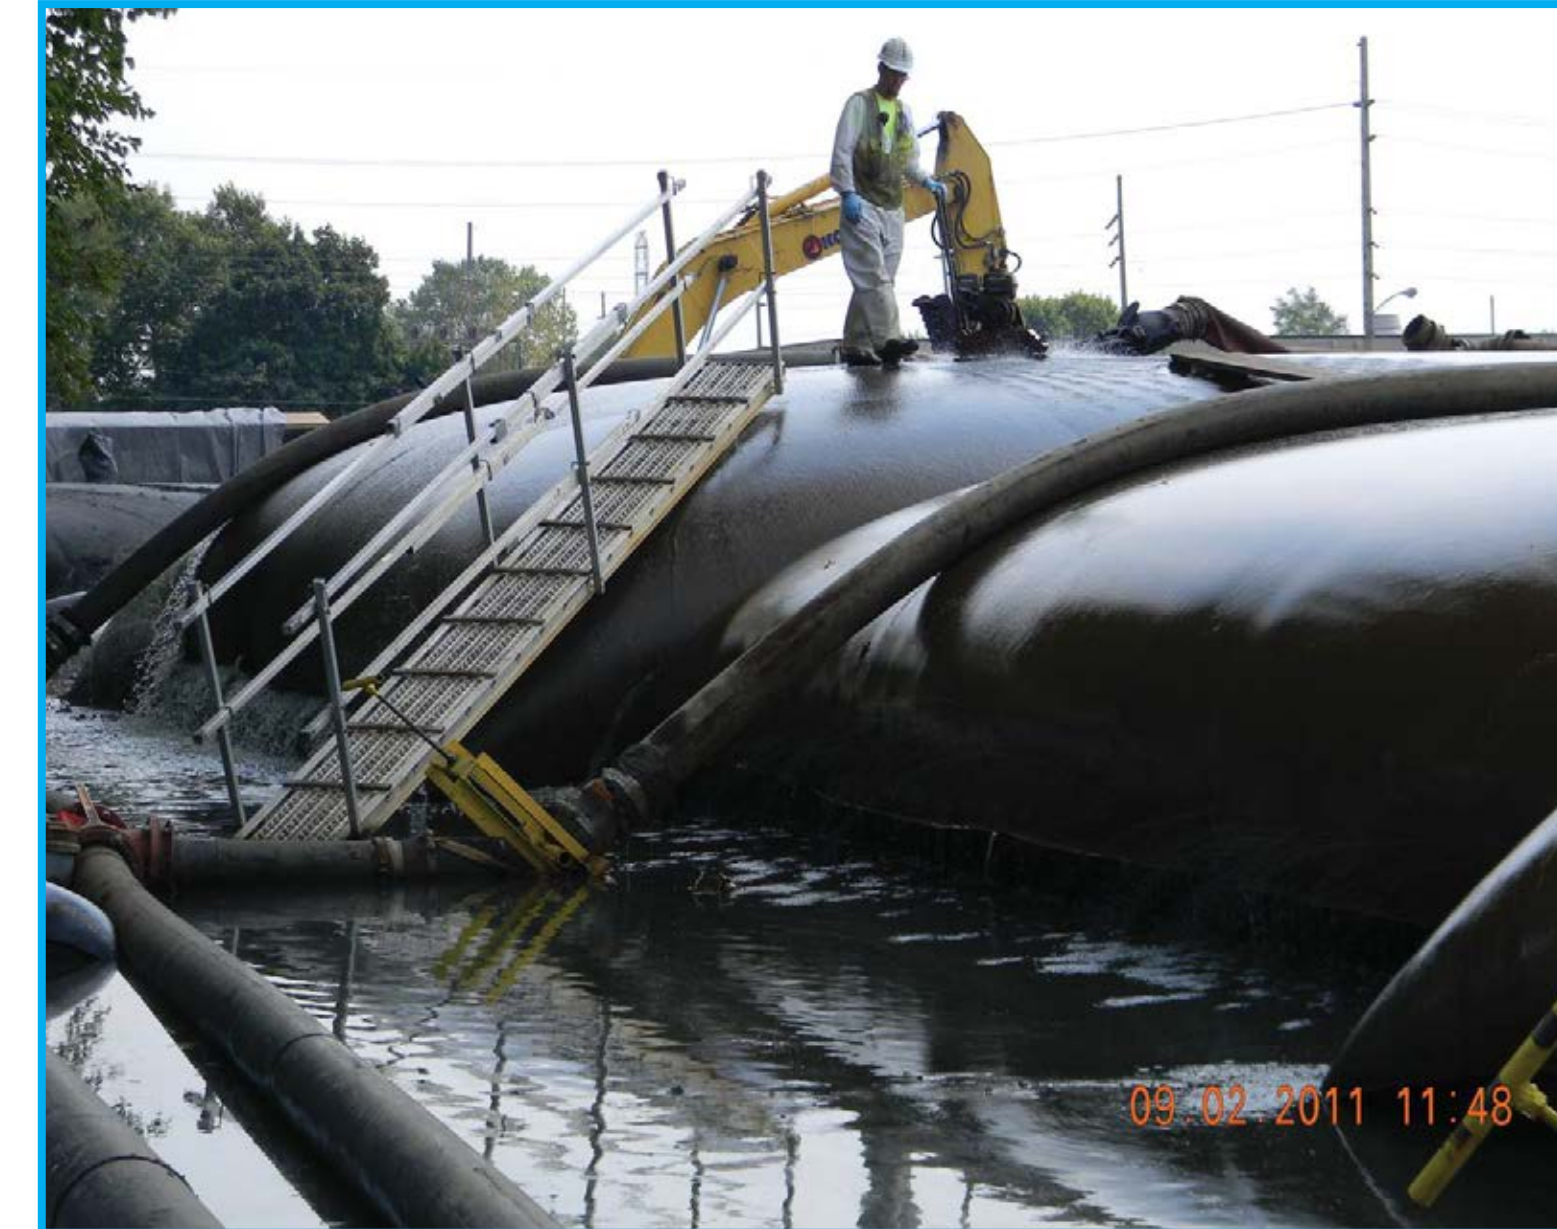
Sediment Dewatering

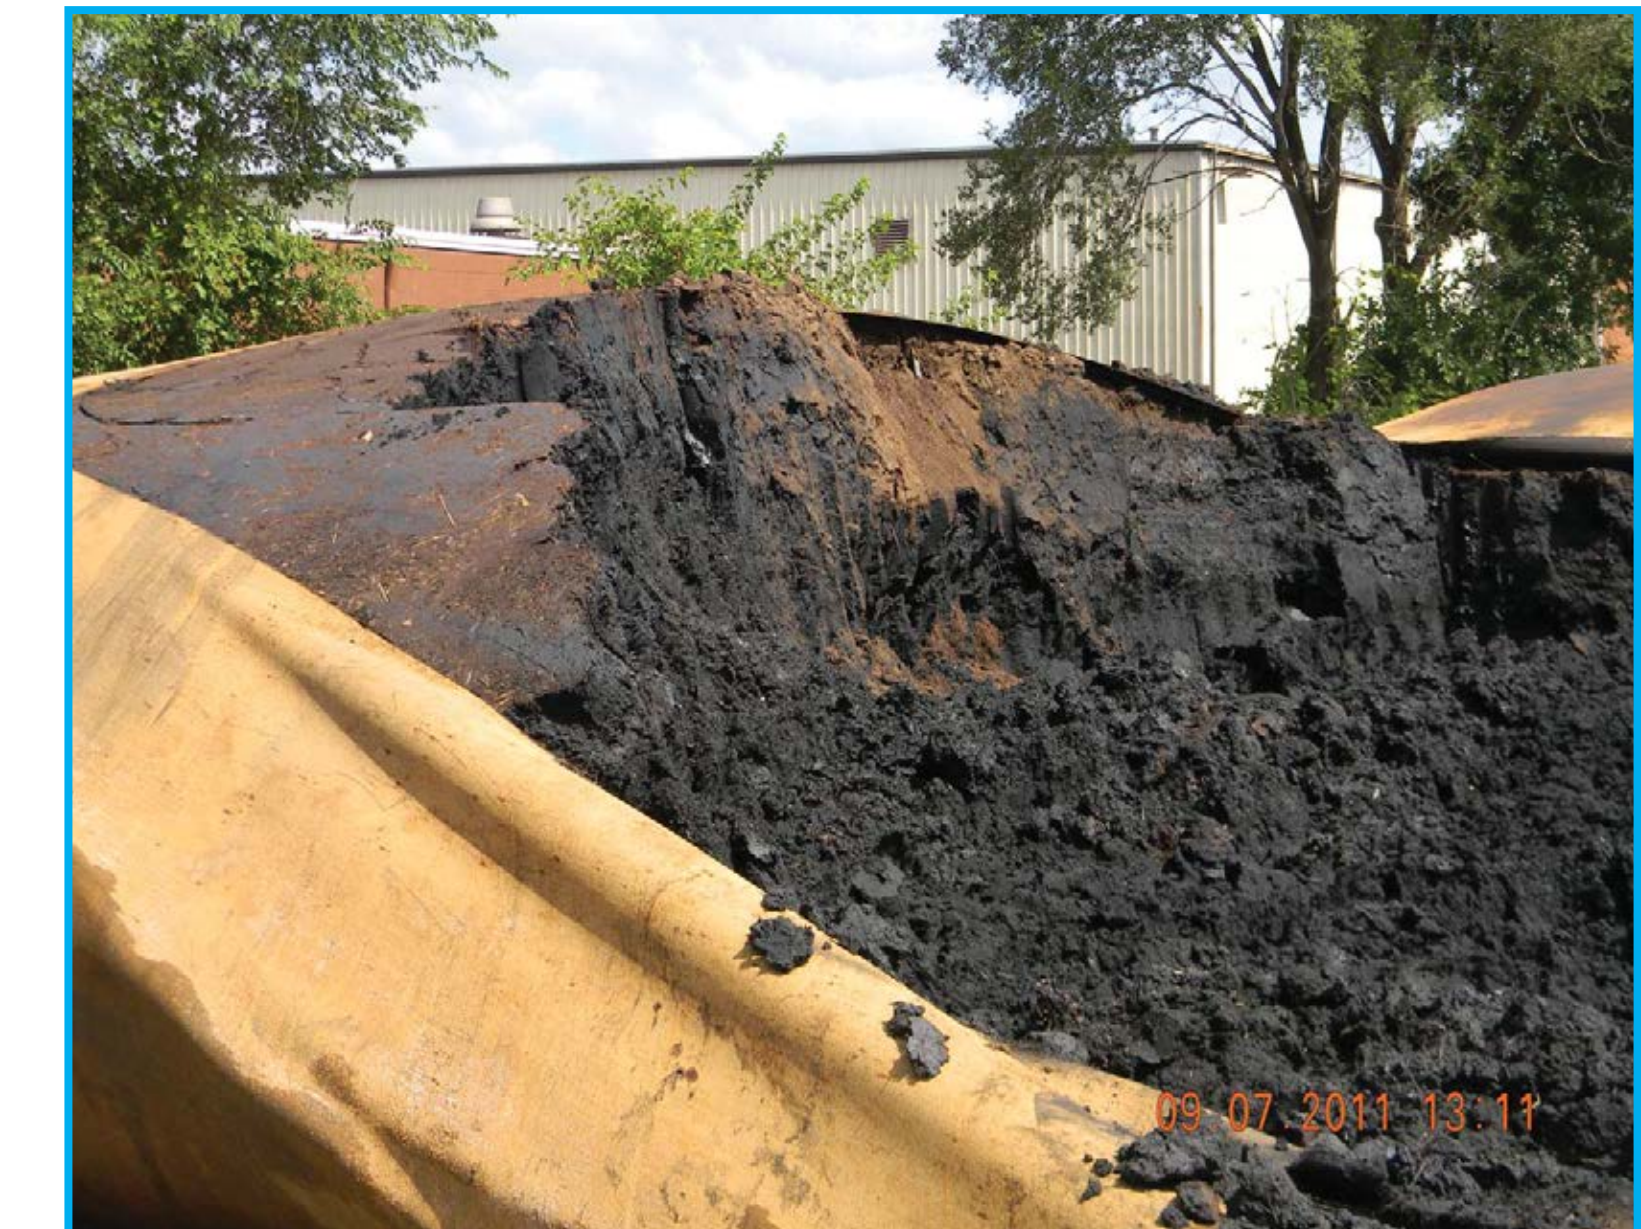
Sediment in Geotextile Tubes

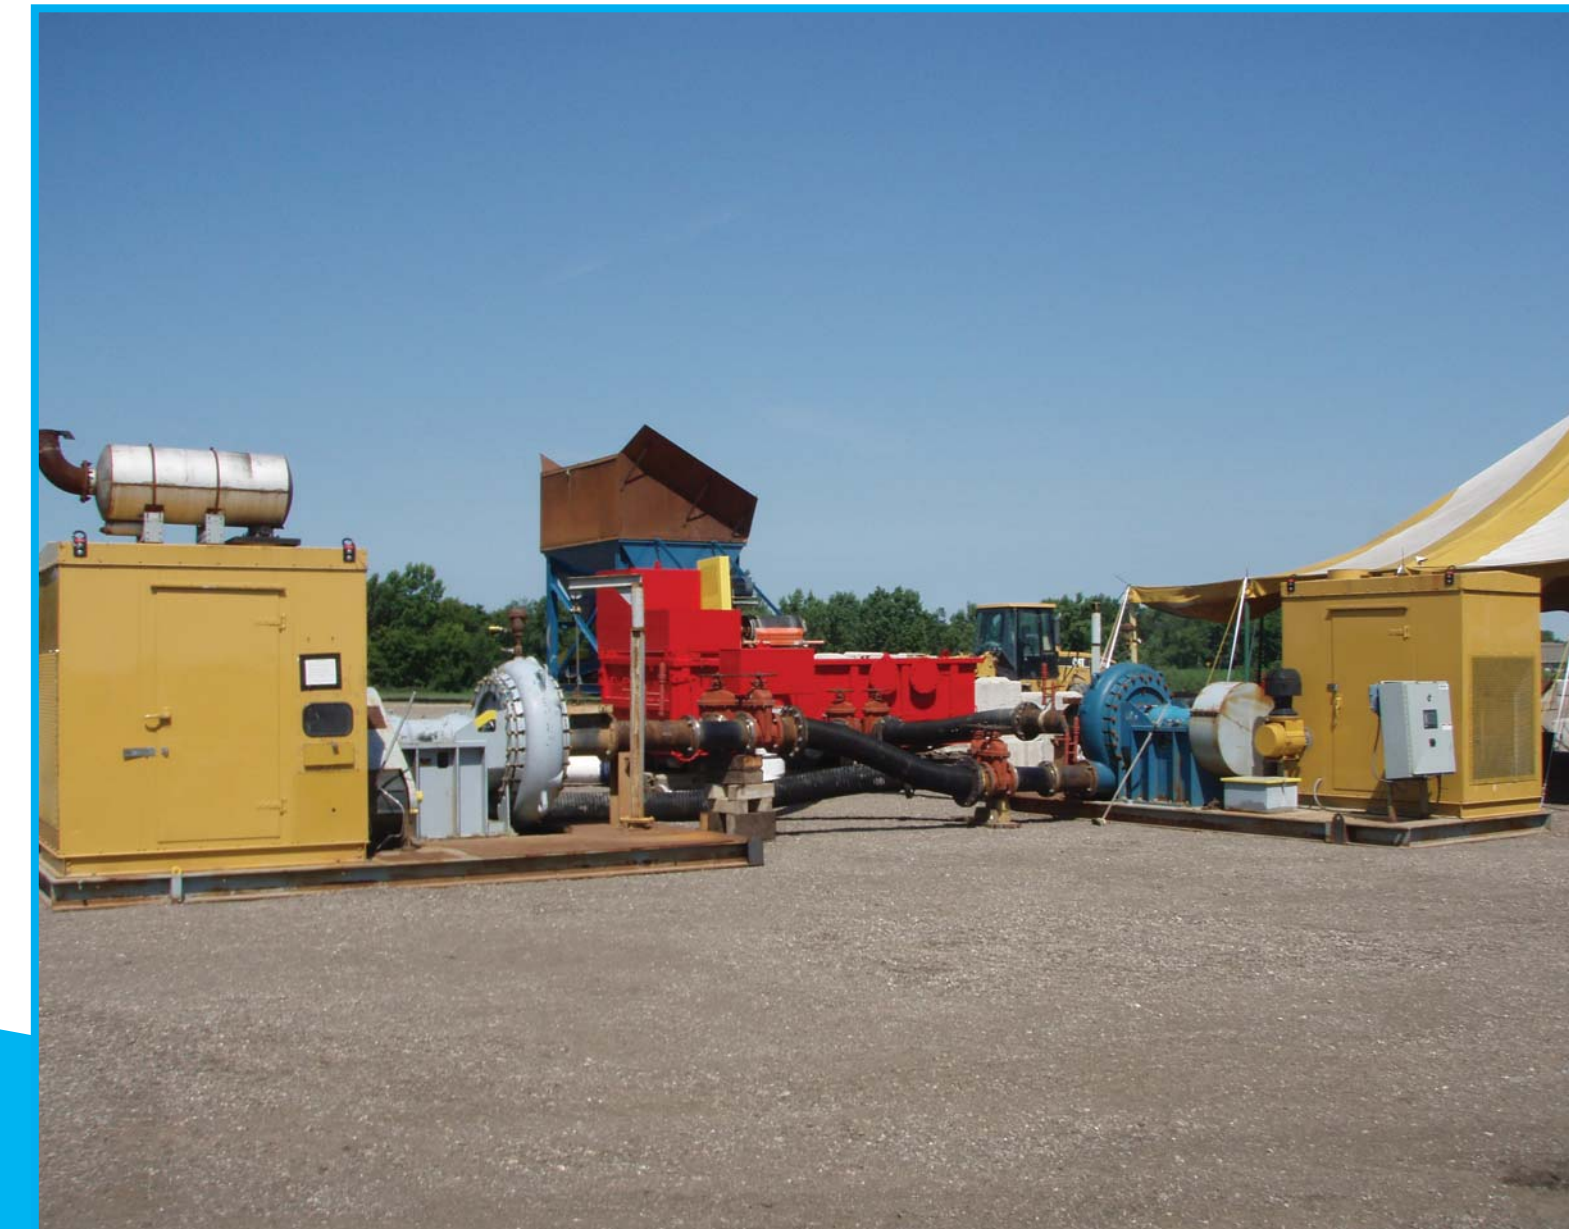
Installing Cap Plant

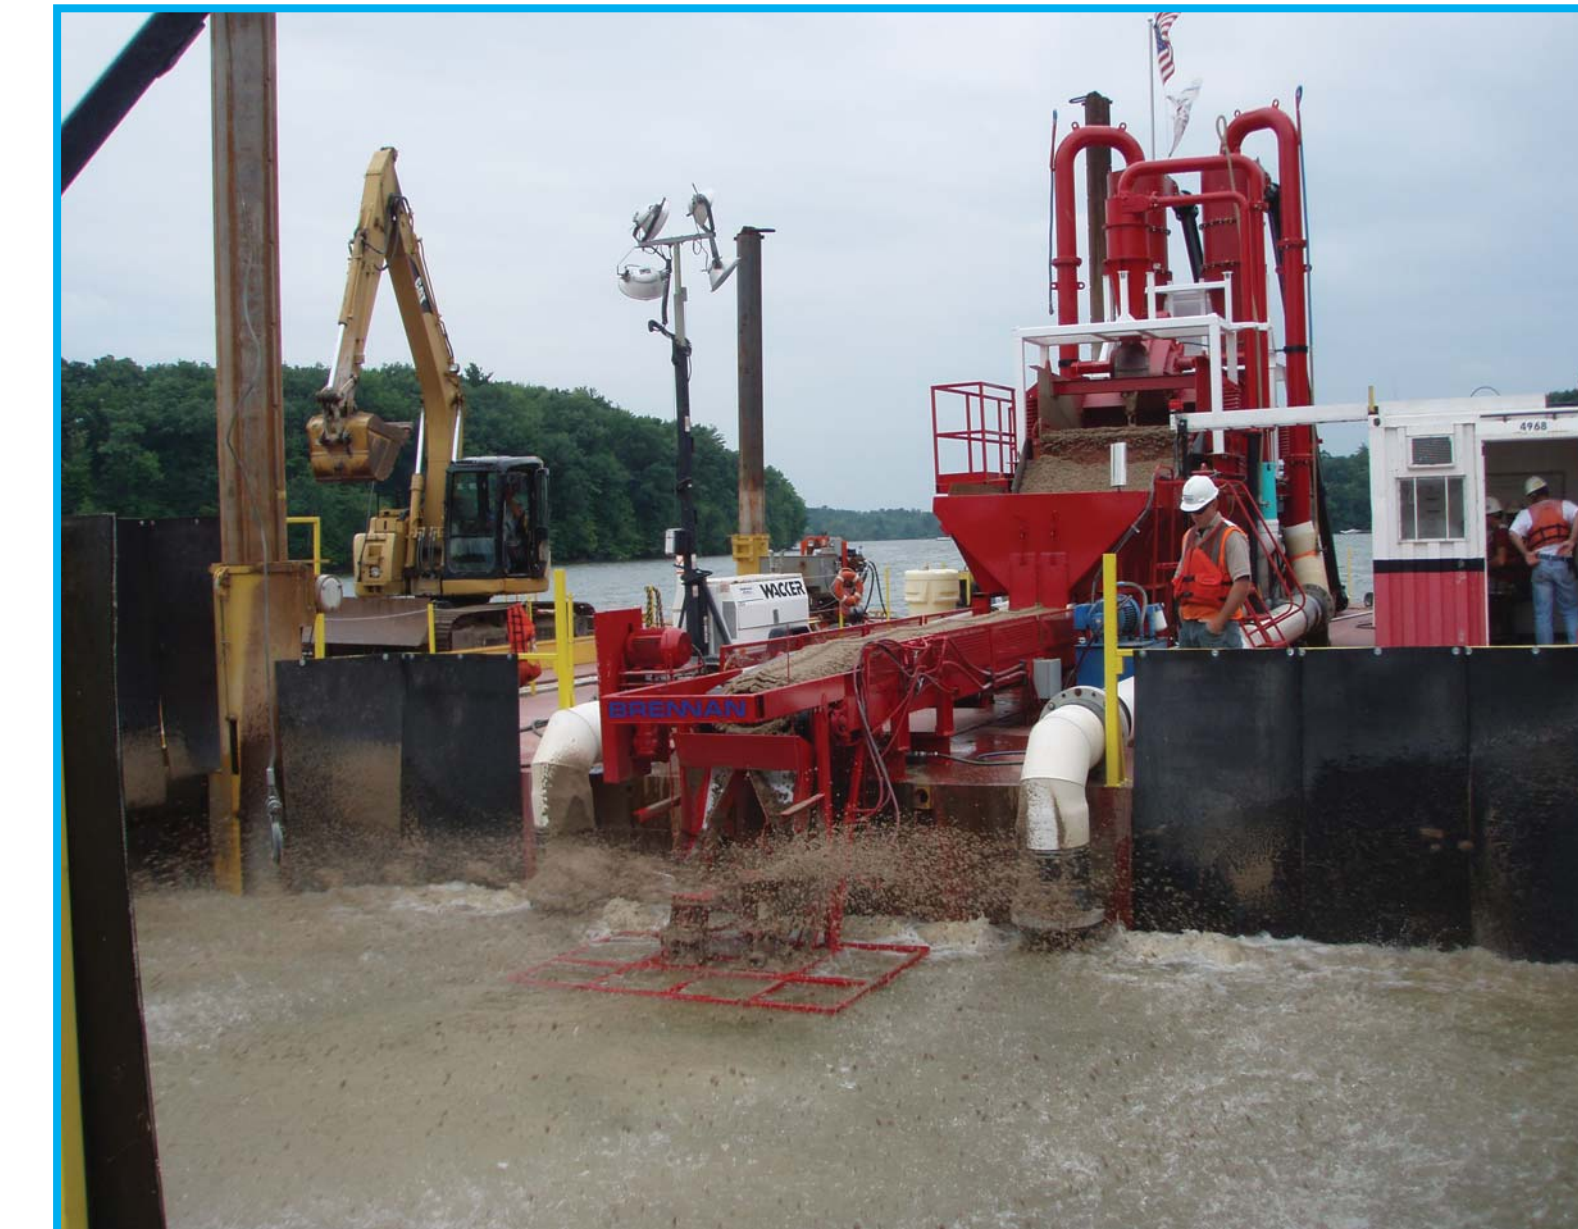
Placing Sand Cap

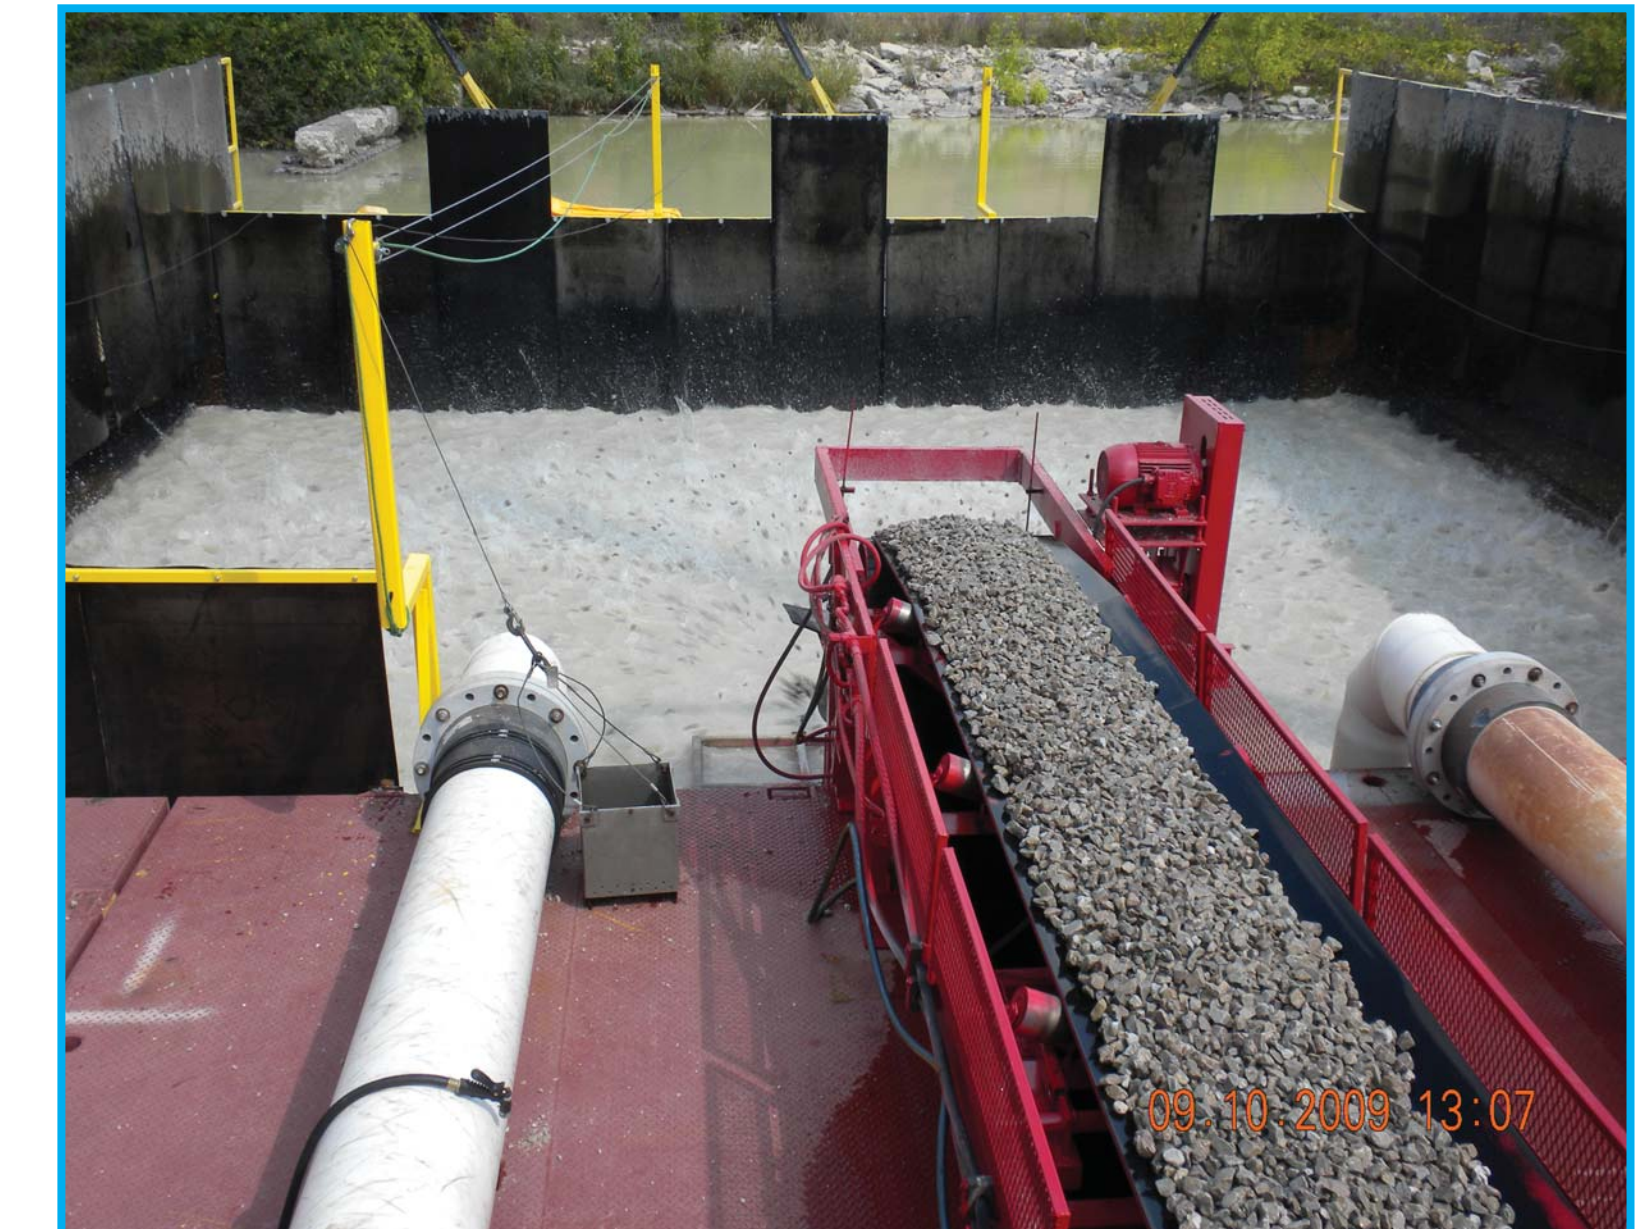
Placing Sand Cap Detail
