West Branch Grand Calumet River, Hammond and East Chicago, Indiana

The Great Lakes Legacy Act

Reach 1 and 2 River Dredging and Capping

Roxana Marsh Excavation and Restoration

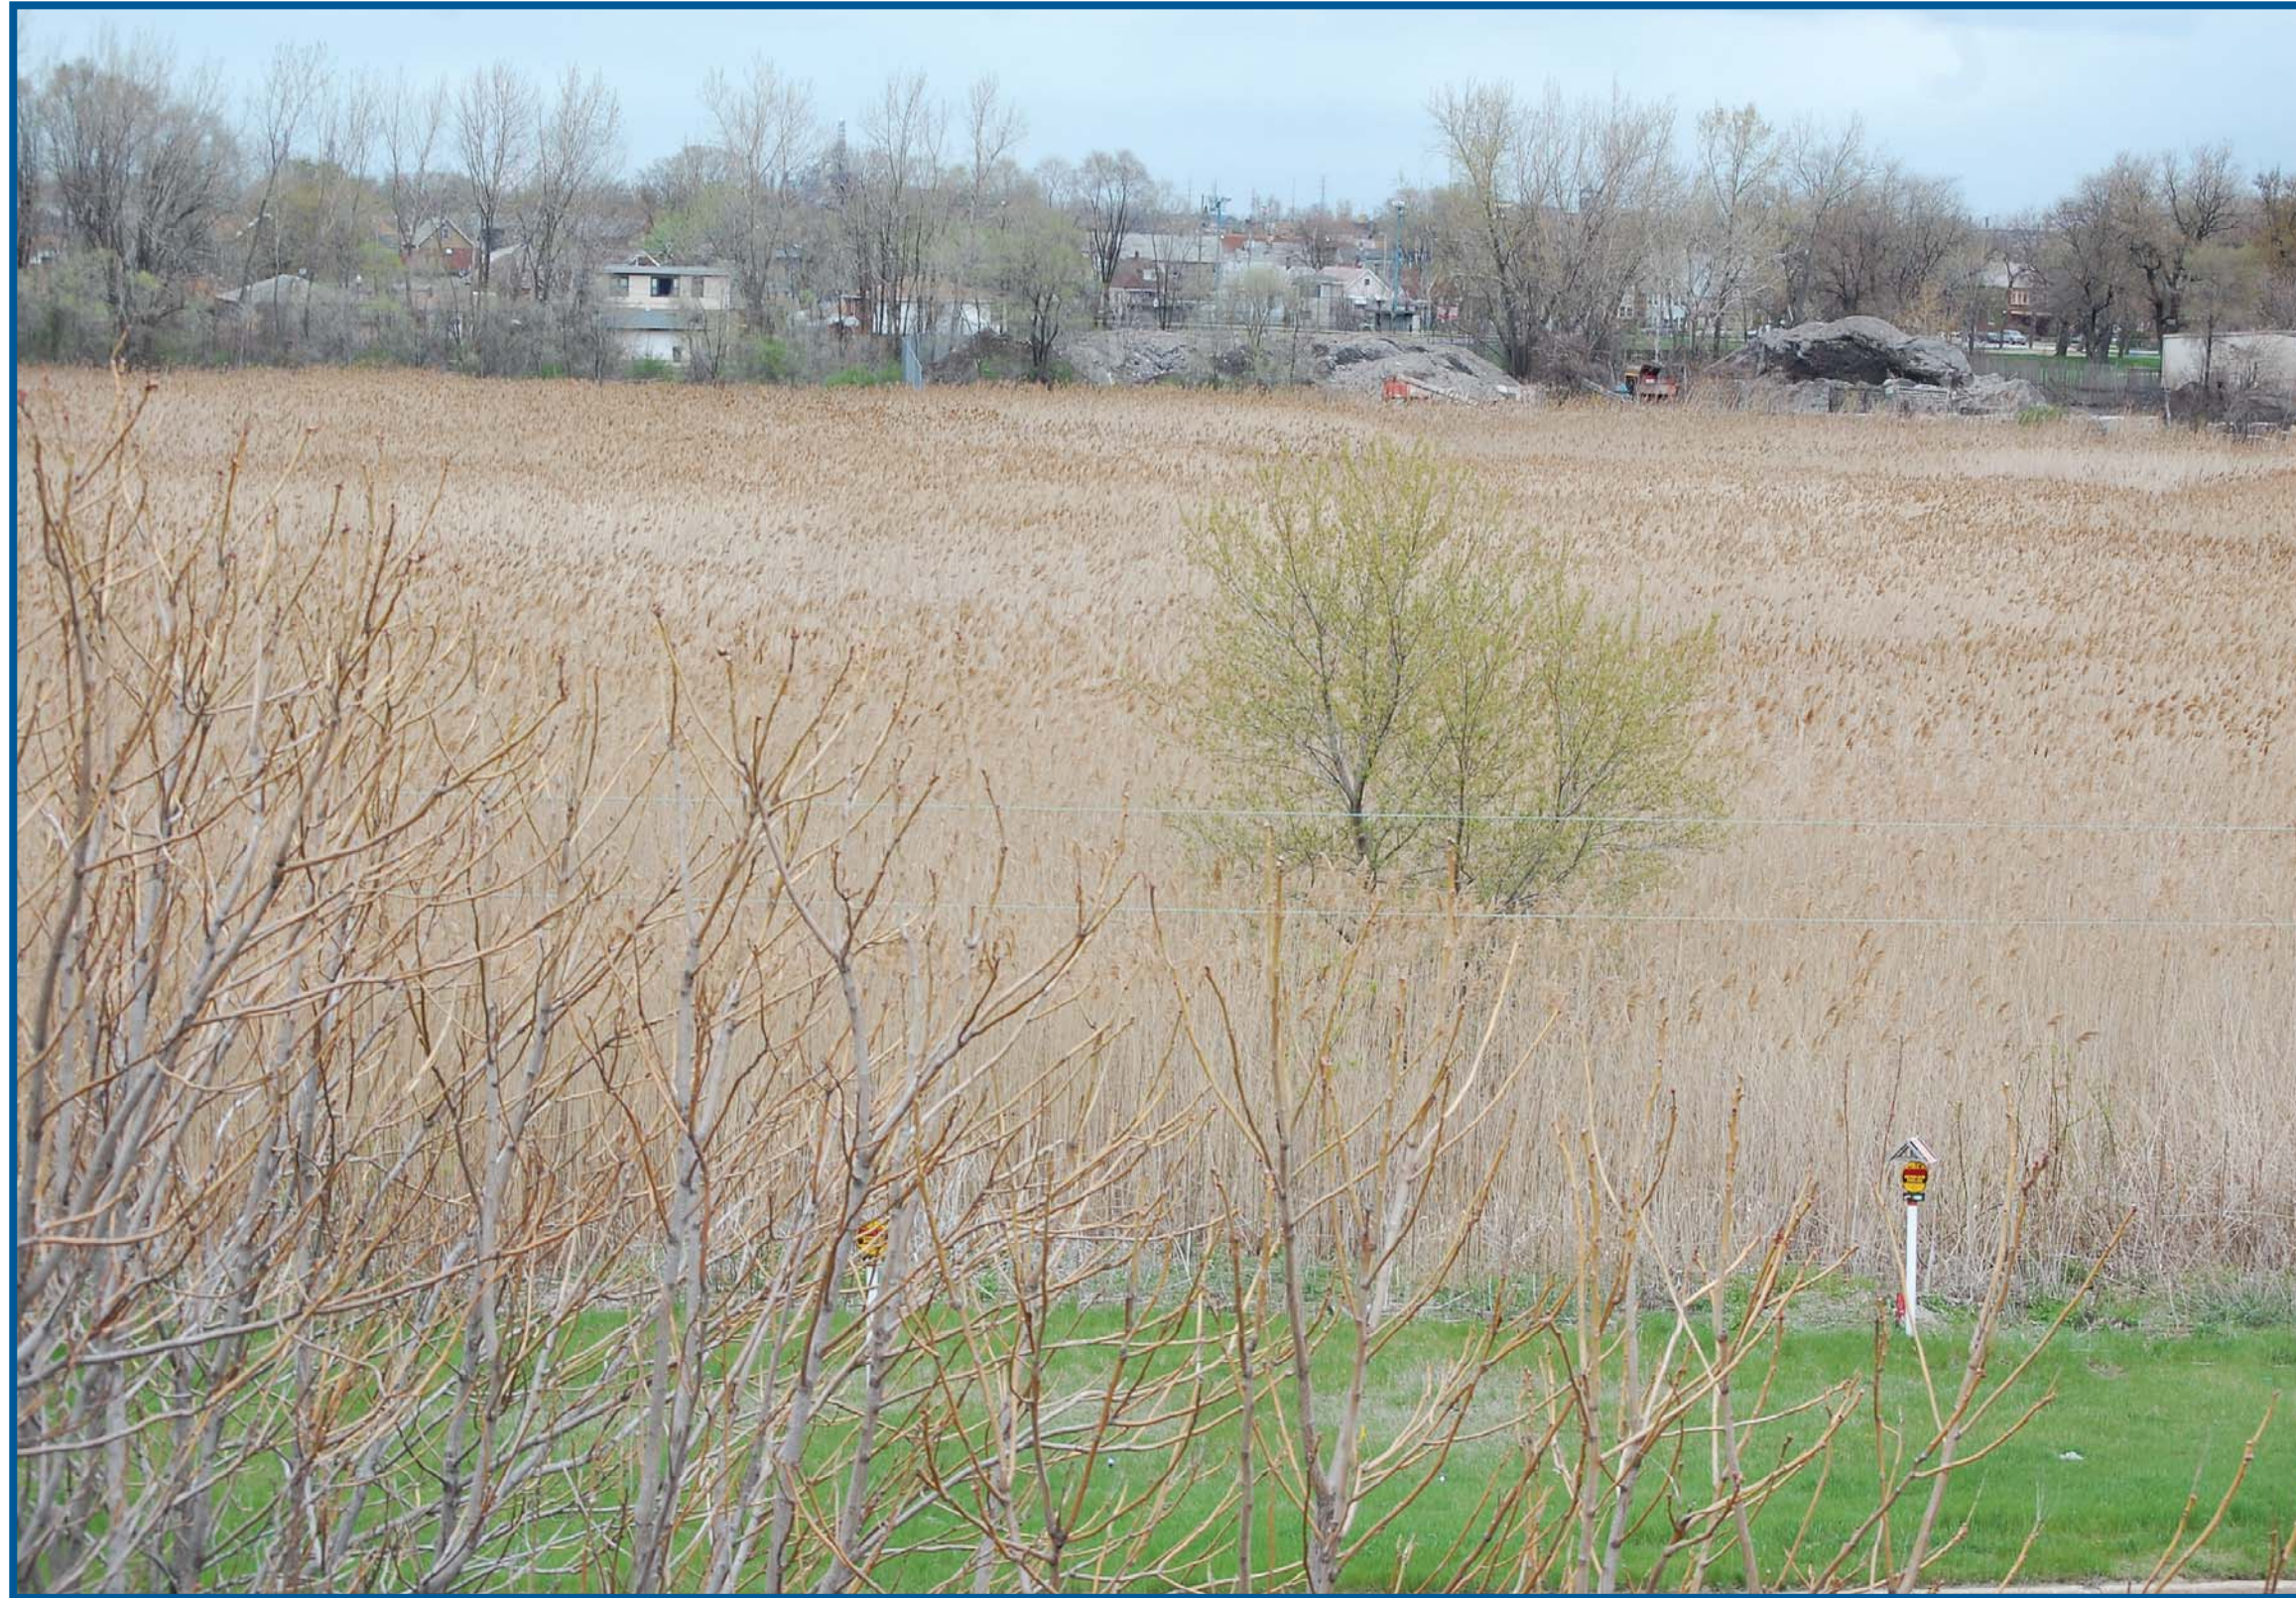
2010 Site Conditions

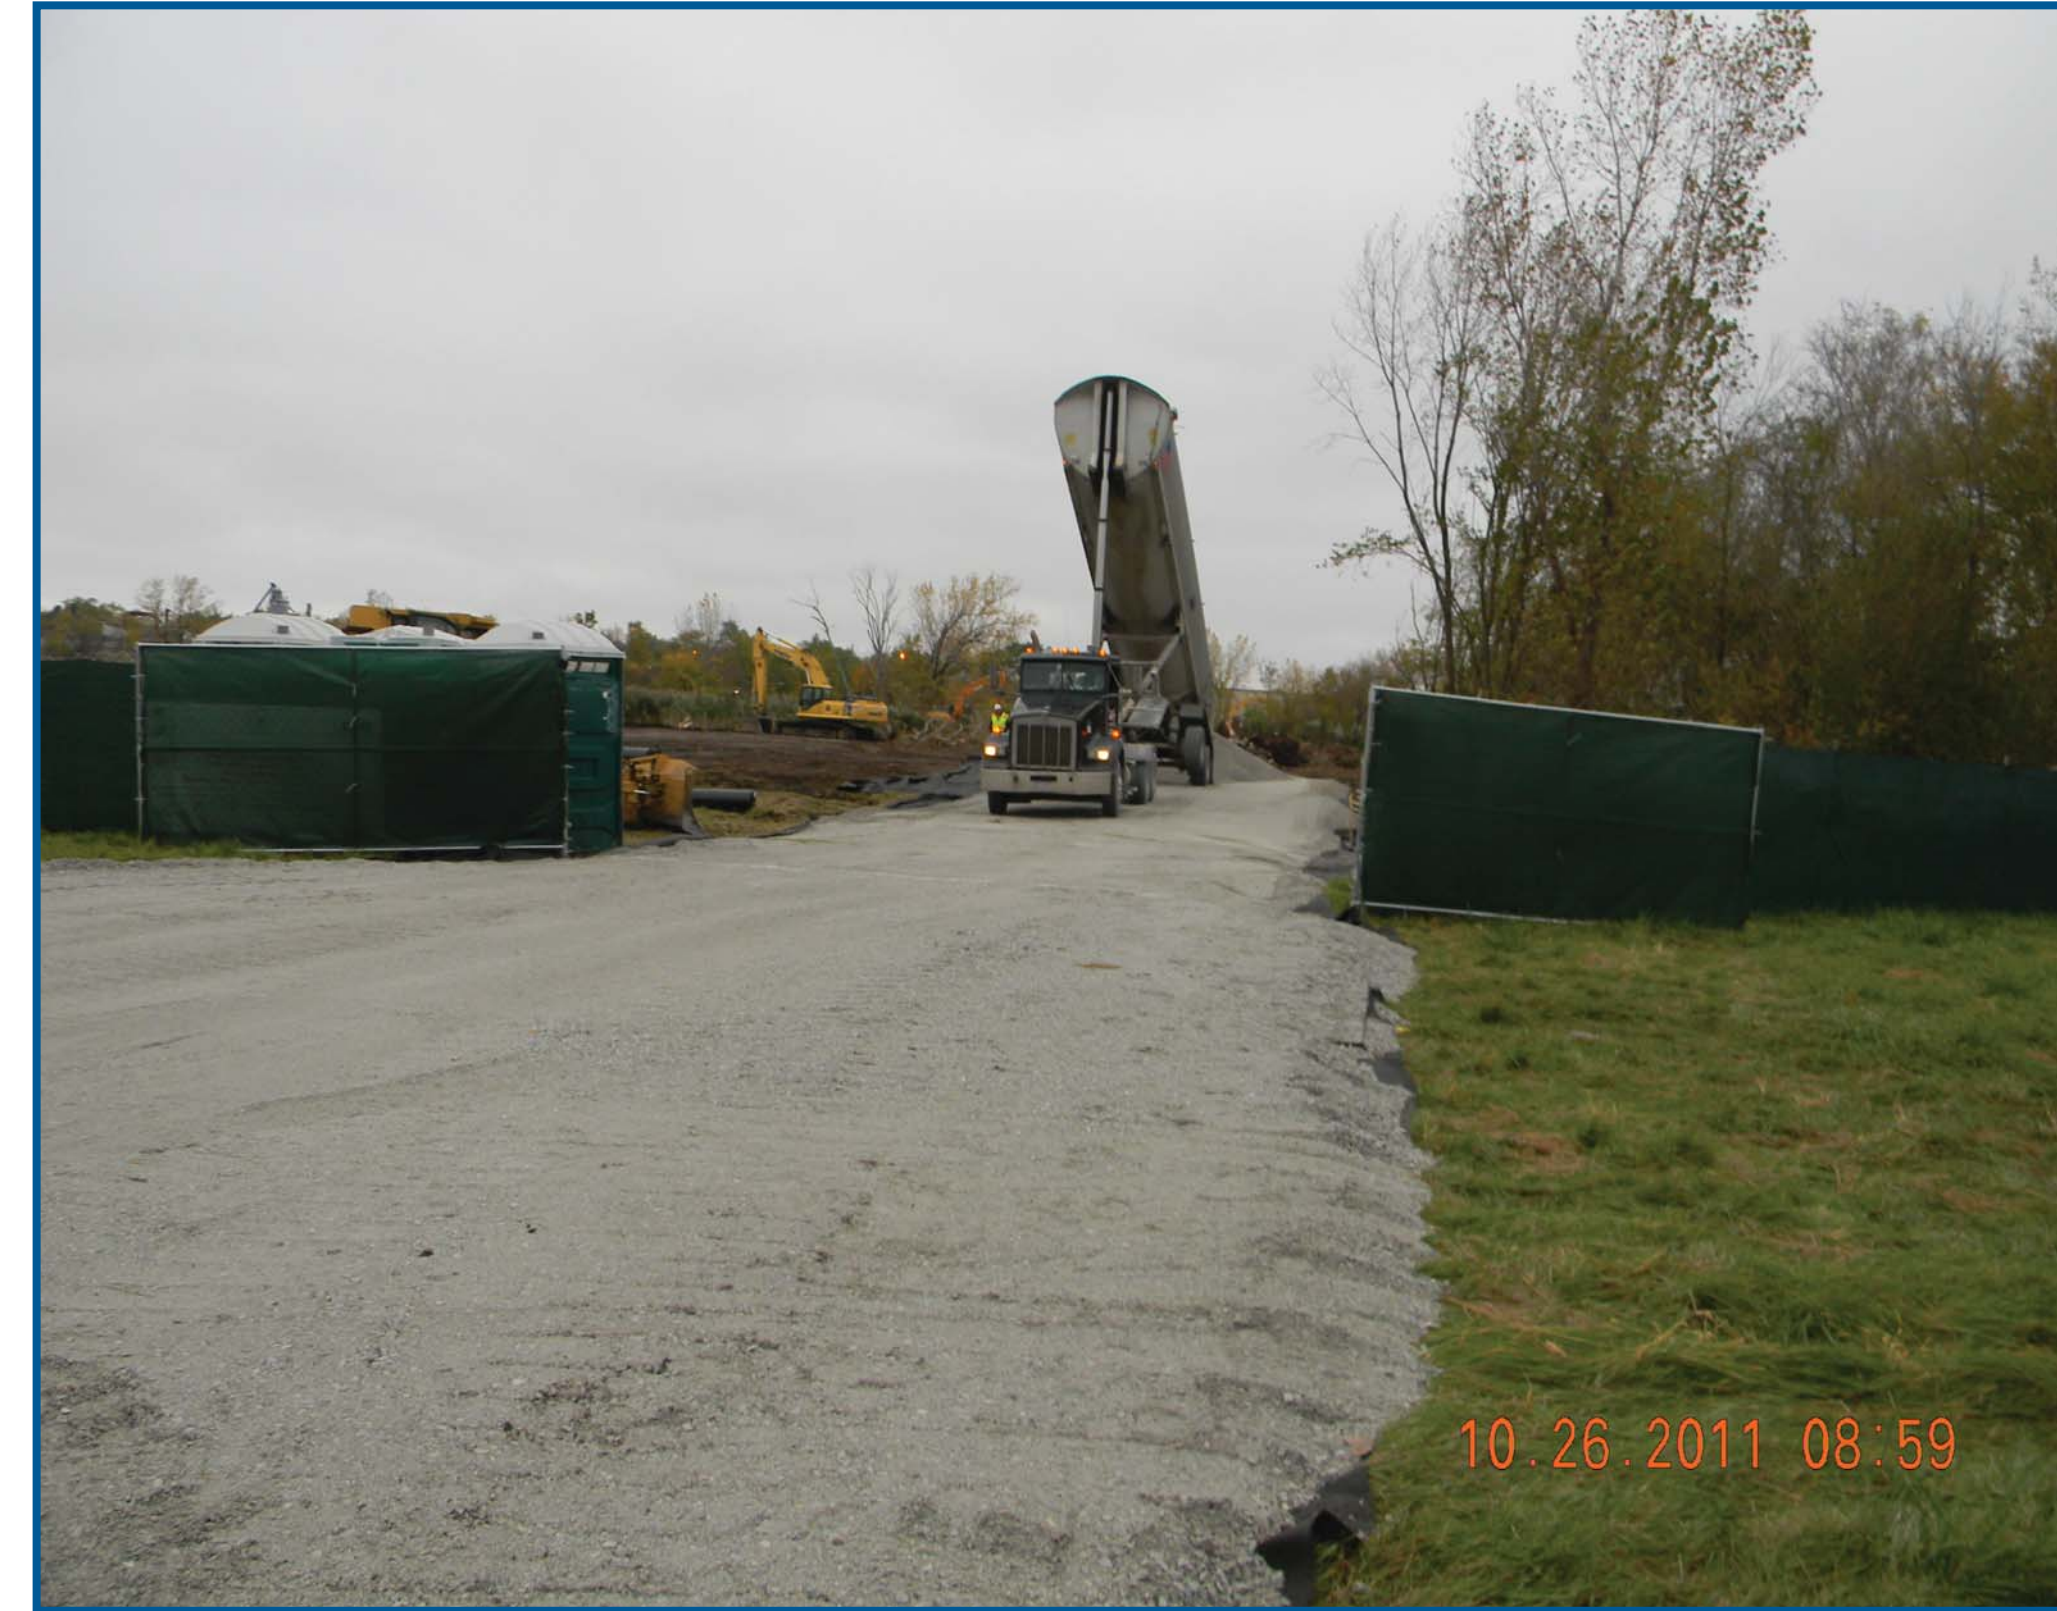
Constructing Staging Area

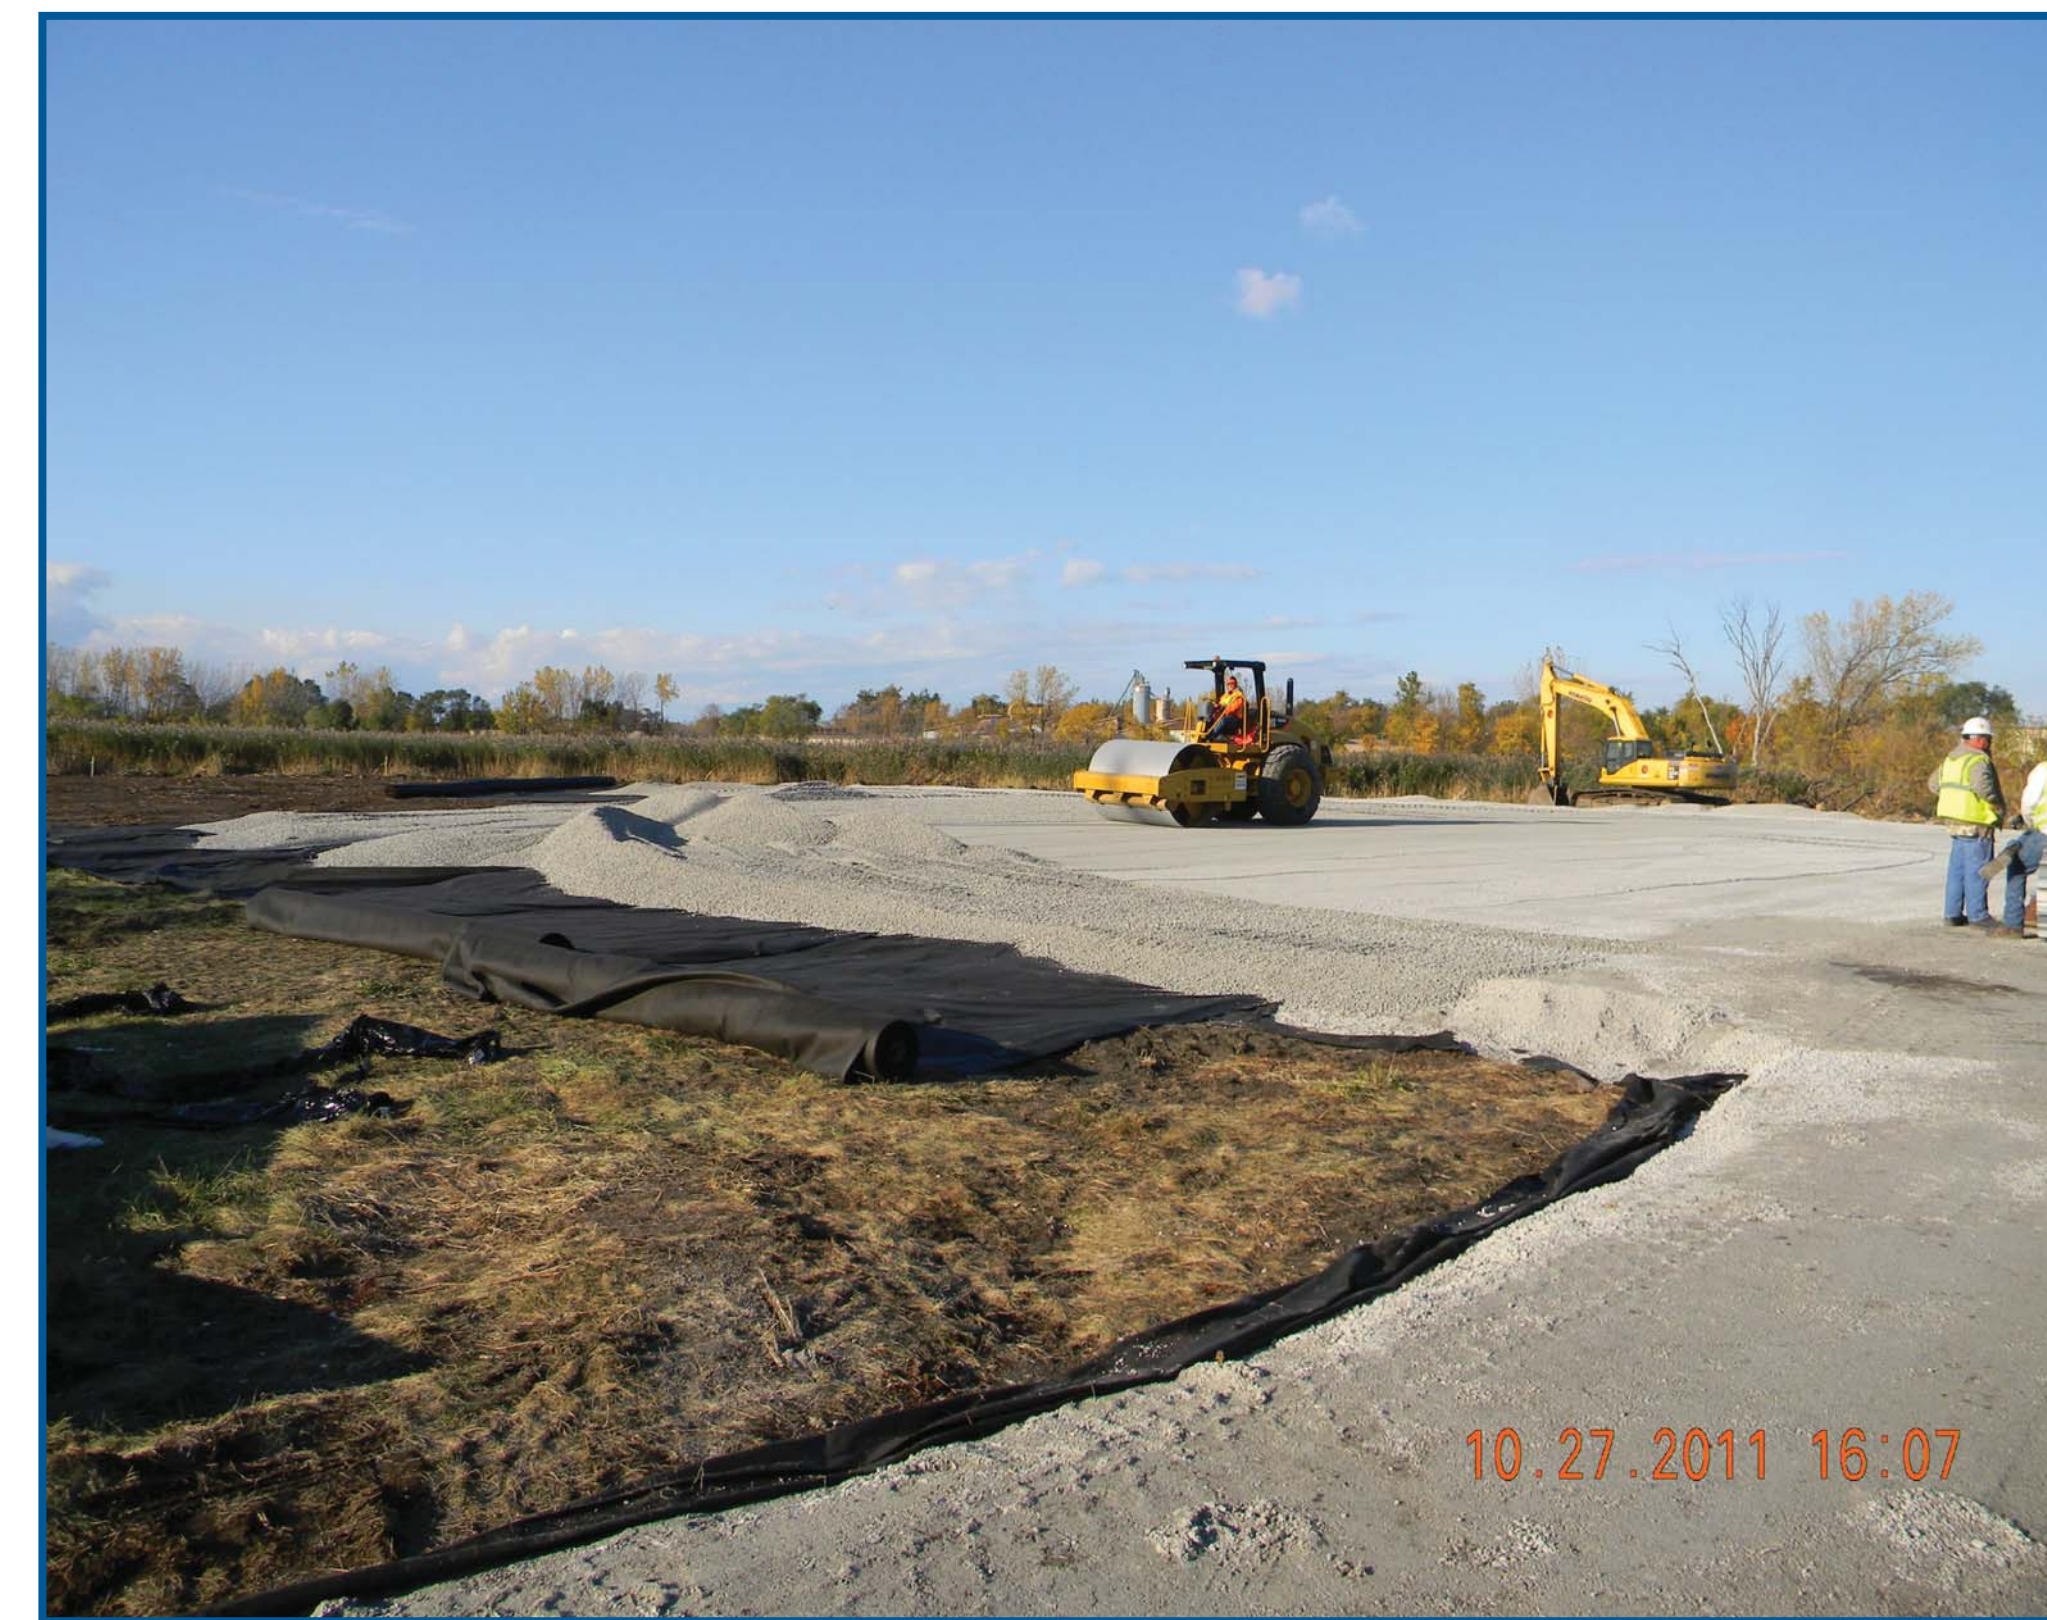
Preparing Sediment Dewatering Area

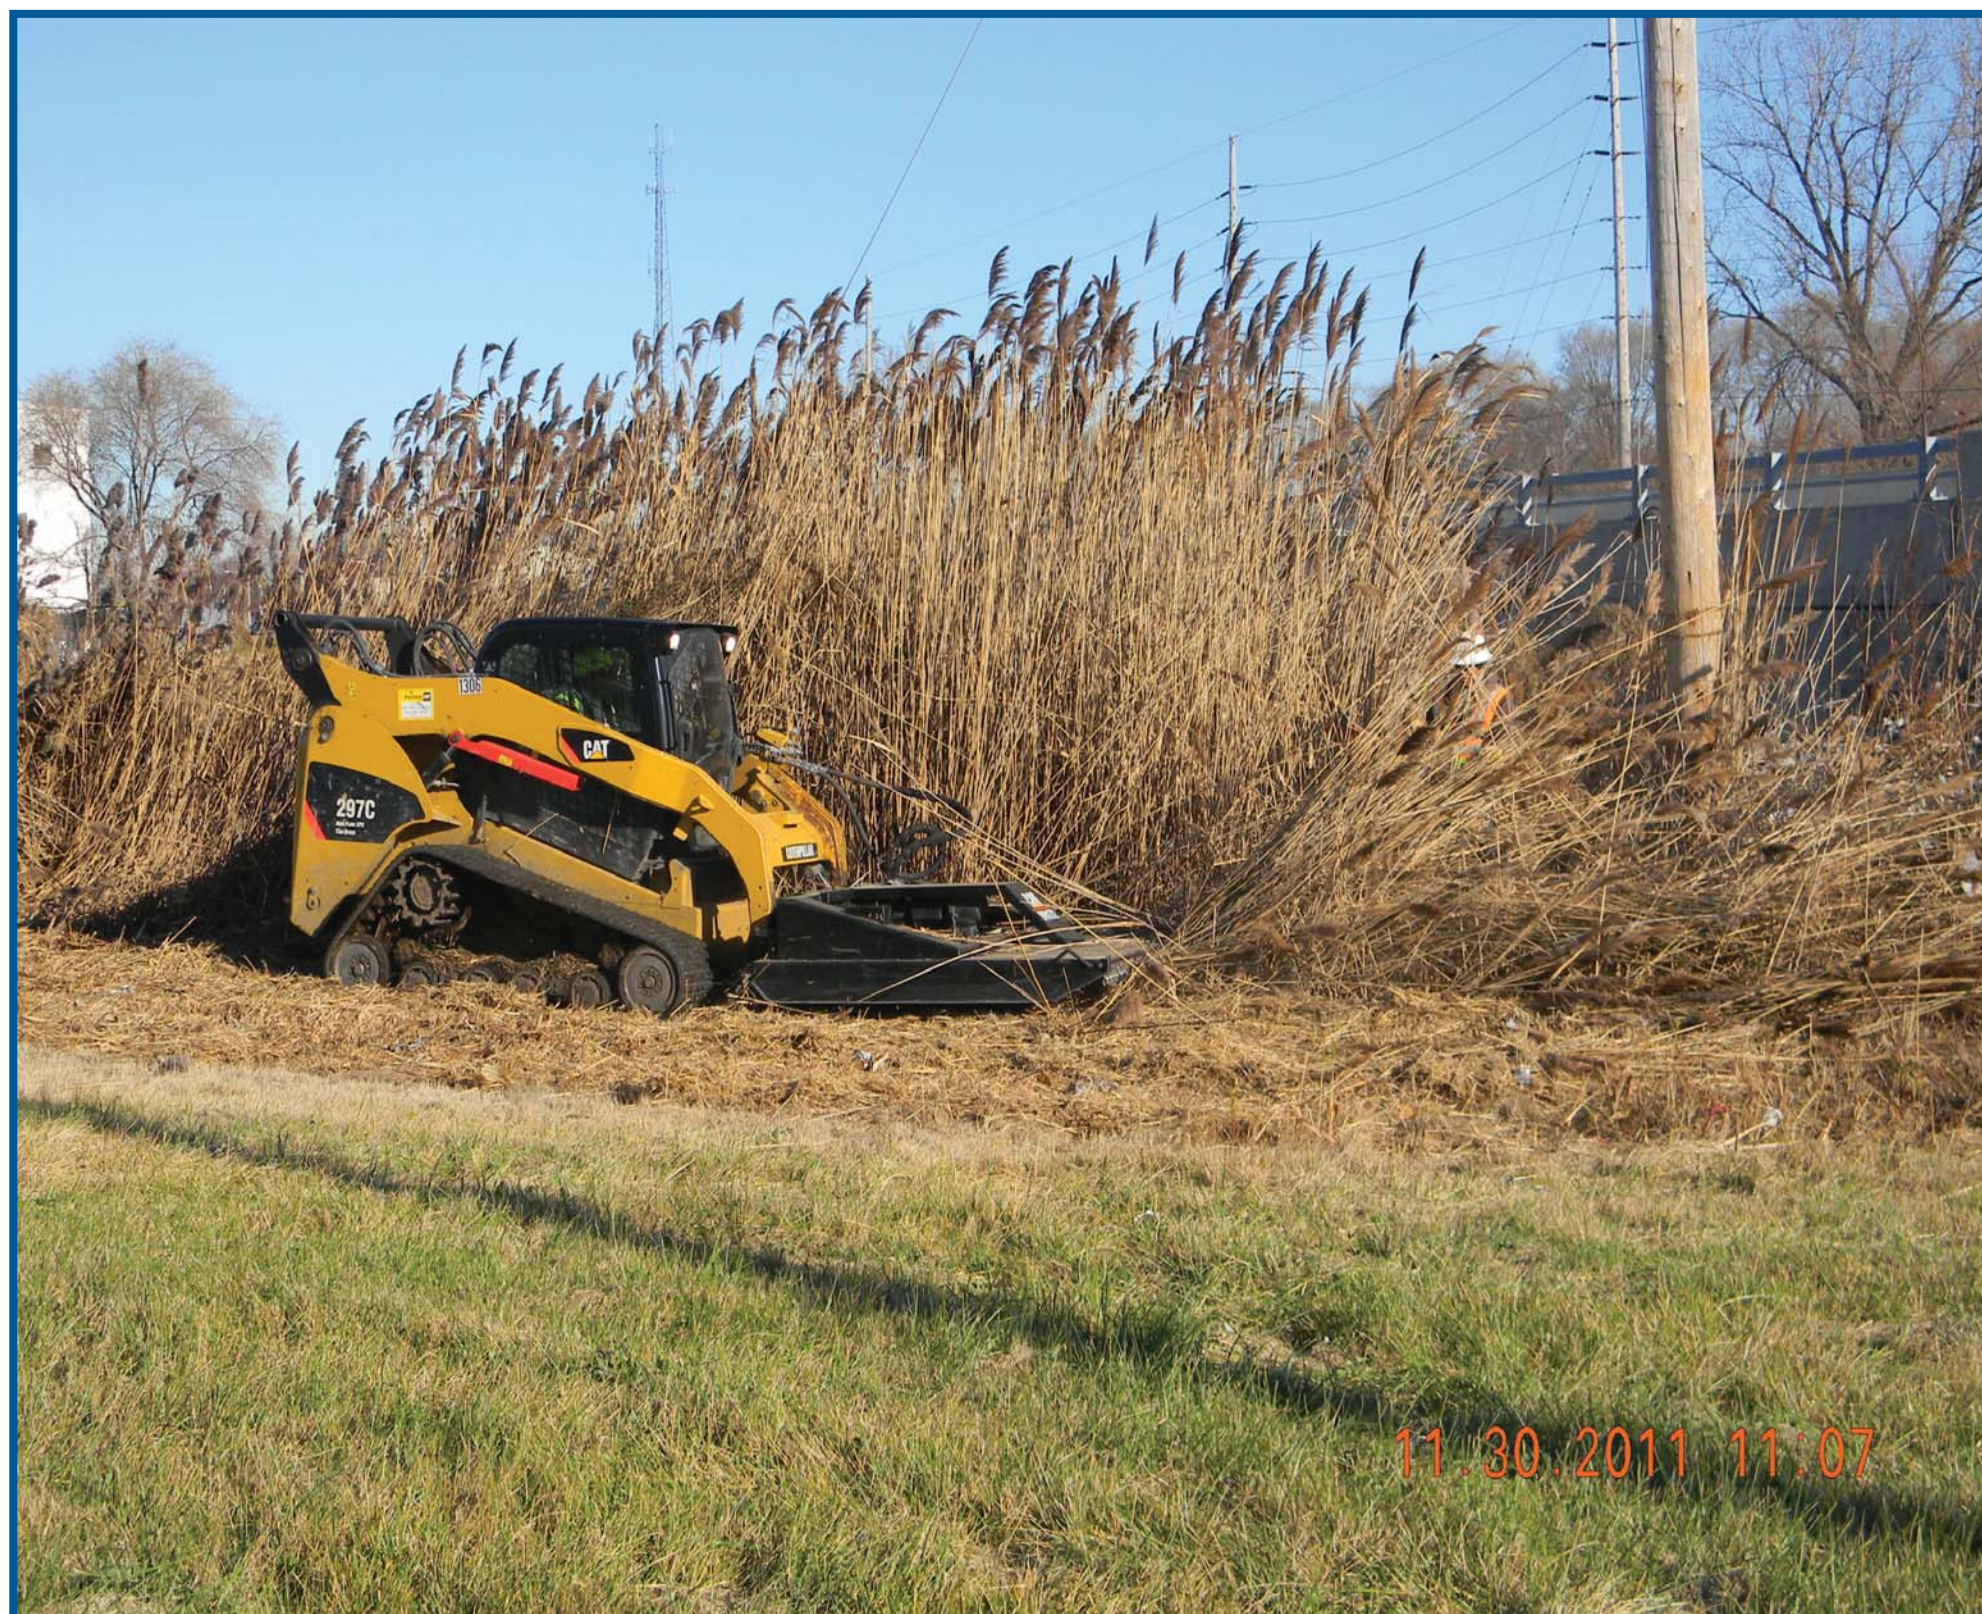
Mowing Dead Invasive Species

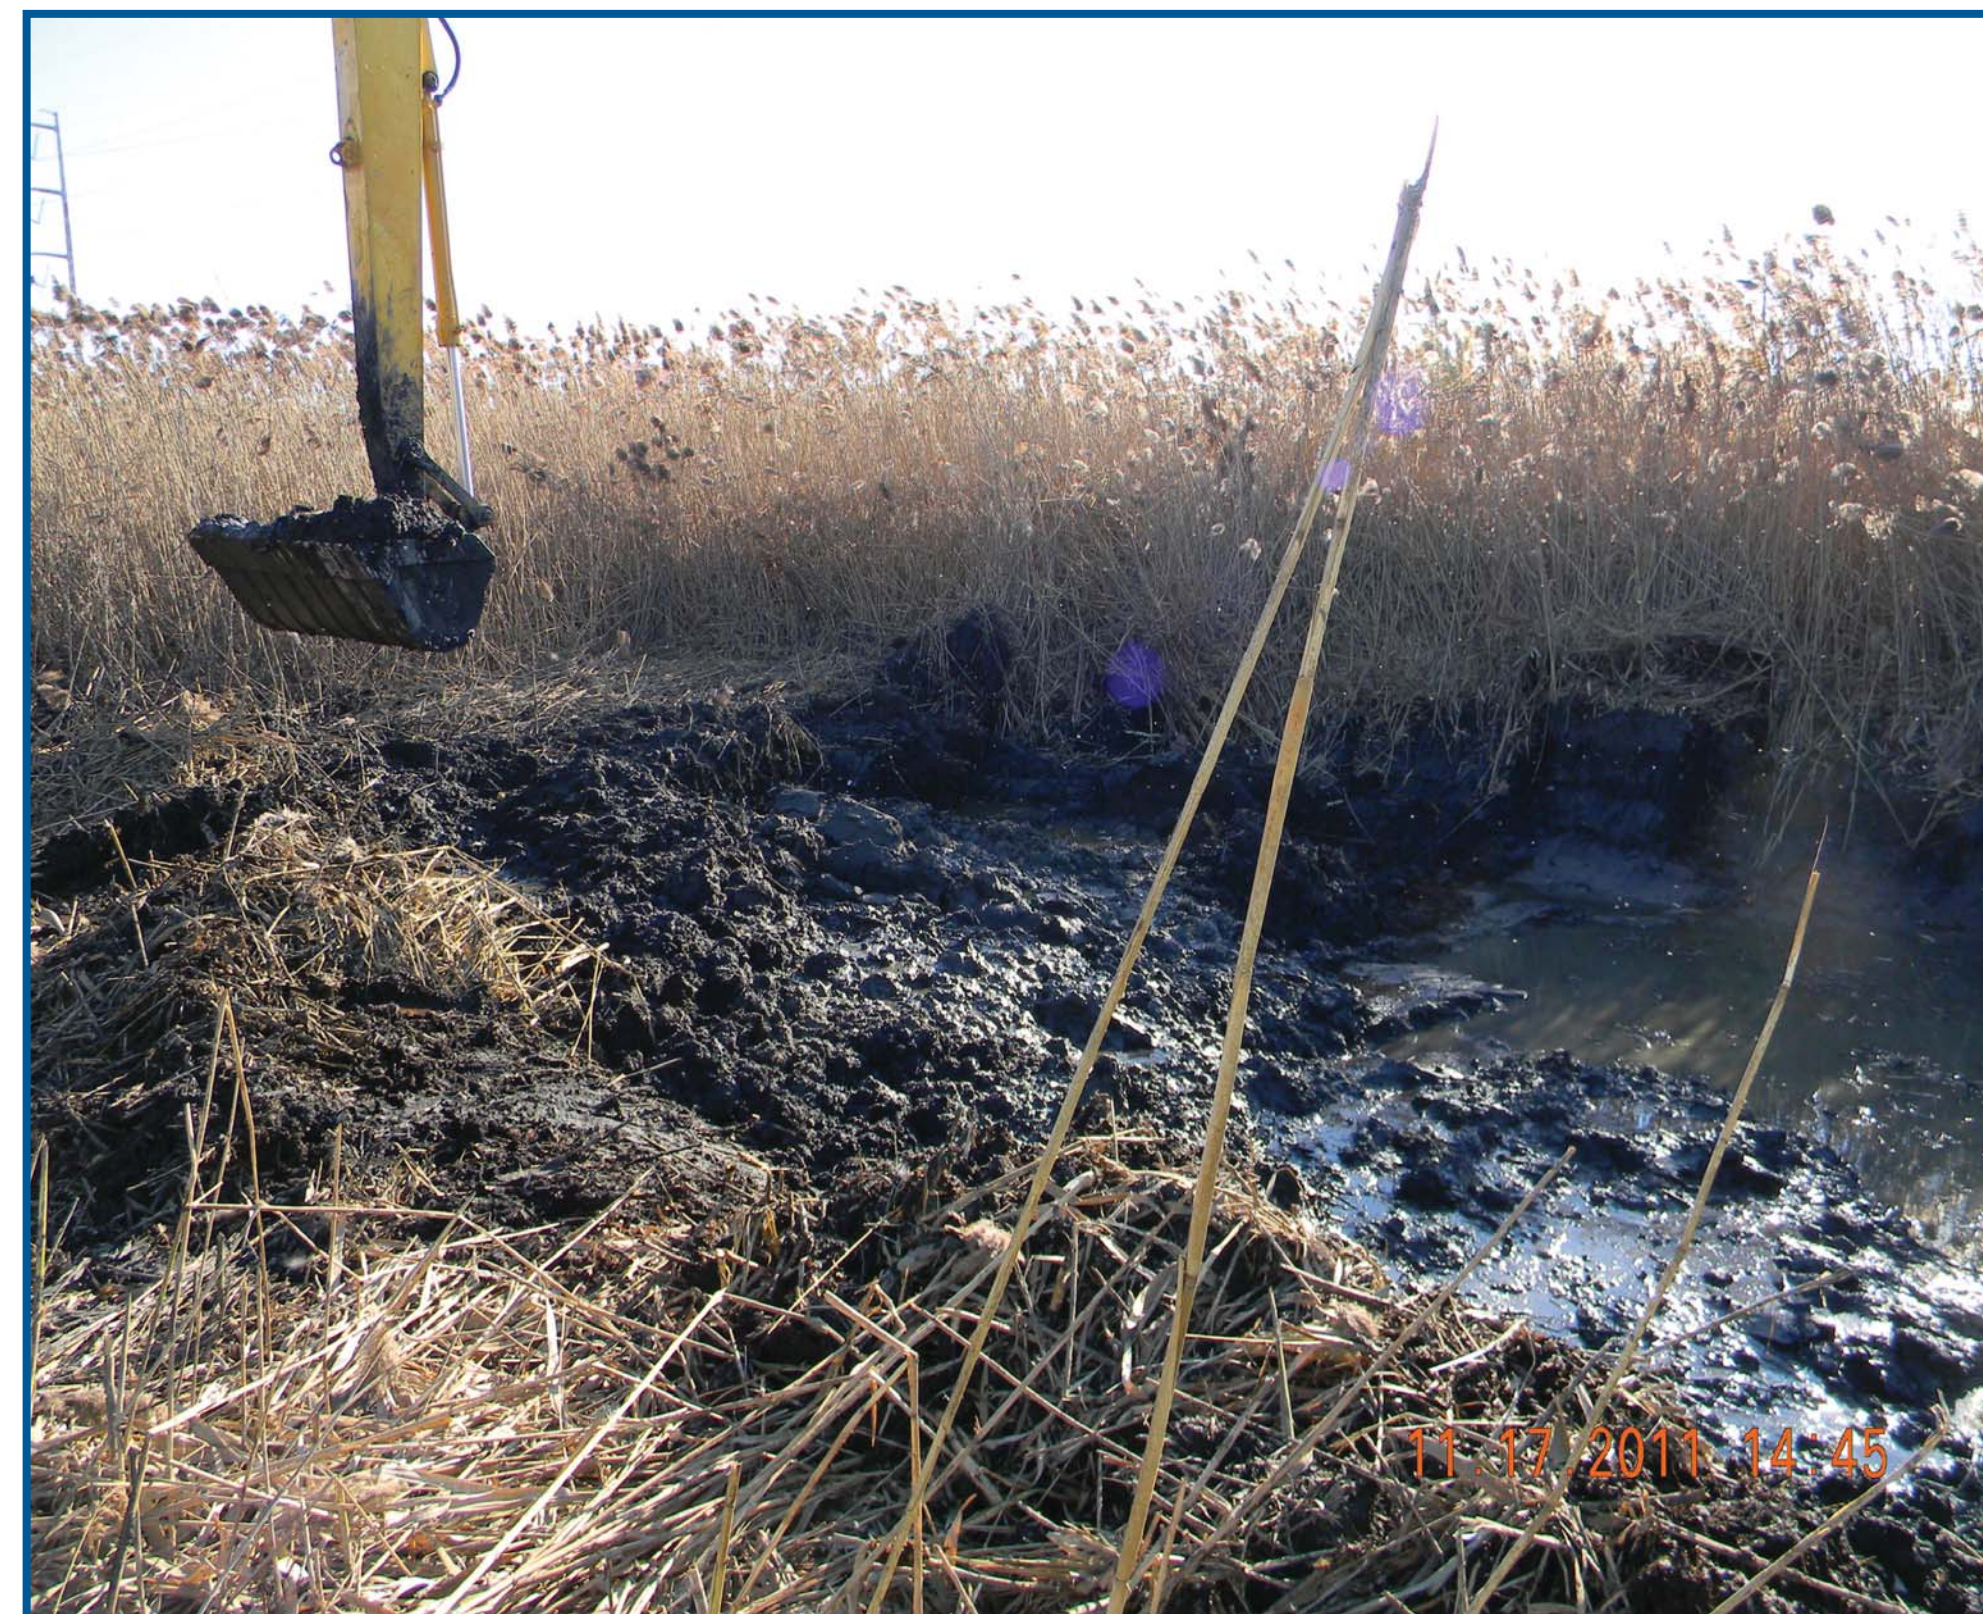
Excavating Marsh Sediment

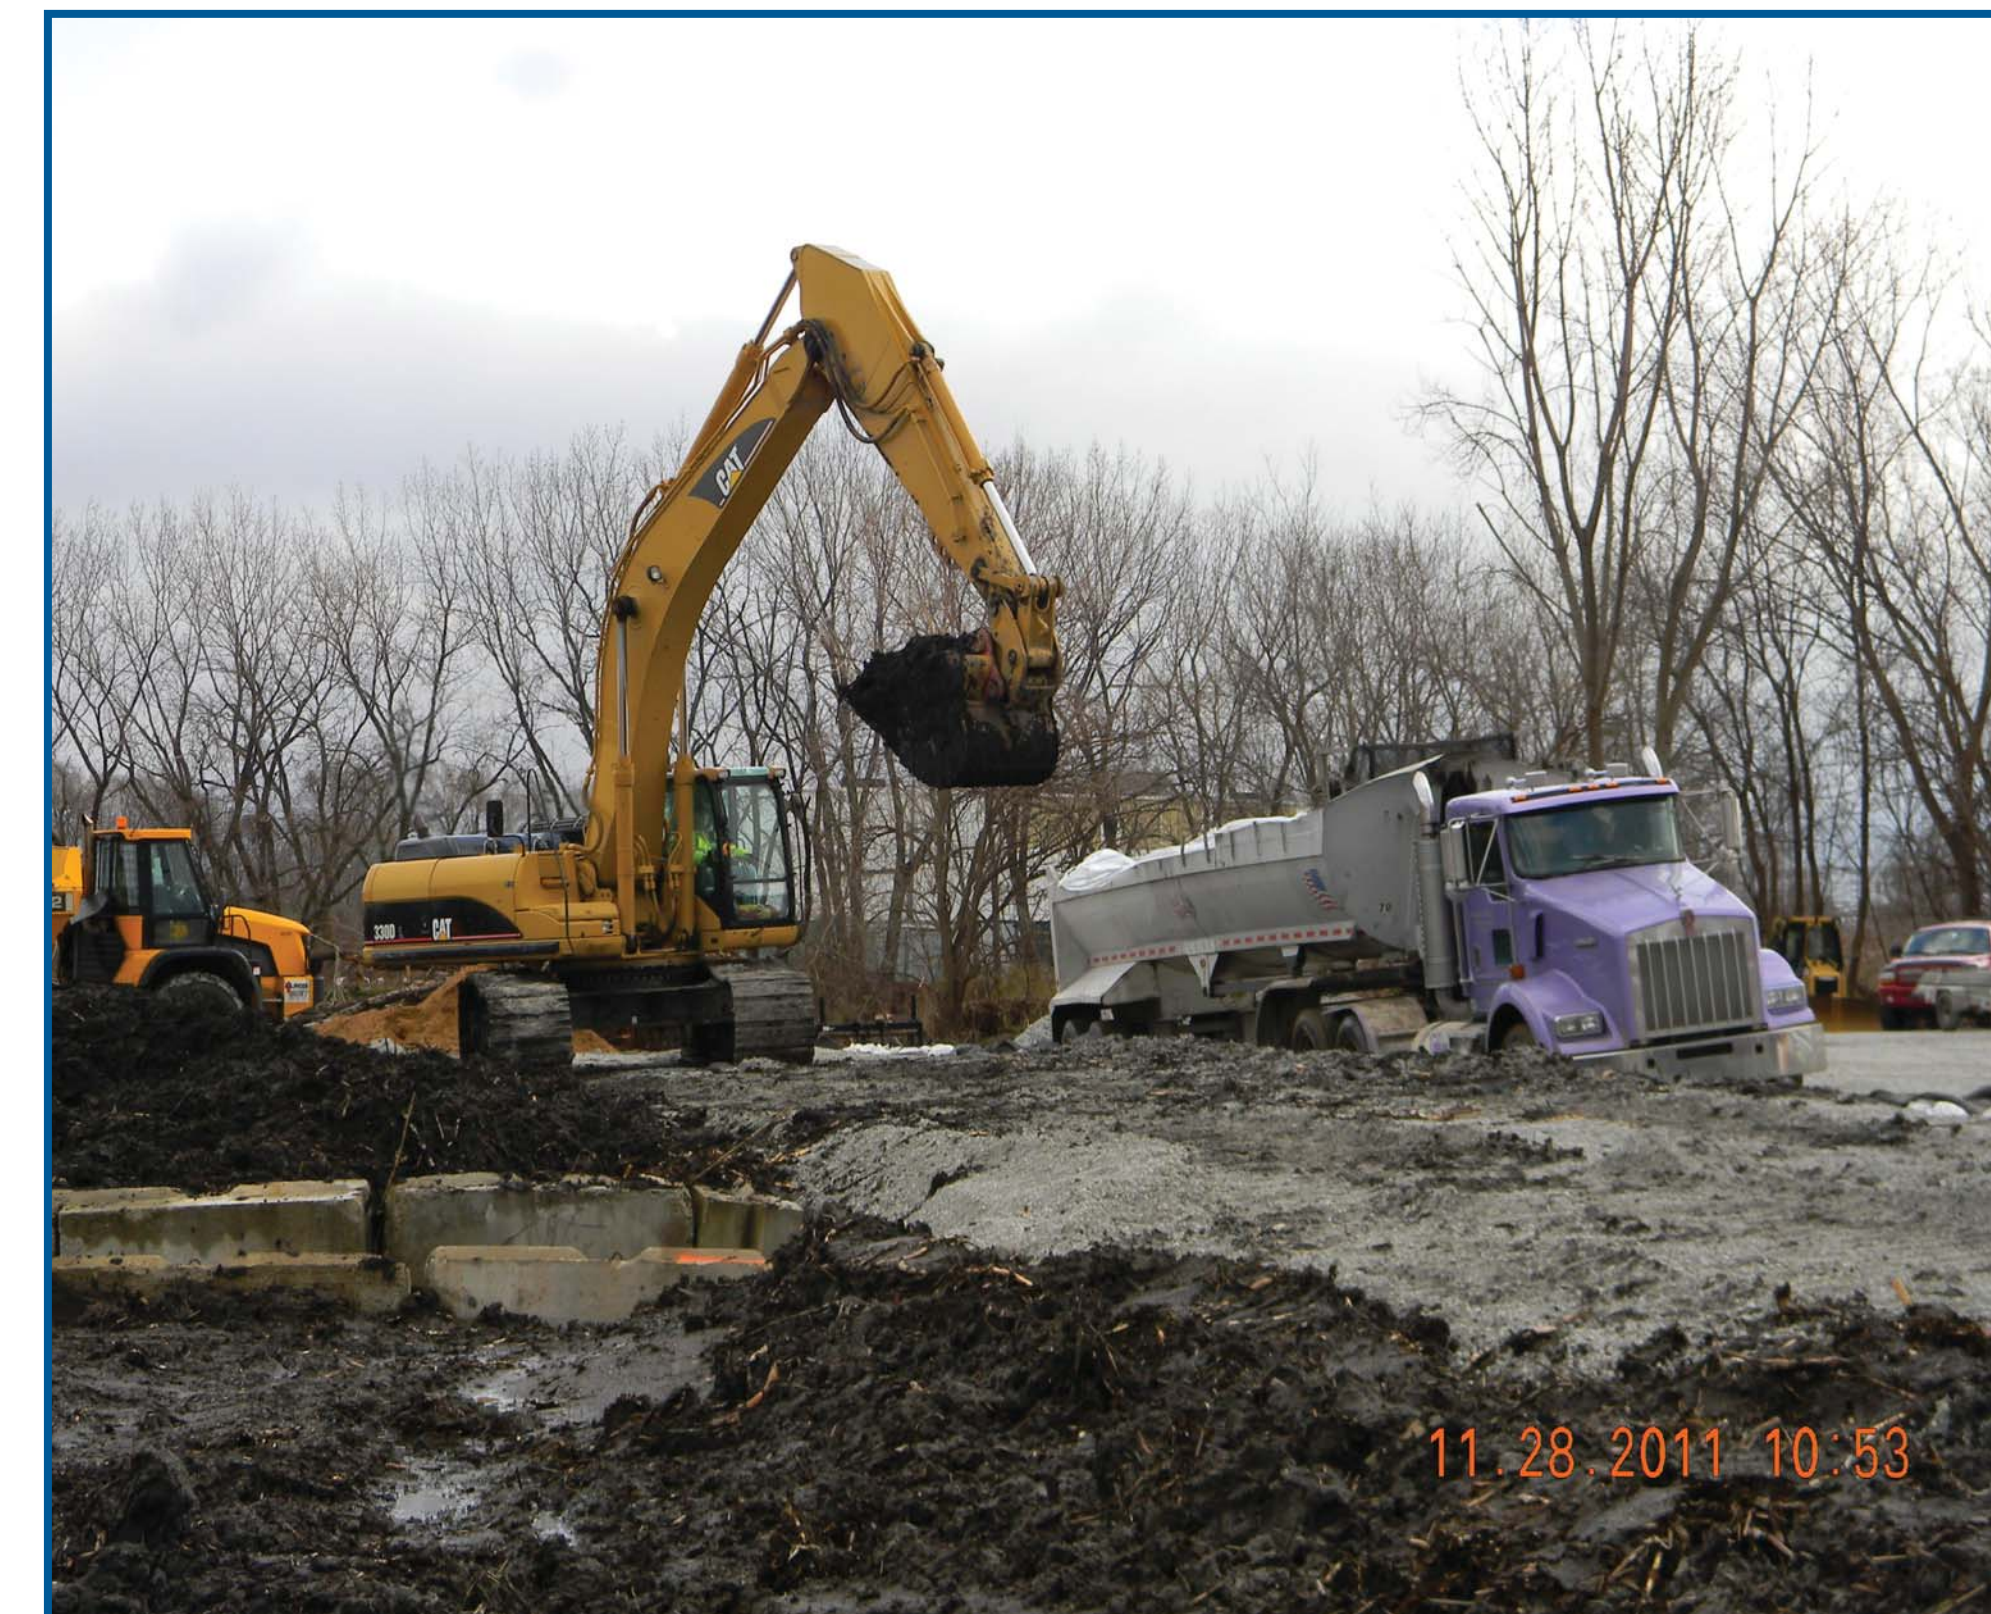
Loading Marsh Sediment
