West Branch Grand Calumet River, Hammond and East Chicago, Indiana

The Great Lakes Legacy Act

Reach 1 and 2 River Dredging and Capping

Roxana Marsh Excavation and Restoration

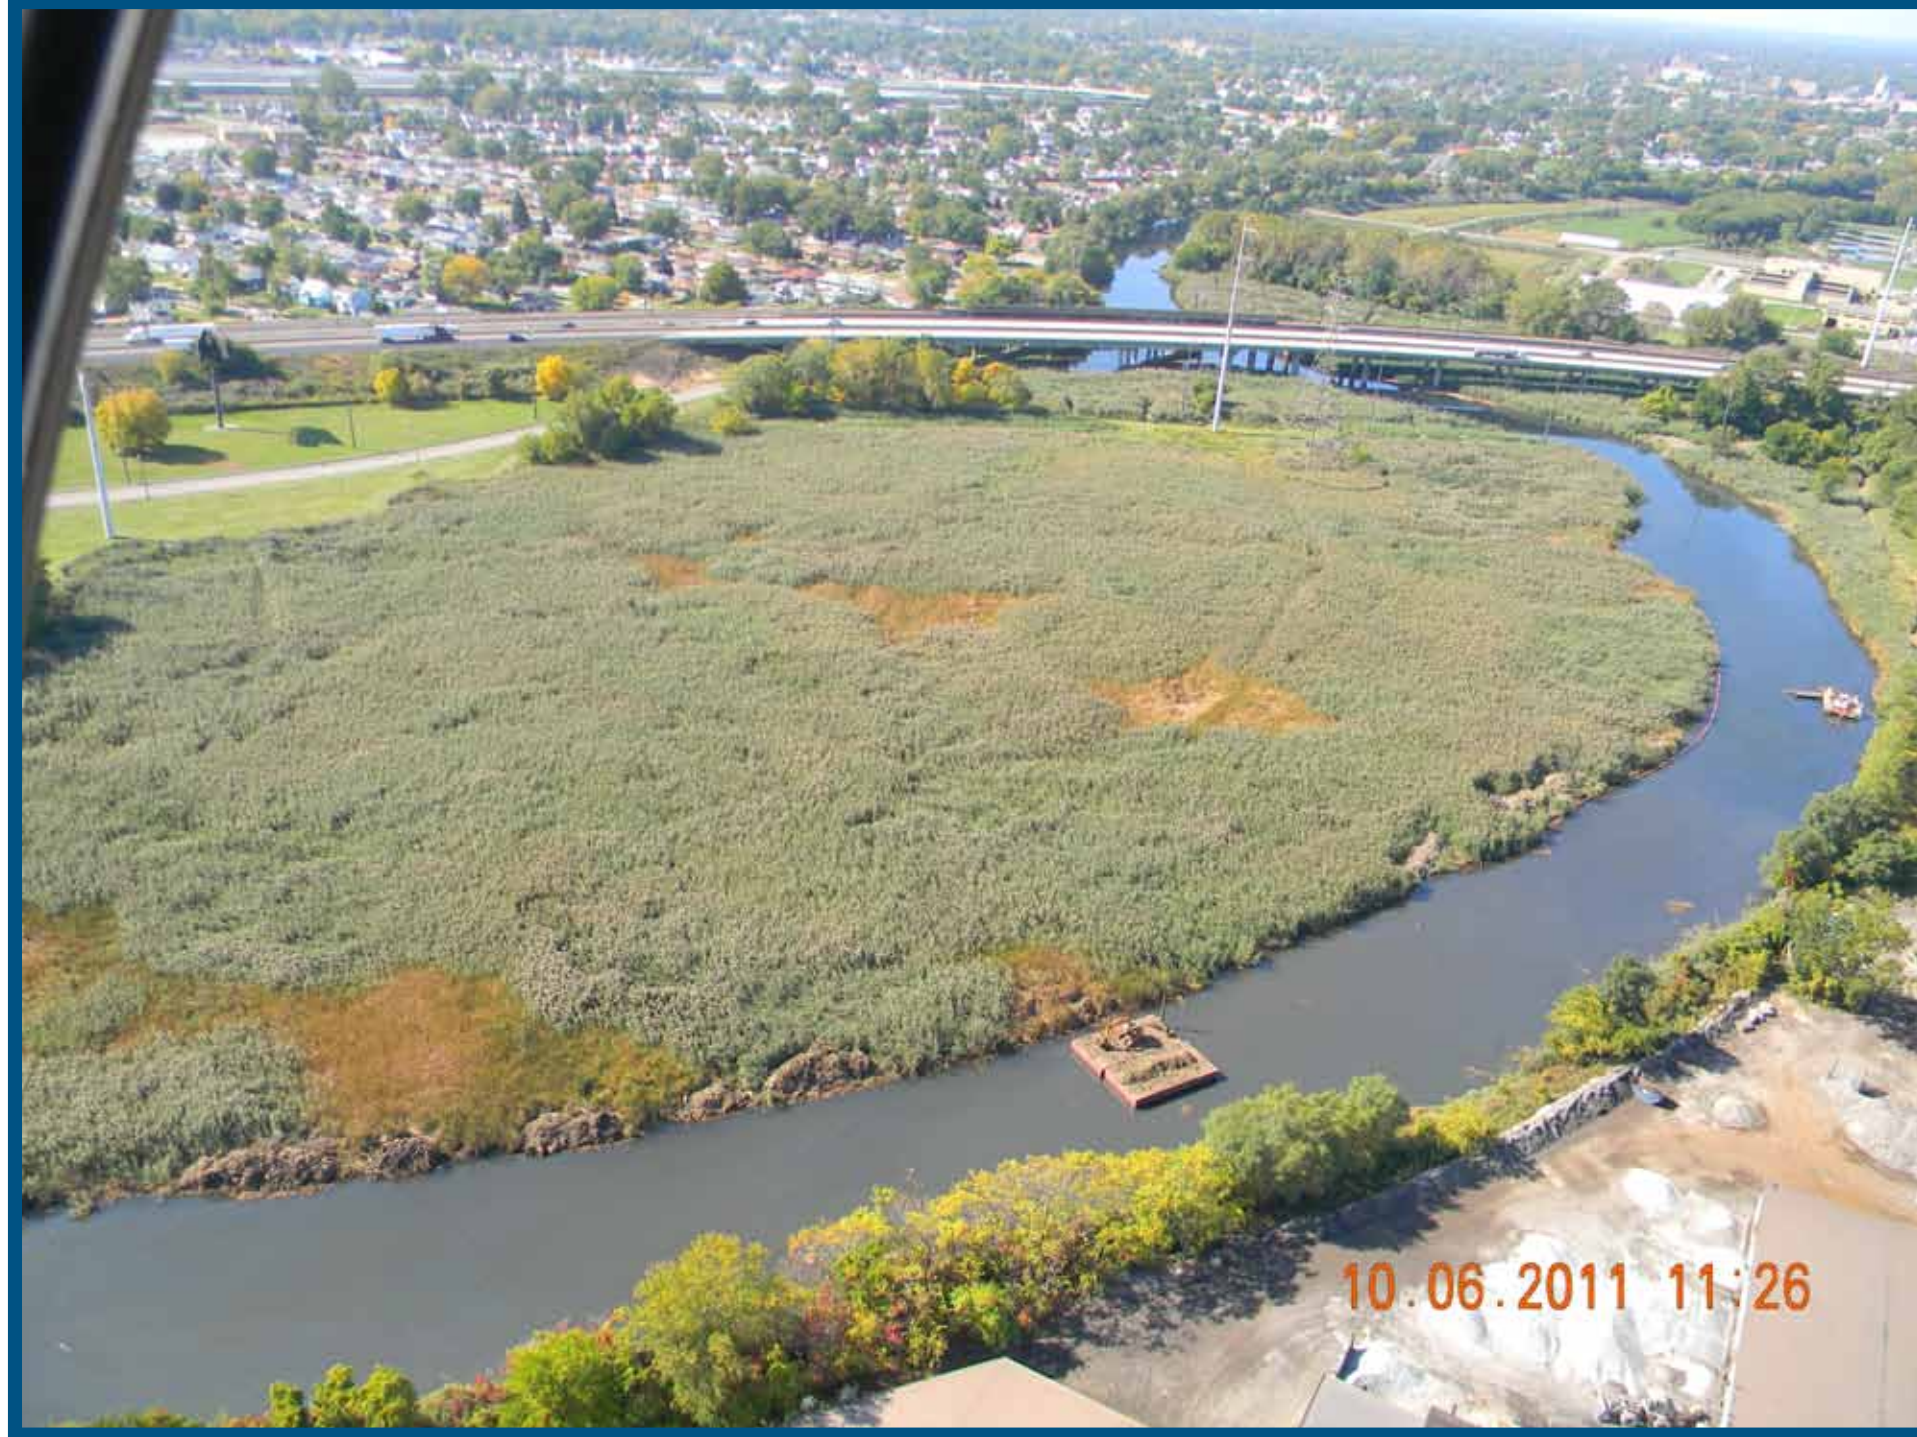
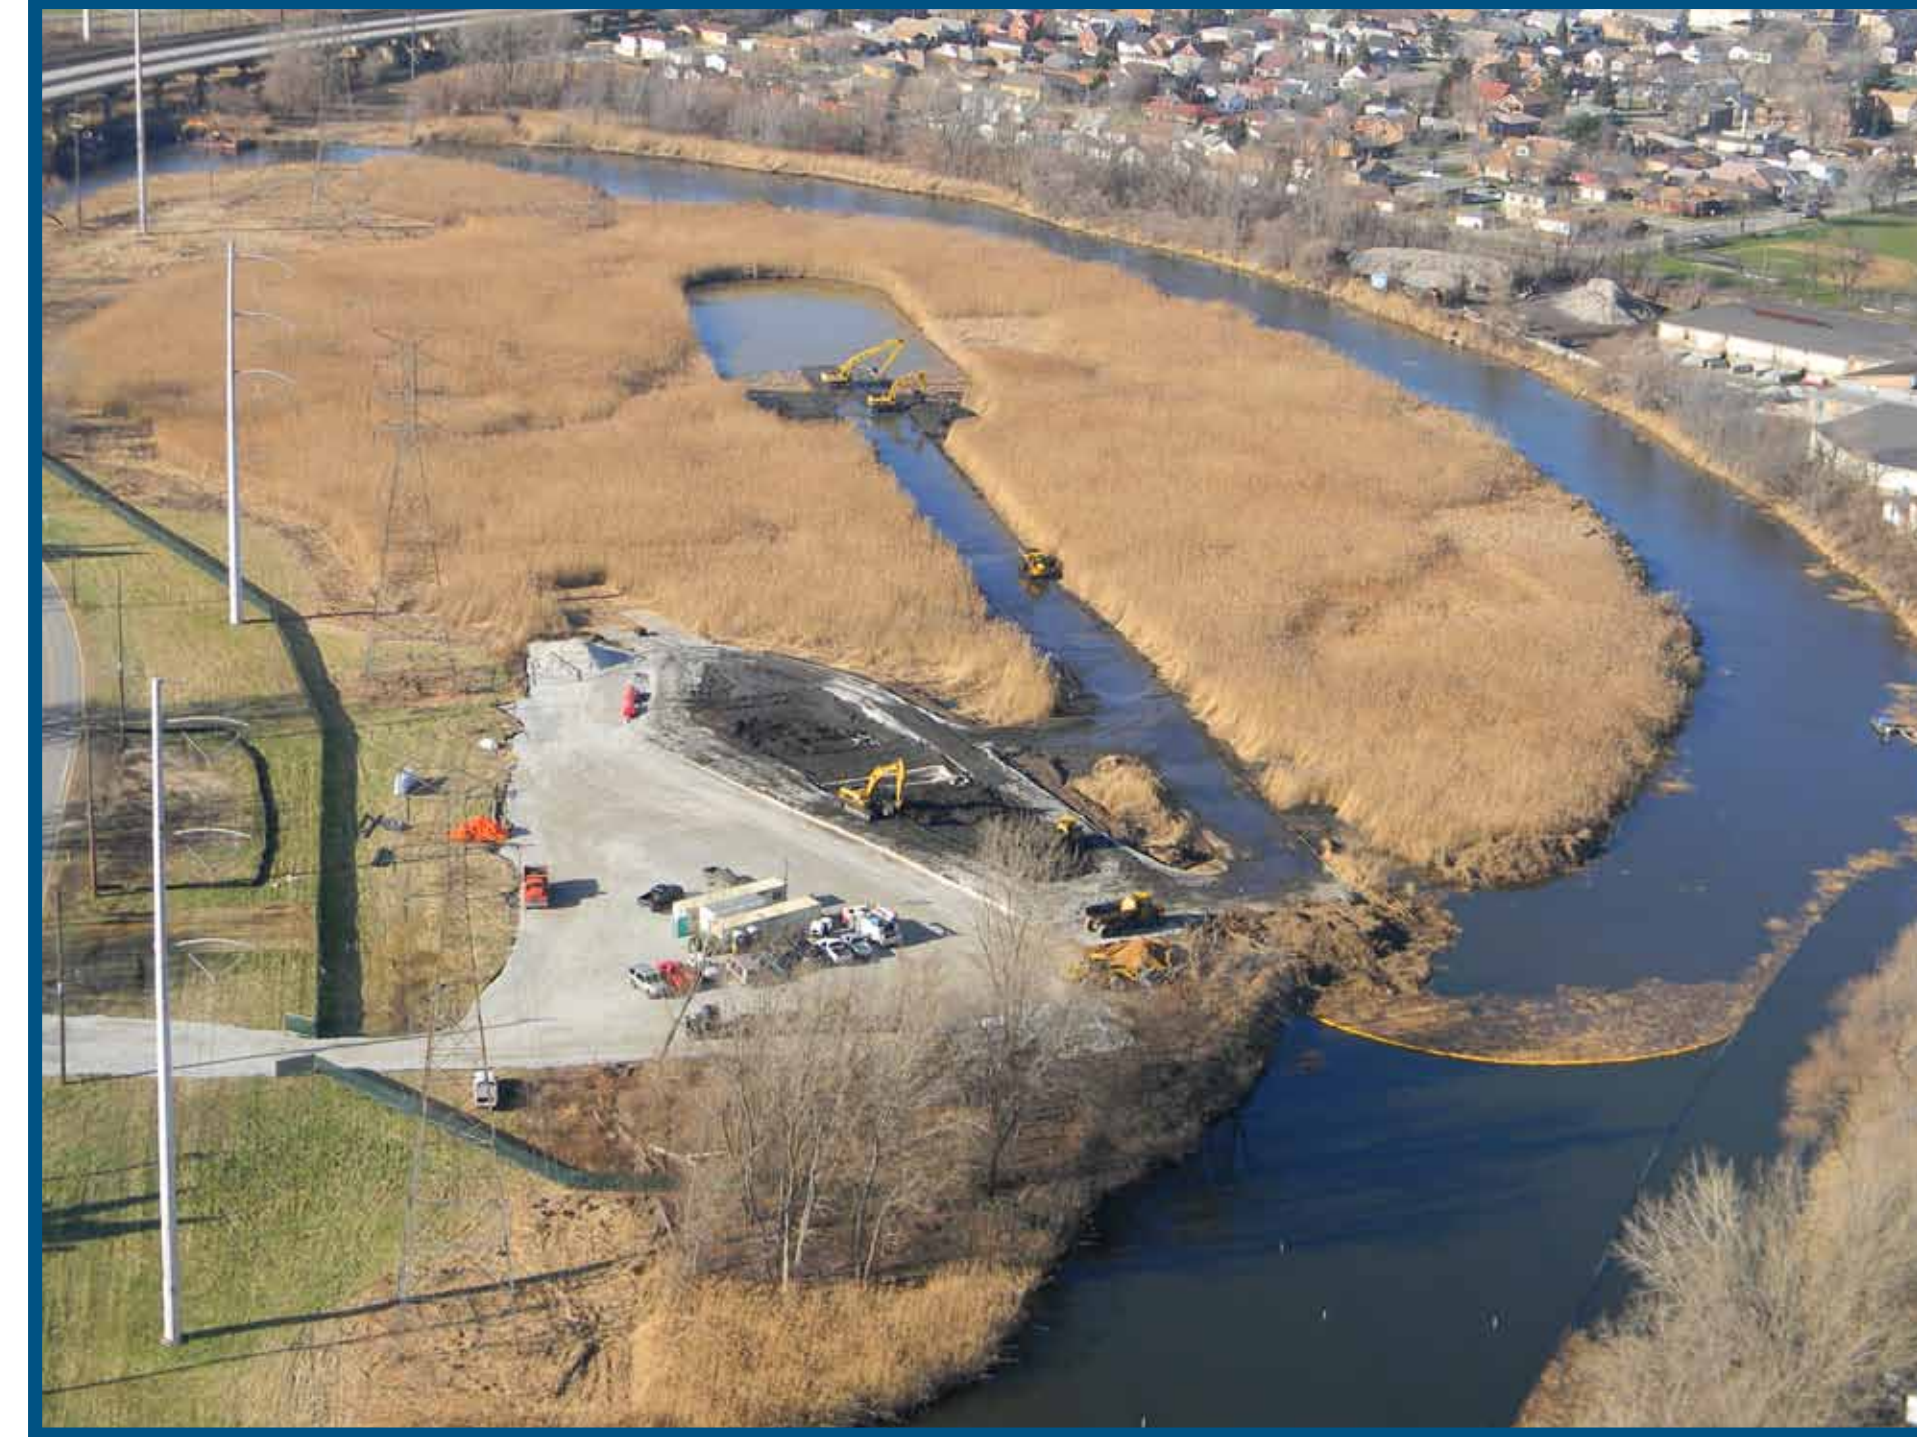
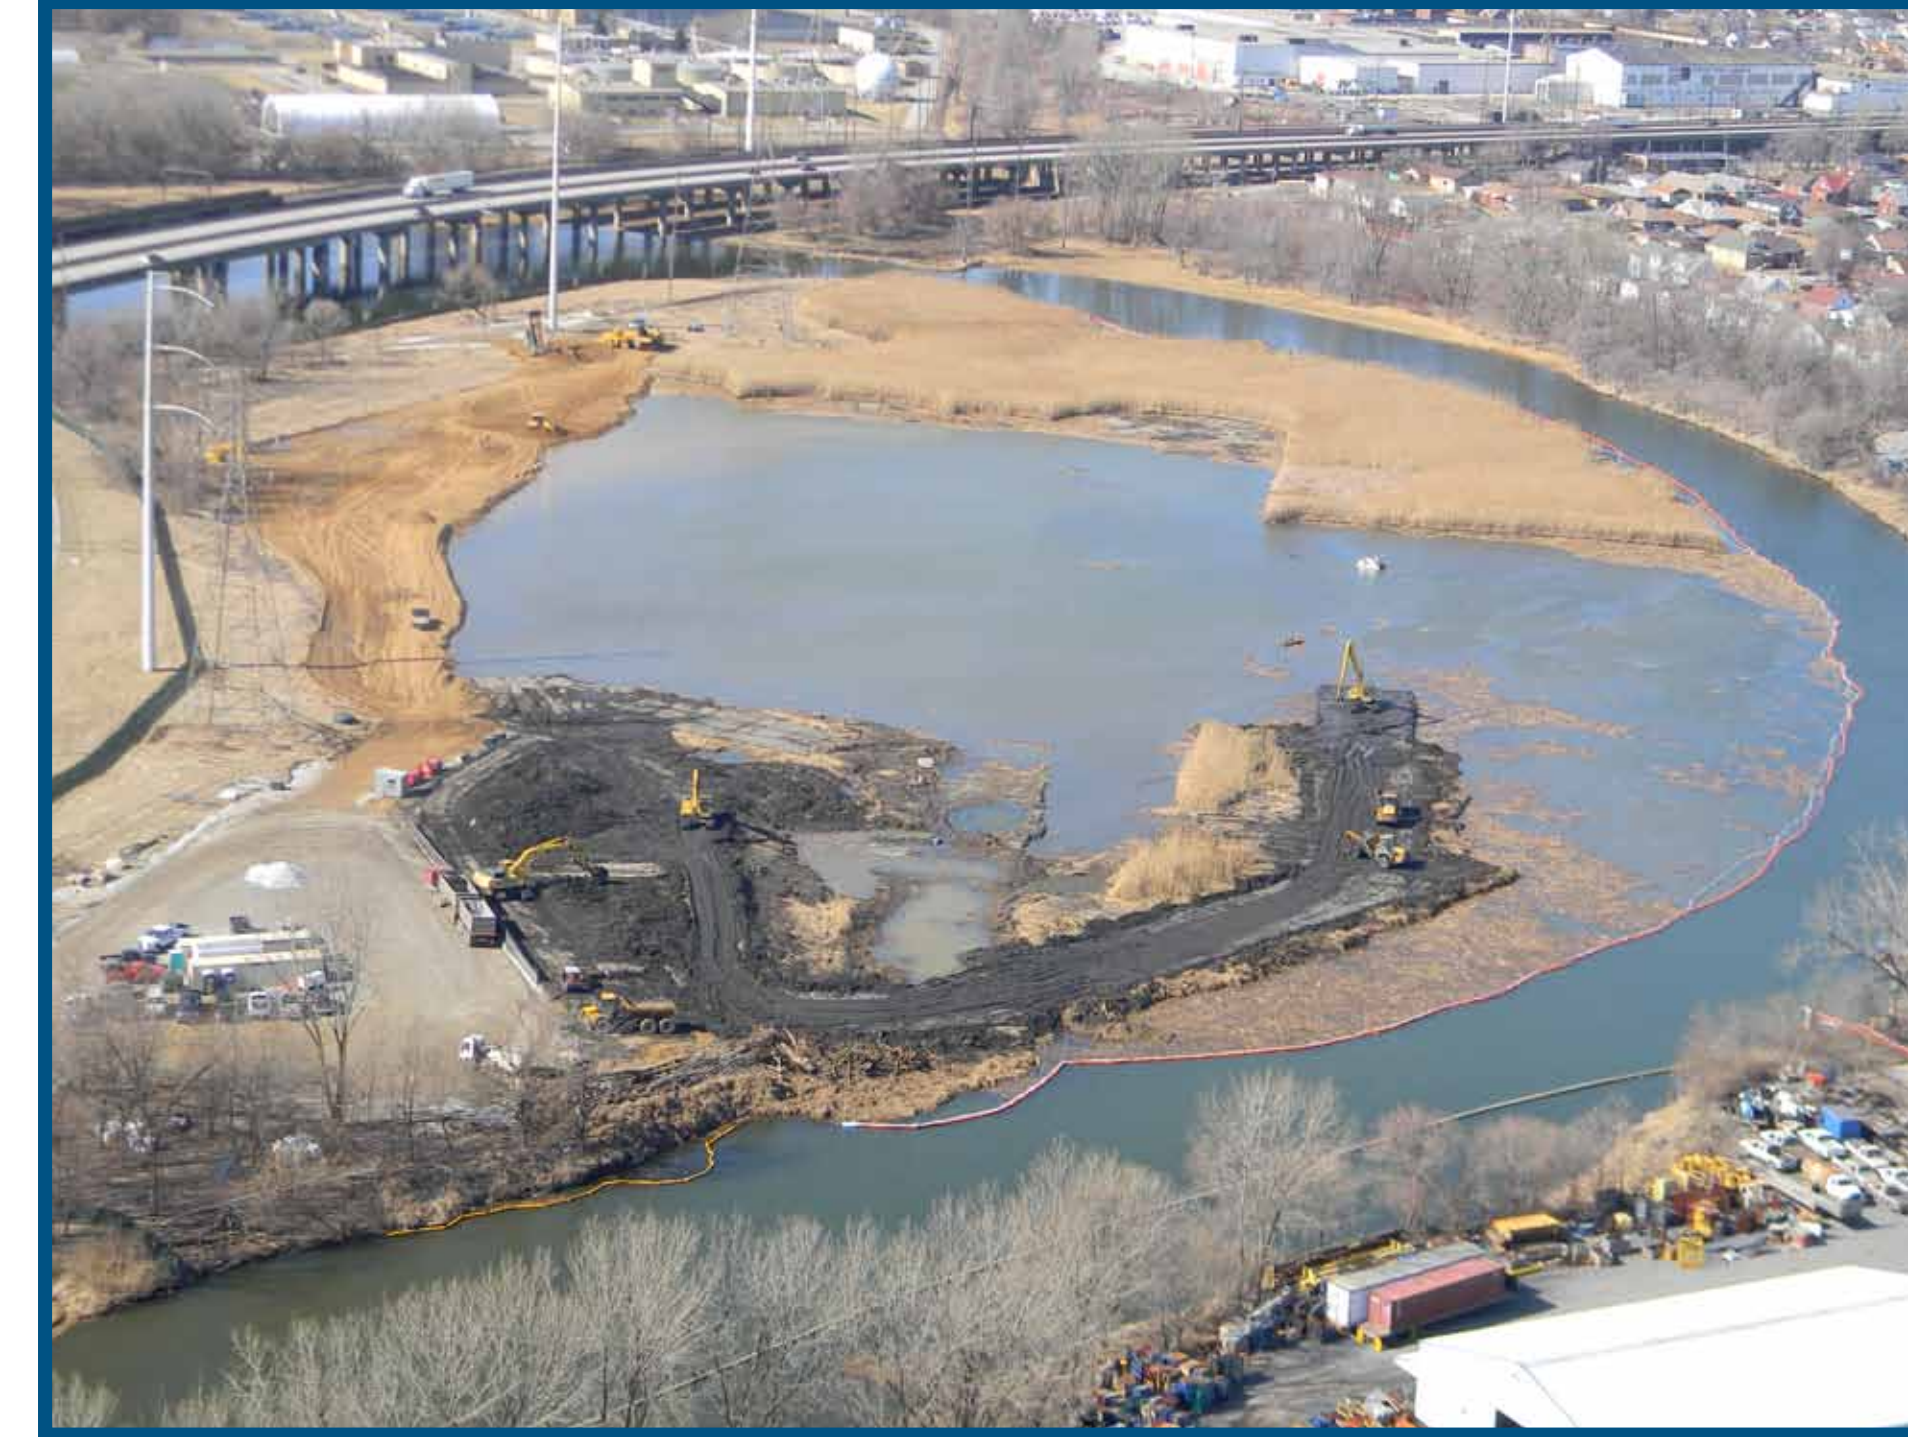
Contaminated marsh sediment was removed by mechanical dredging and a pond was created to provide habitat for migratory birds and other wildlife.

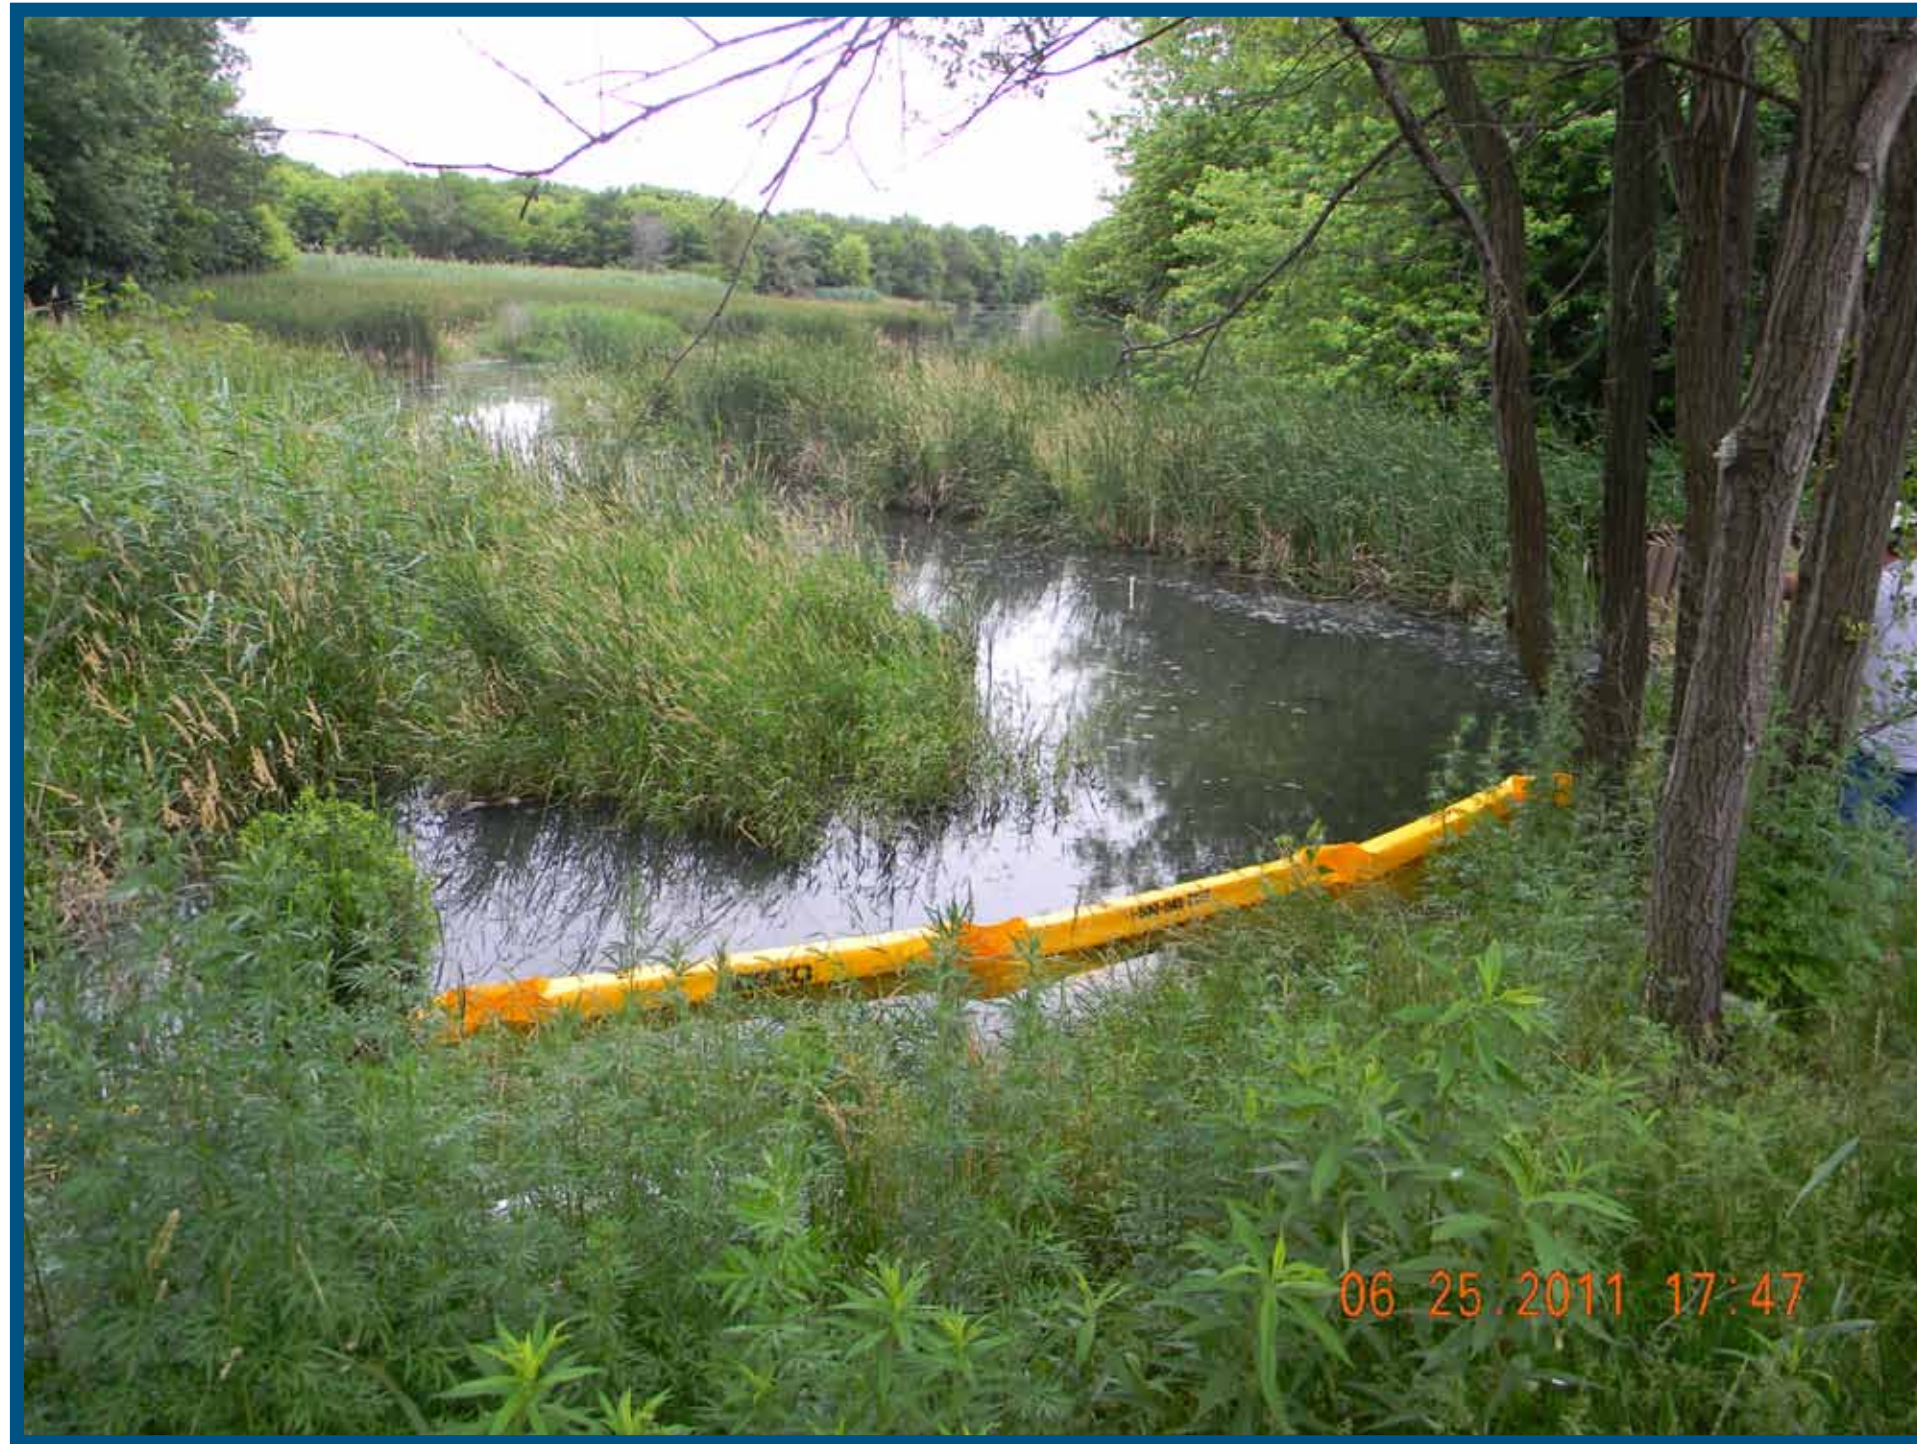
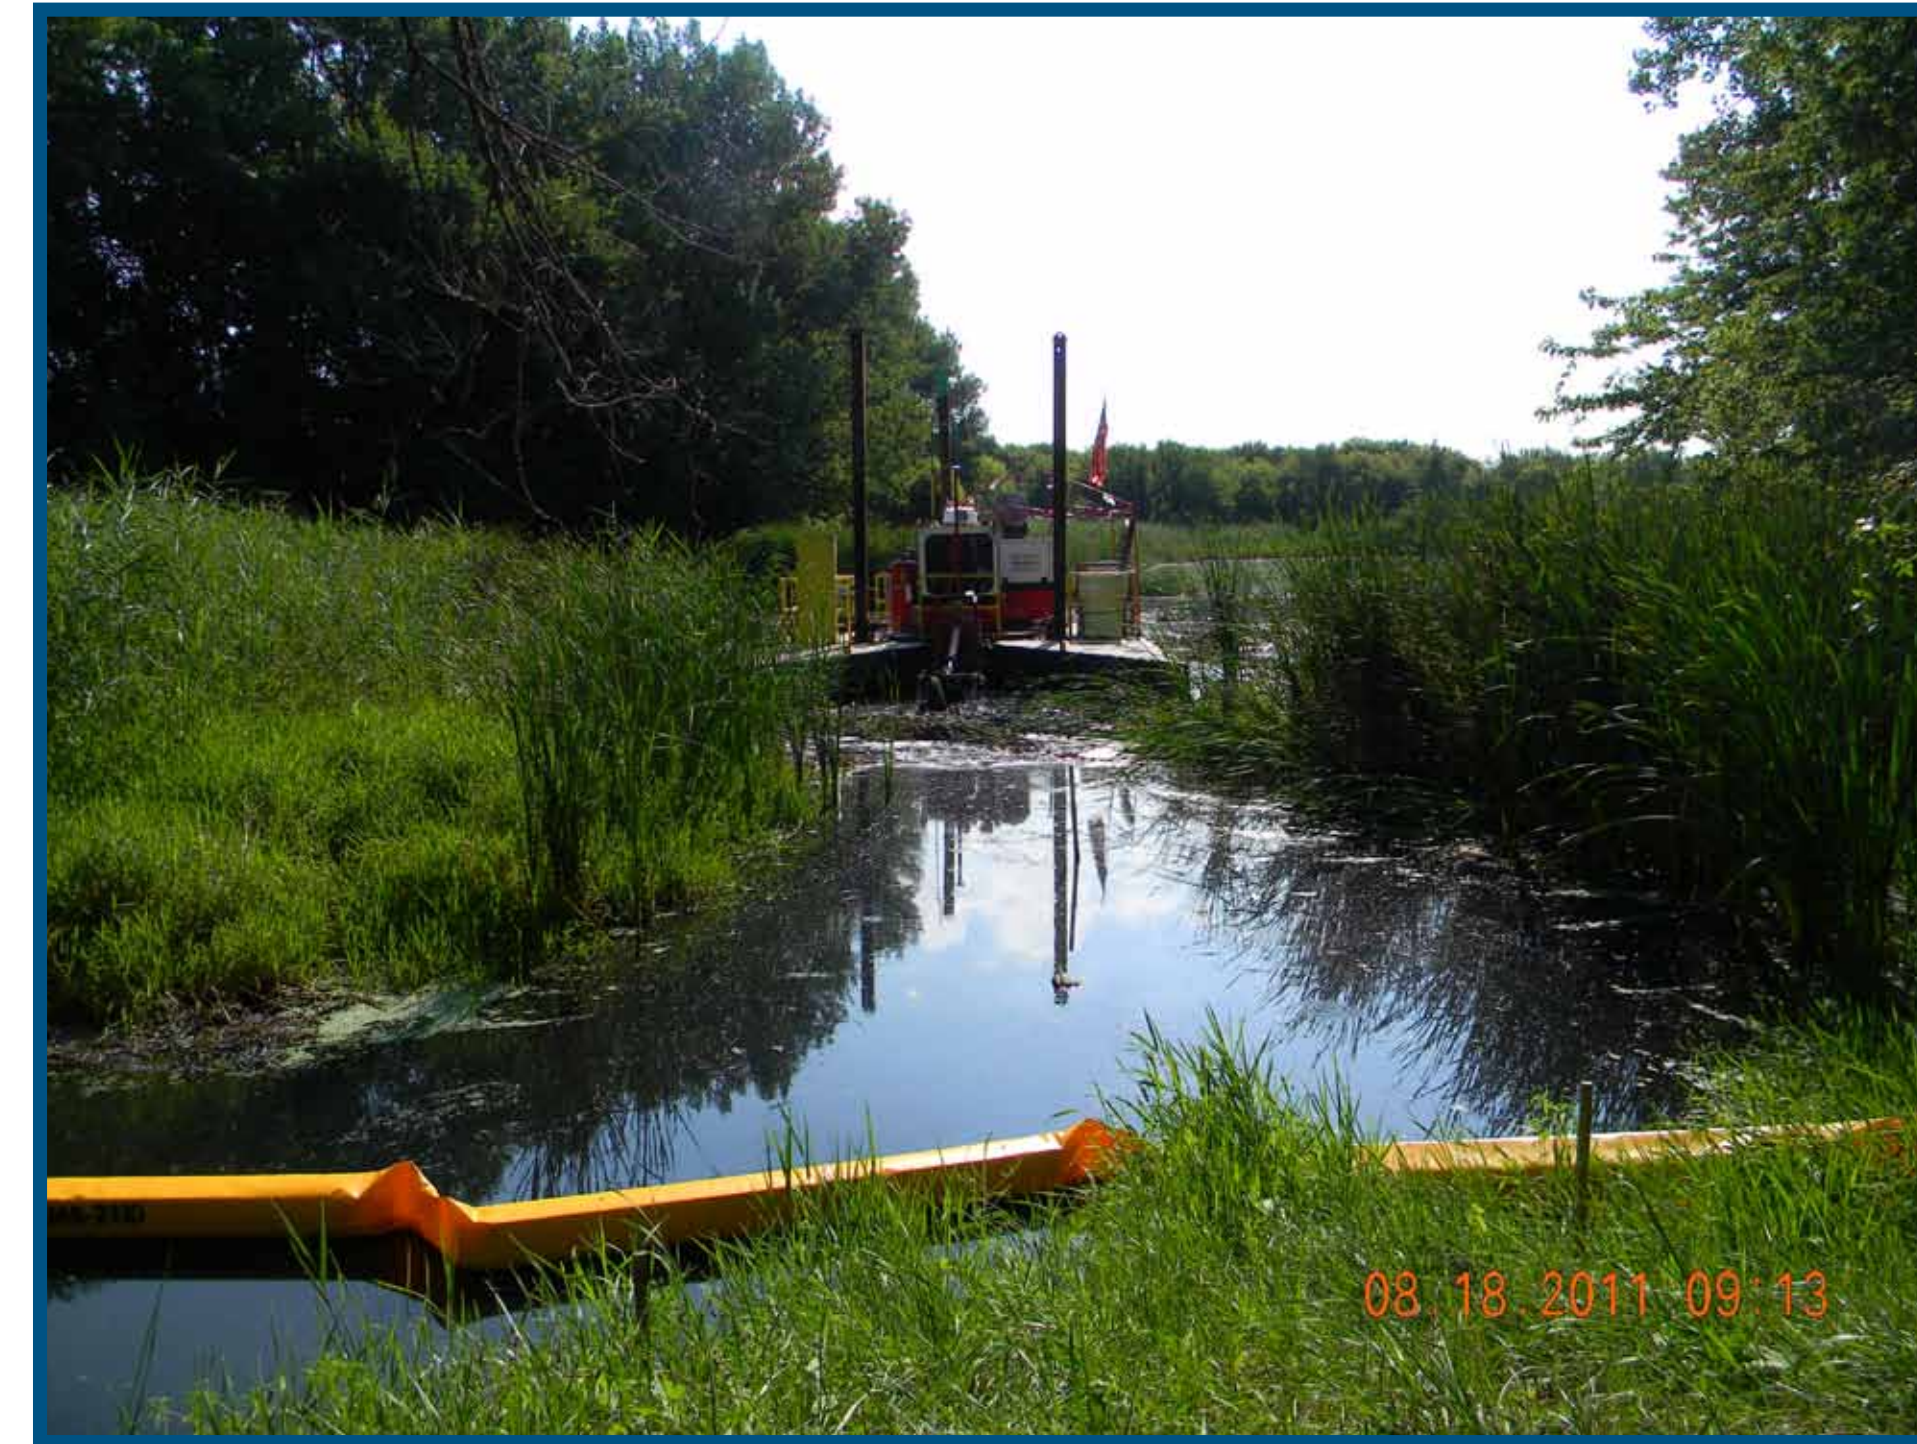
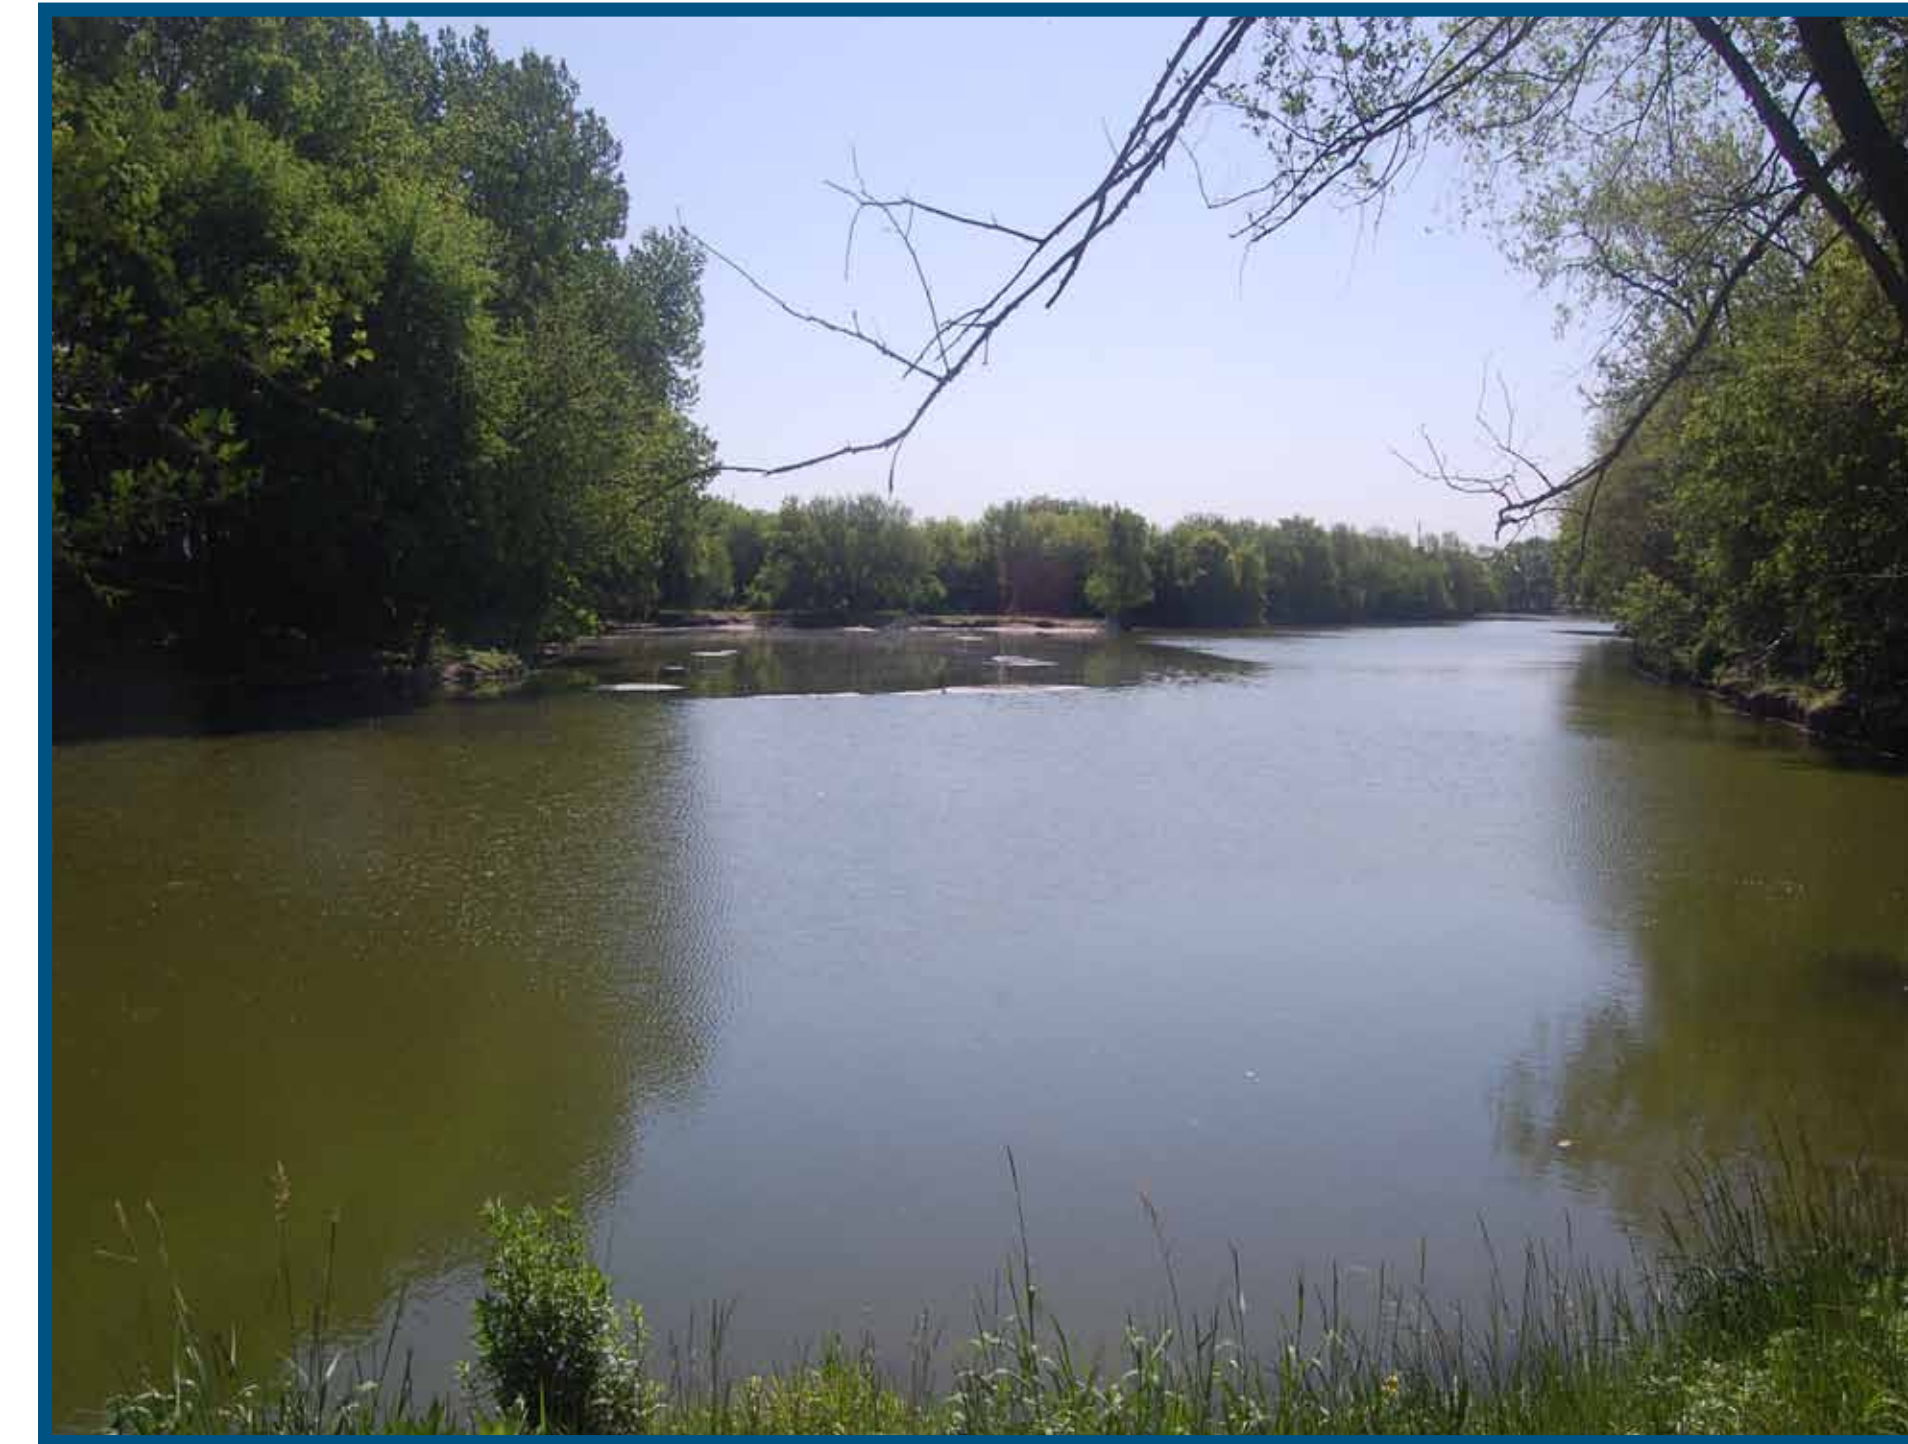
Contaminated river sediment and invasive species were removed by hydraulic dredging to improve the health of fish and wildlife and to restore native habitat.

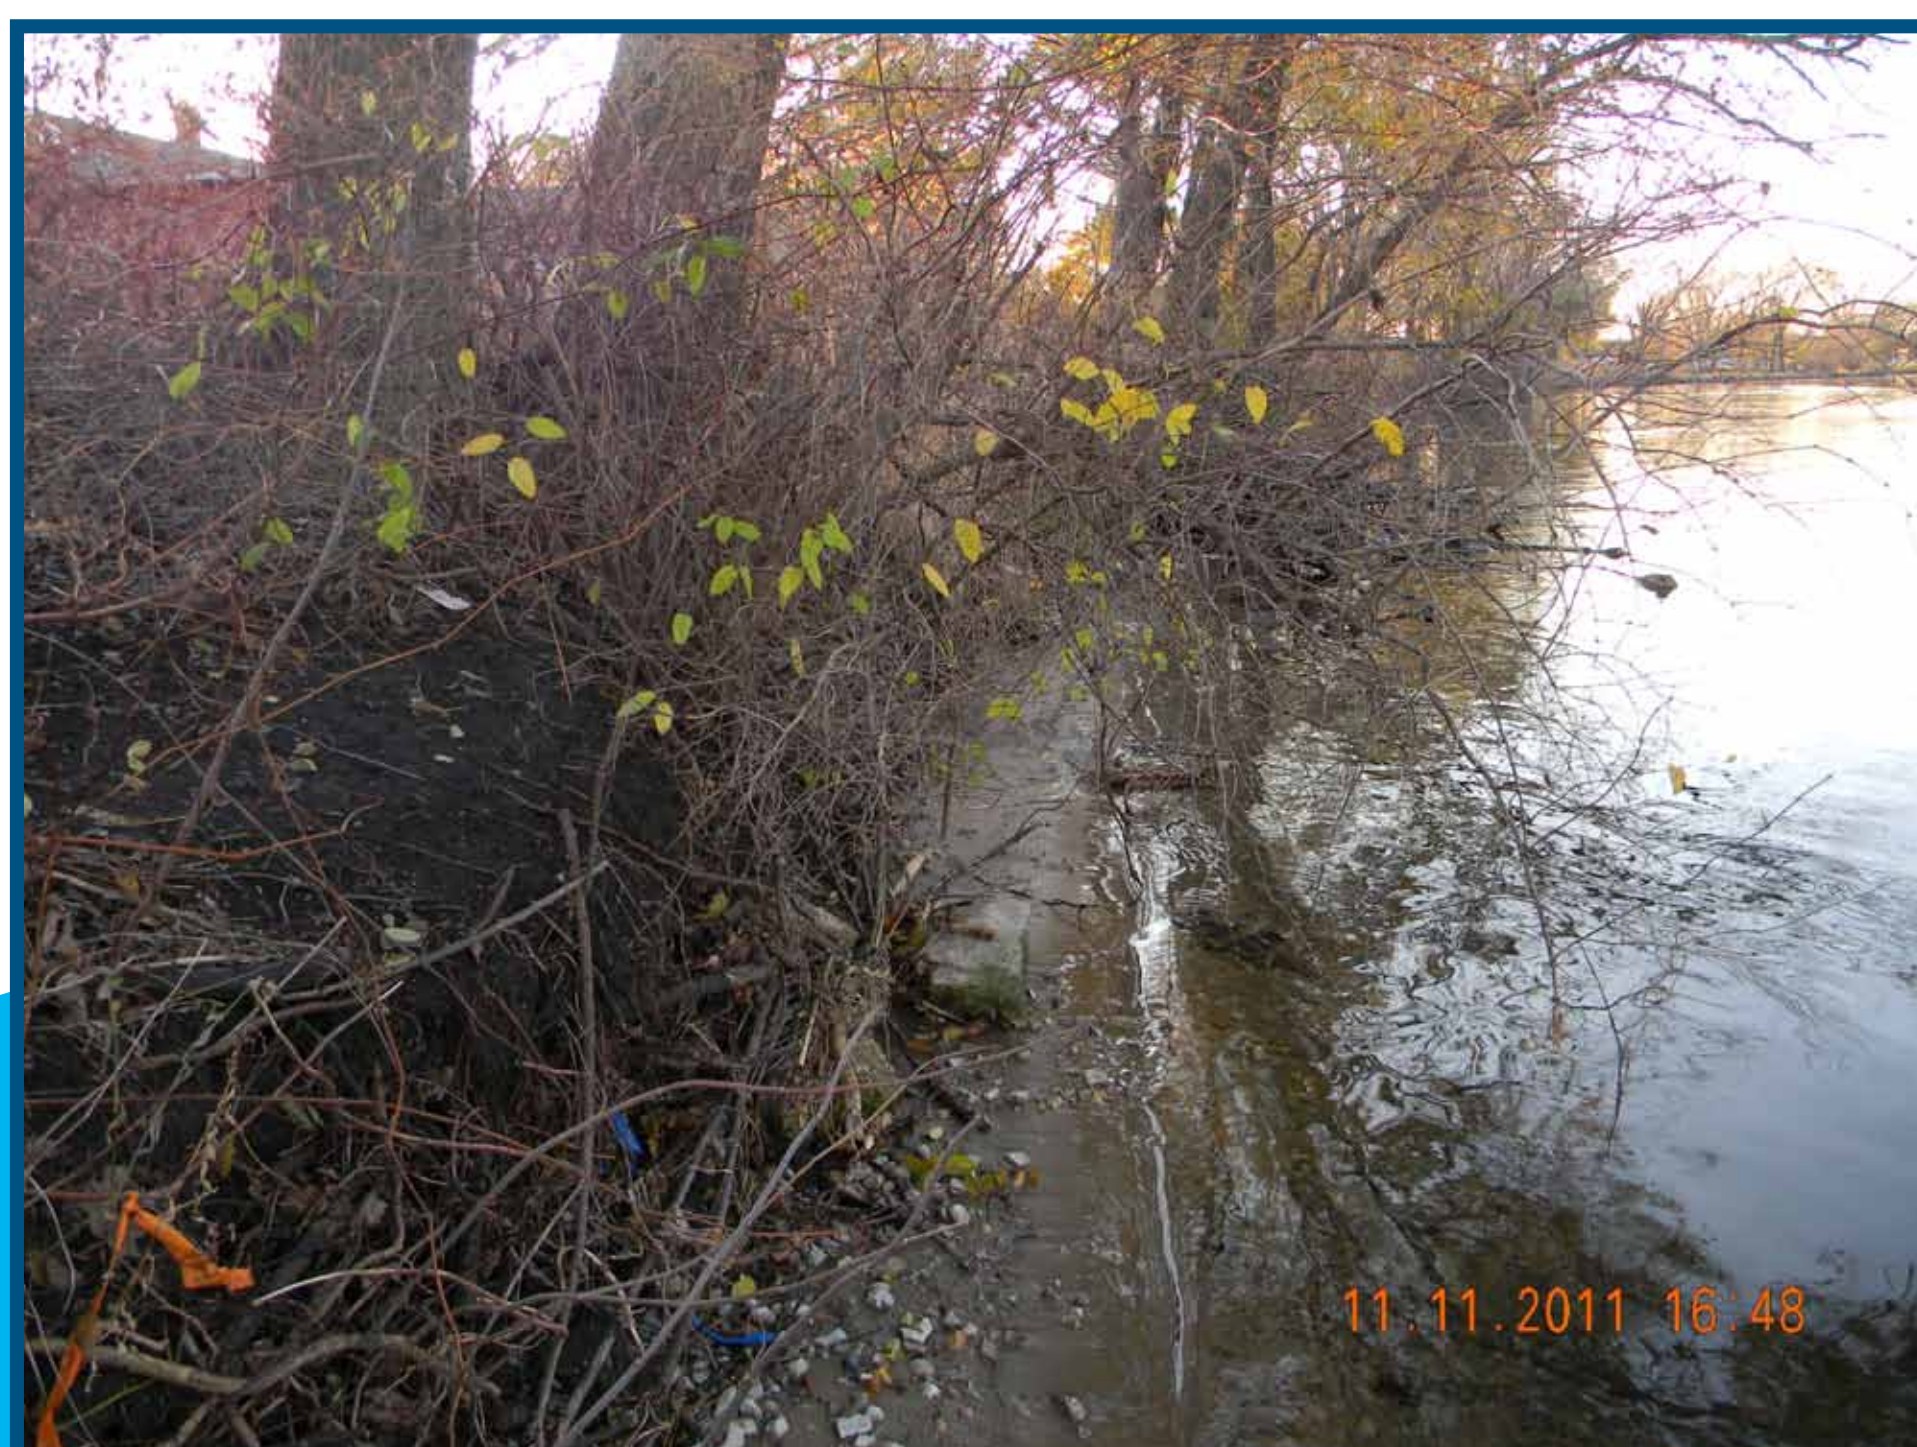
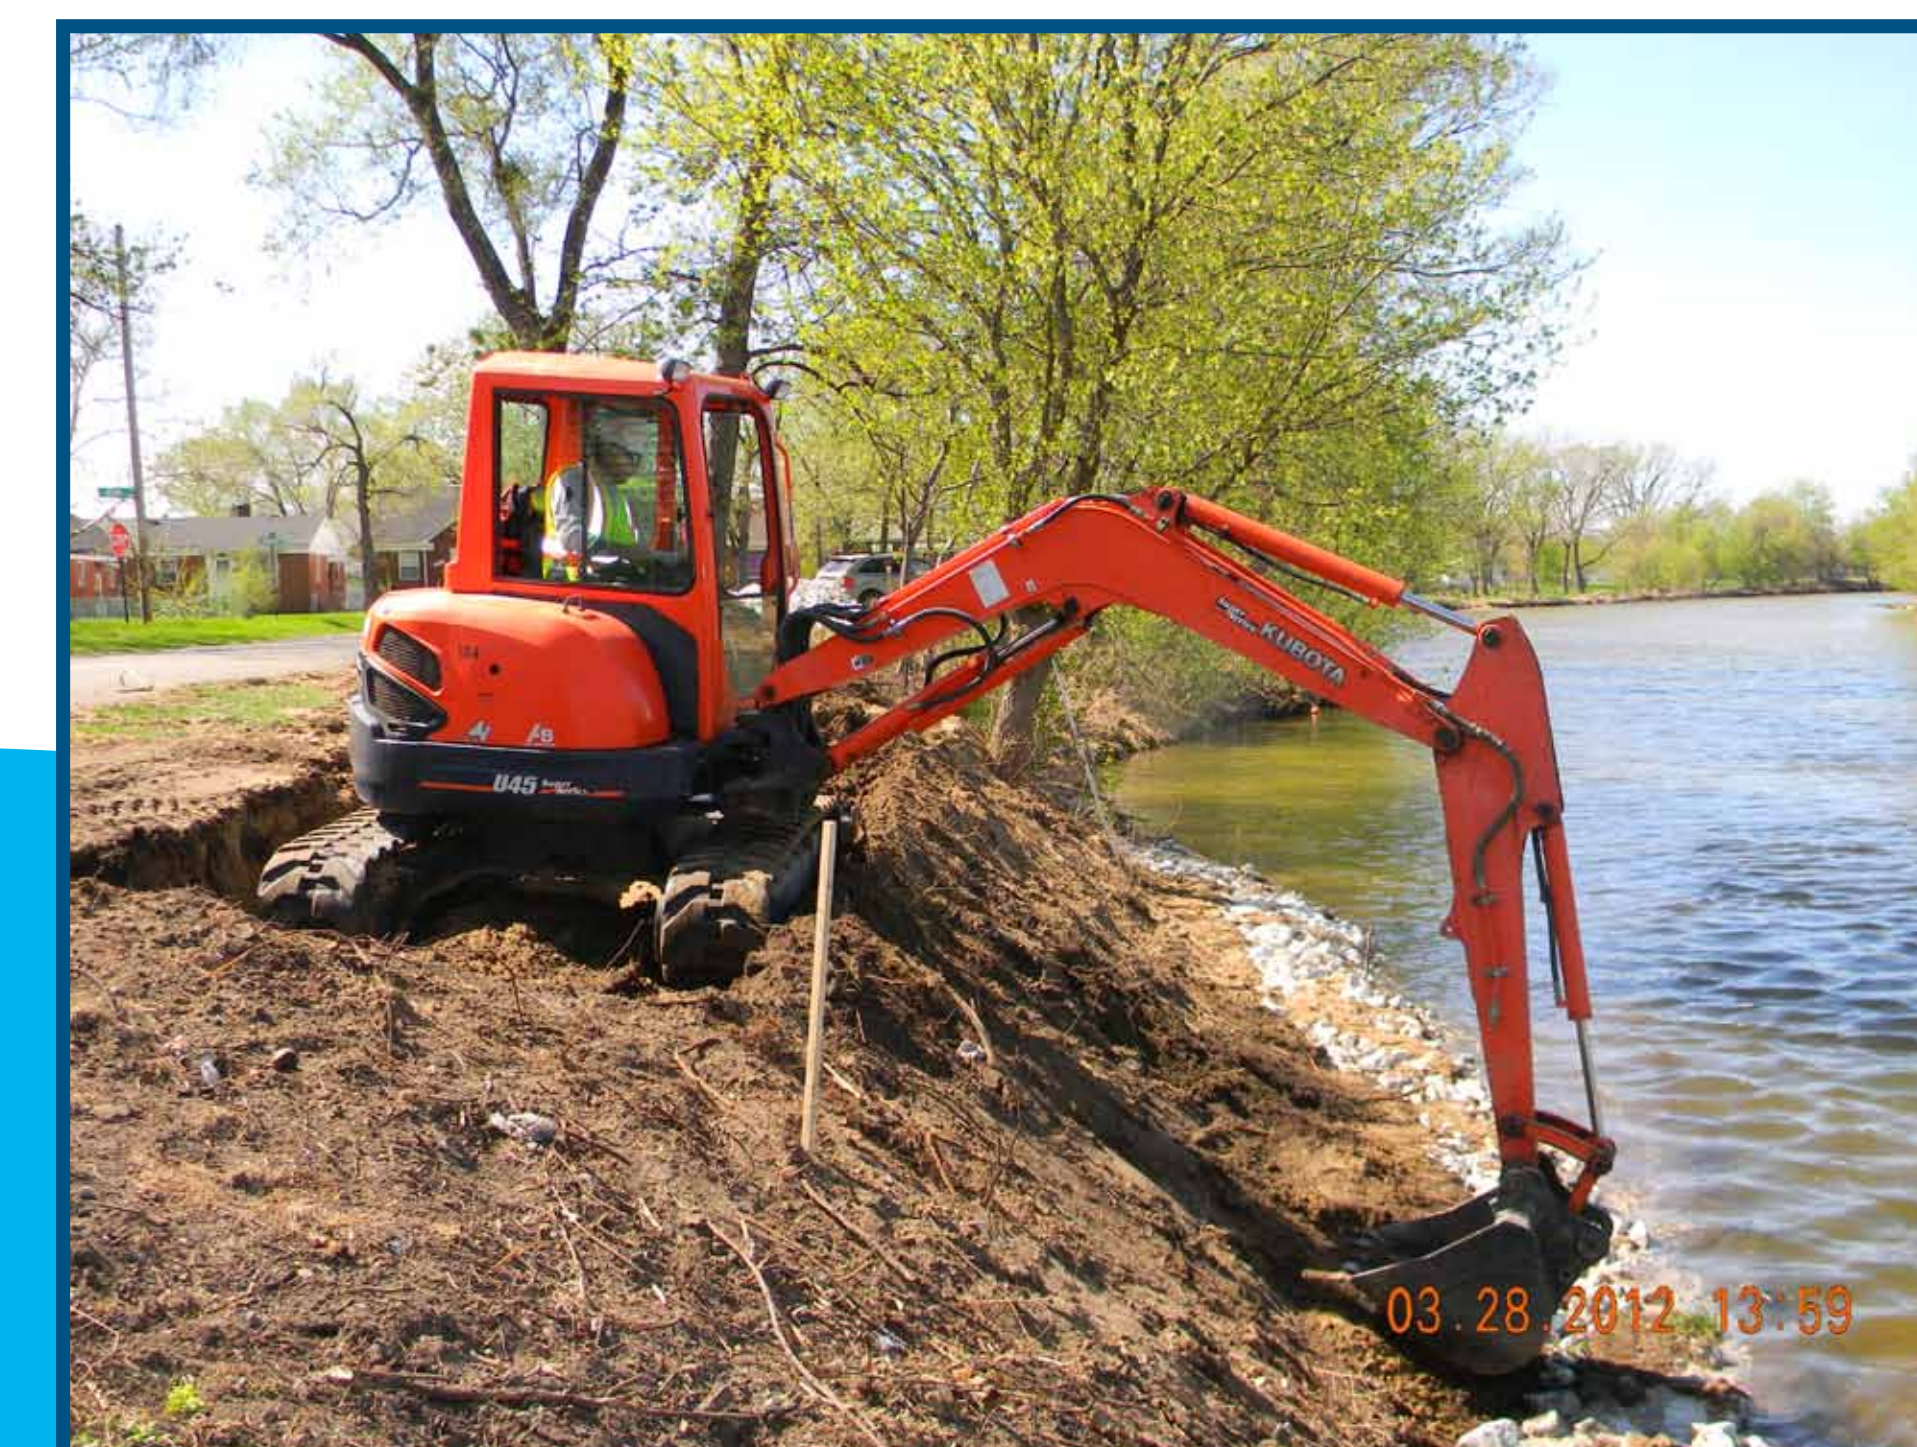
A bioengineered bank stabilization solution was constructed to prevent erosion and restore native habitat.
