Notice of Availability of an Environmental Assessment Worksheet (EAW)

Scanlon Reservoir Sediment Remediation

Doc Type: Public Notice

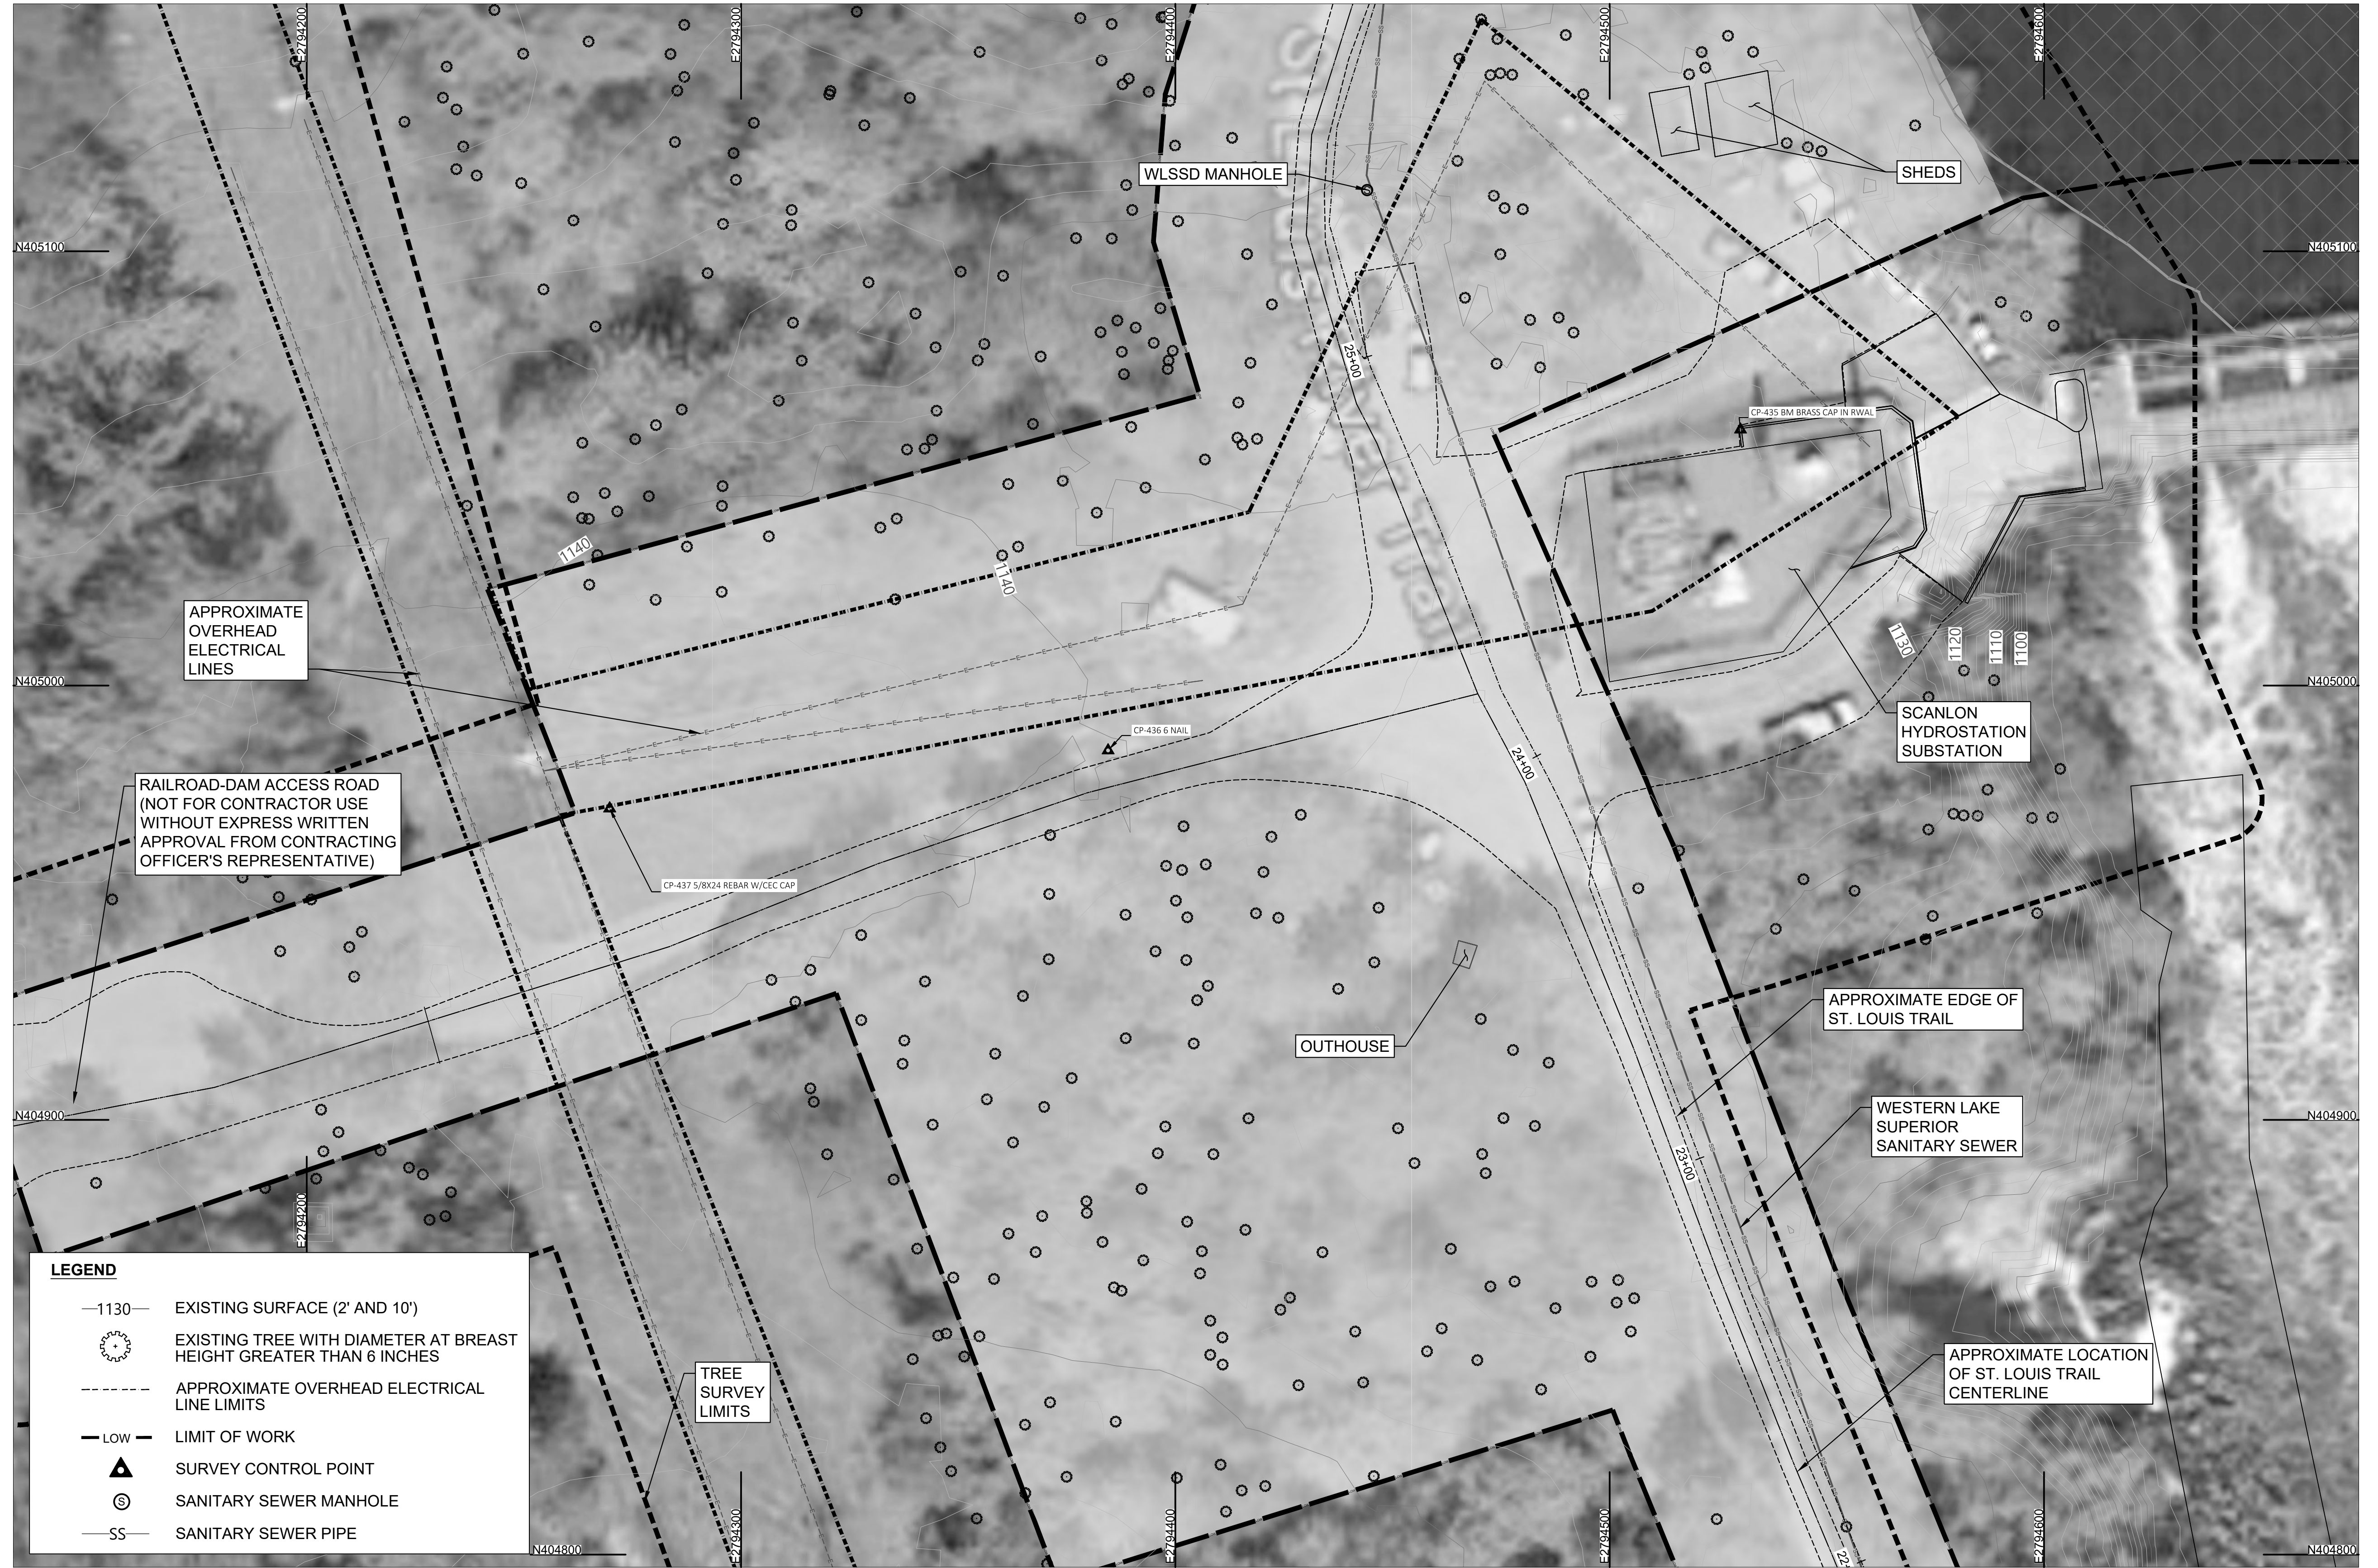
A6 G-006 EXISTING CONDITIONS - ENLARGED PLAN VIEW

- 1130— EXISTING SURFACE (2' AND 10')
- ⊙ EXISTING TREE WITH DIAMETER AT BREAST HEIGHT GREATER THAN 6 INCHES
- - - - - APPROXIMATE OVERHEAD ELECTRICAL LINE LIMITS
- LOW — LIMIT OF WORK
- ▲ SURVEY CONTROL POINT
- ⊙ SANITARY SEWER MANHOLE
- SS— SANITARY SEWER PIPE

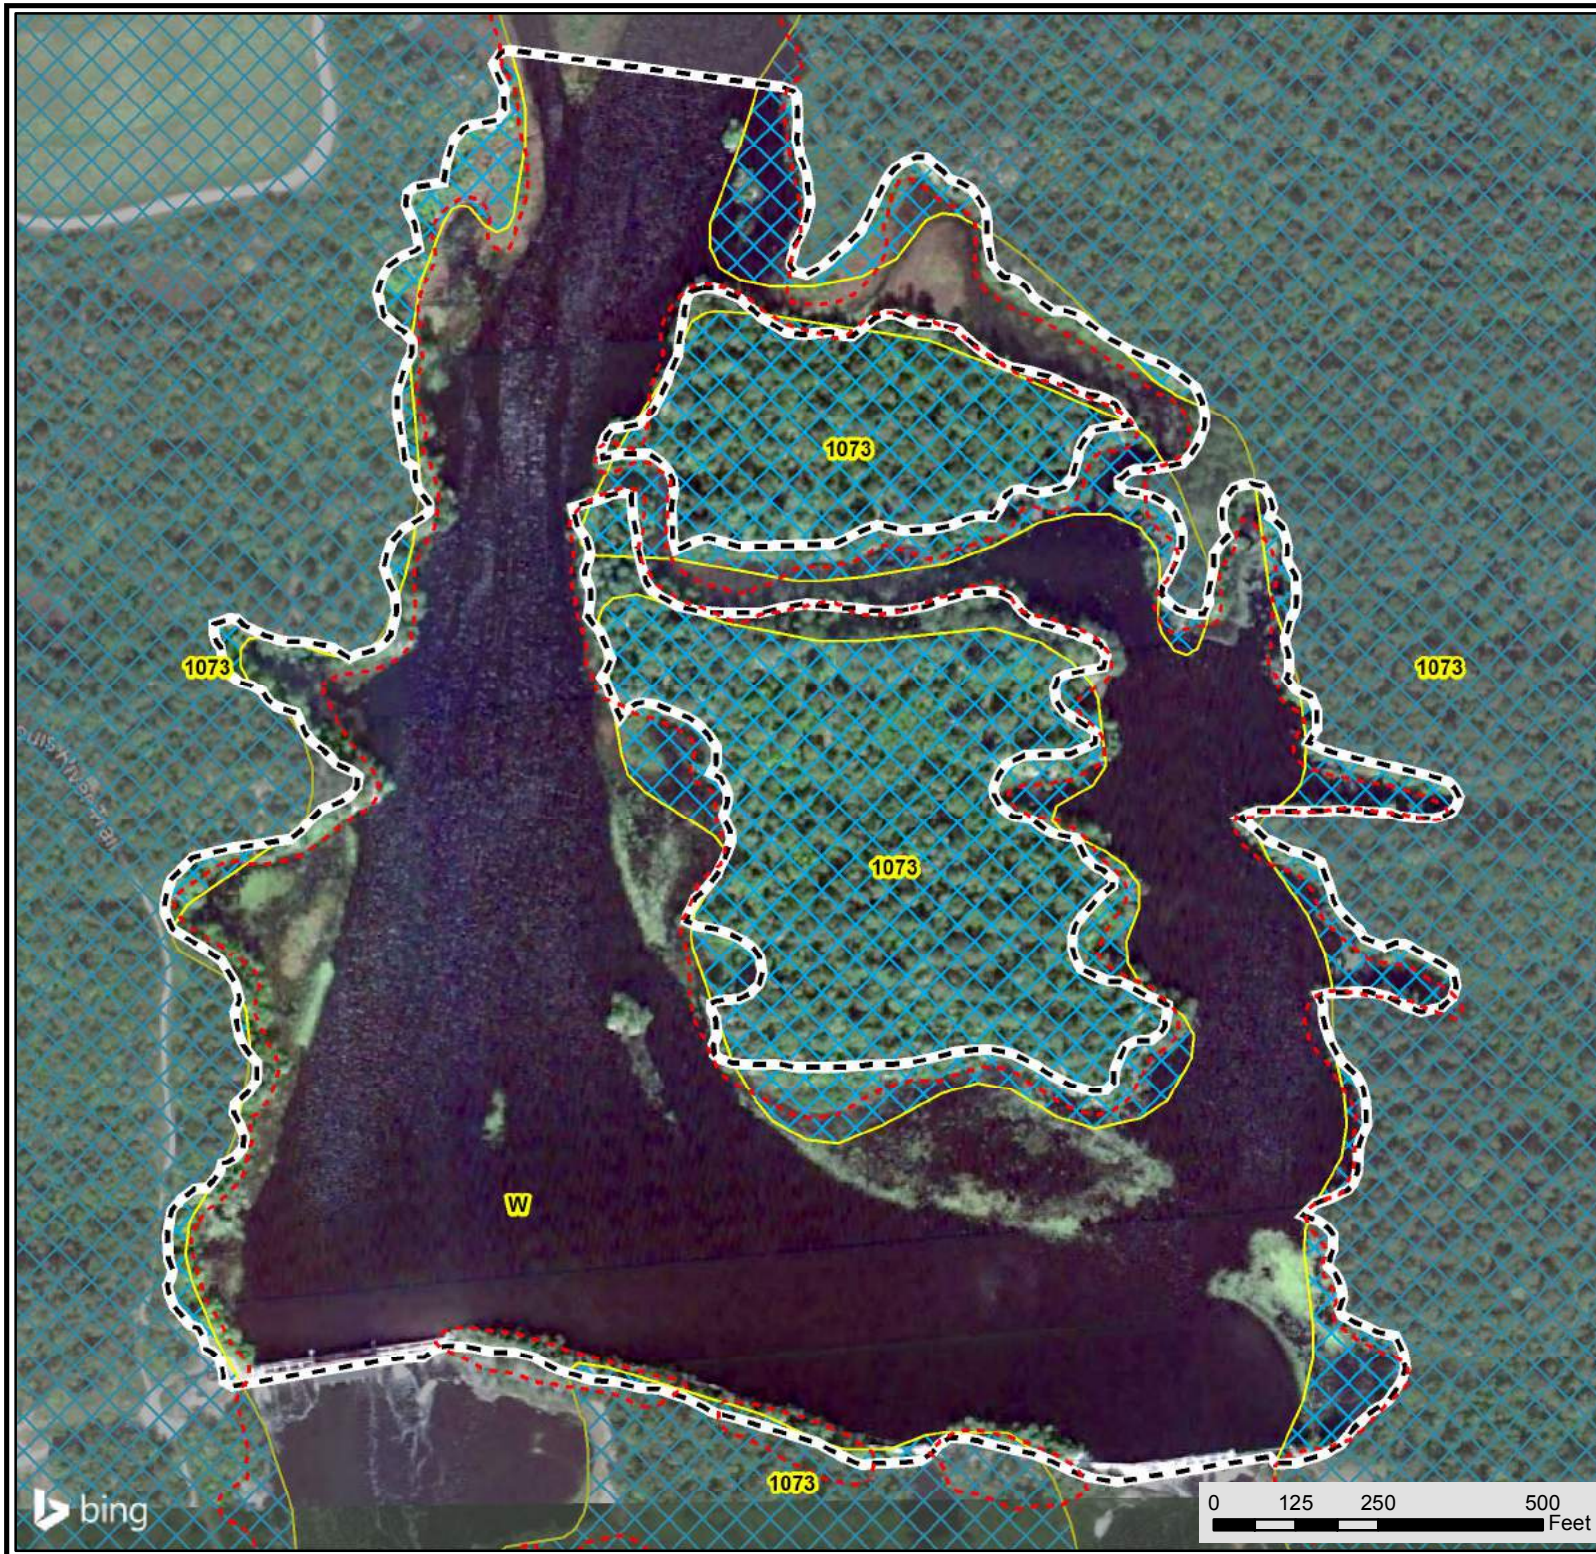
Figure 2. Soils Map

- Area of Interest (AOI)
- Target Reservoir Elevation OHWL (1,120 Feet)
- gSSURGO Soils**
 - 1073: Borofolists; Hydric - Inclusions
 - W: Water

Several information sources were consulted to evaluate the property and identify hydric soil units and potential wetlands on the site. Soil types were identified using the U.S. Department of Agriculture (USDA) Natural Resources Conservation Service (NRCS) Web Soil Survey map for Carlton County, MN (Figure 2). The general topography of the site was reviewed using an online two-foot topographic map (Figure 3). Potential wetlands were identified using a National Wetlands Inventory (NWI) map (Figure 4) as well as the MNDNR Public Waters Inventory Map (Figure 5). Maps can only be used to establish the probability and approximate location of wetlands on the site; therefore, the USACE does not accept the use of these maps to make final wetland determinations. Final wetland determinations were made with onsite observations and fieldwork. Prior to the fieldwork, background information was reviewed to establish the probability and approximate location of wetlands on the site. The following maps were reviewed offsite or onsite as part of the wetland determination:

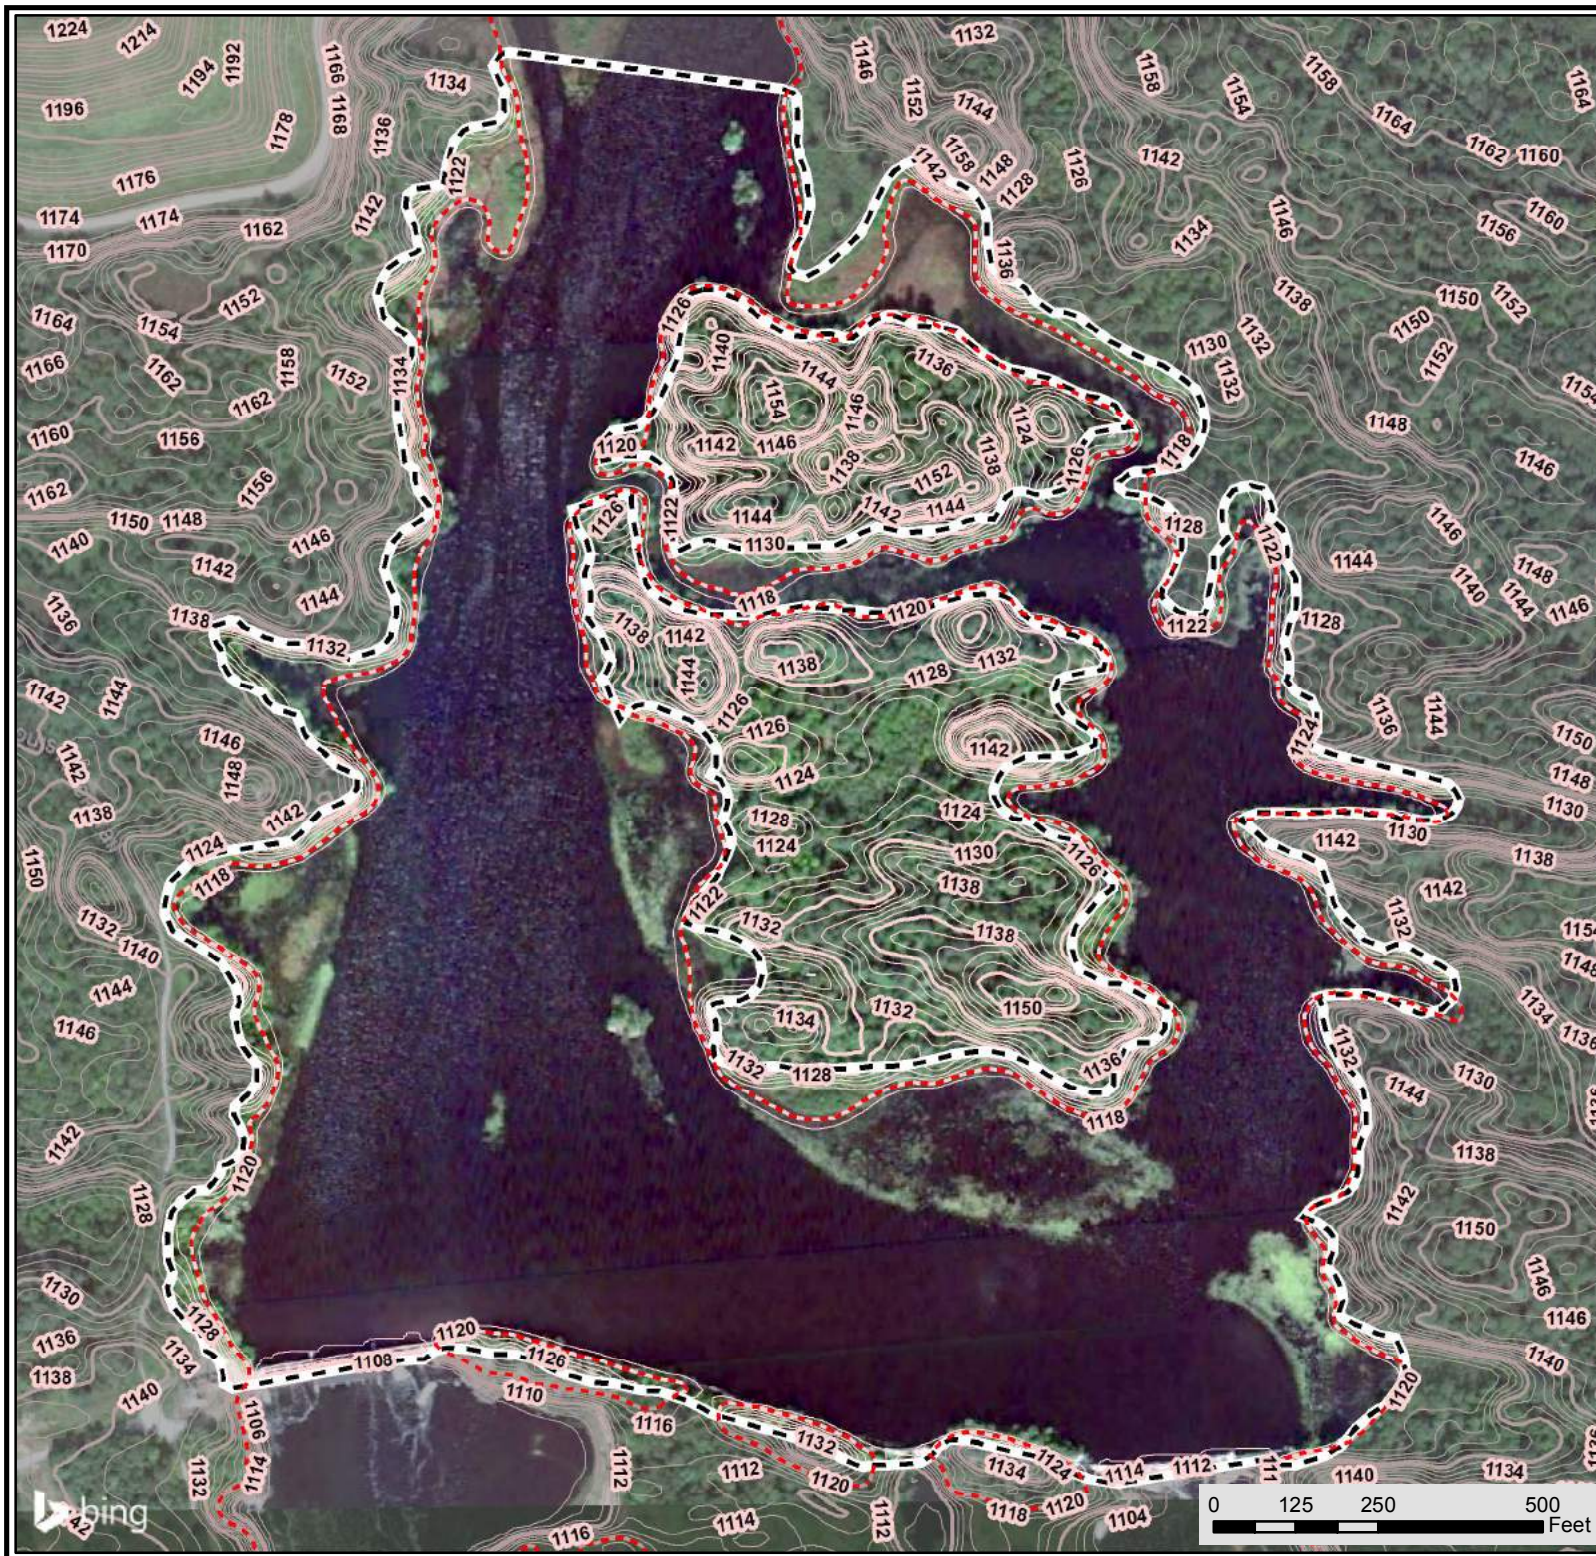
Figure 4. Topographical Map

- Area of Interest (AOI)
- Target Reservoir
- Elevation OHWL (1,120 Feet)
- 2-Foot Contour From LiDAR**
 - Index
 - Intermediate

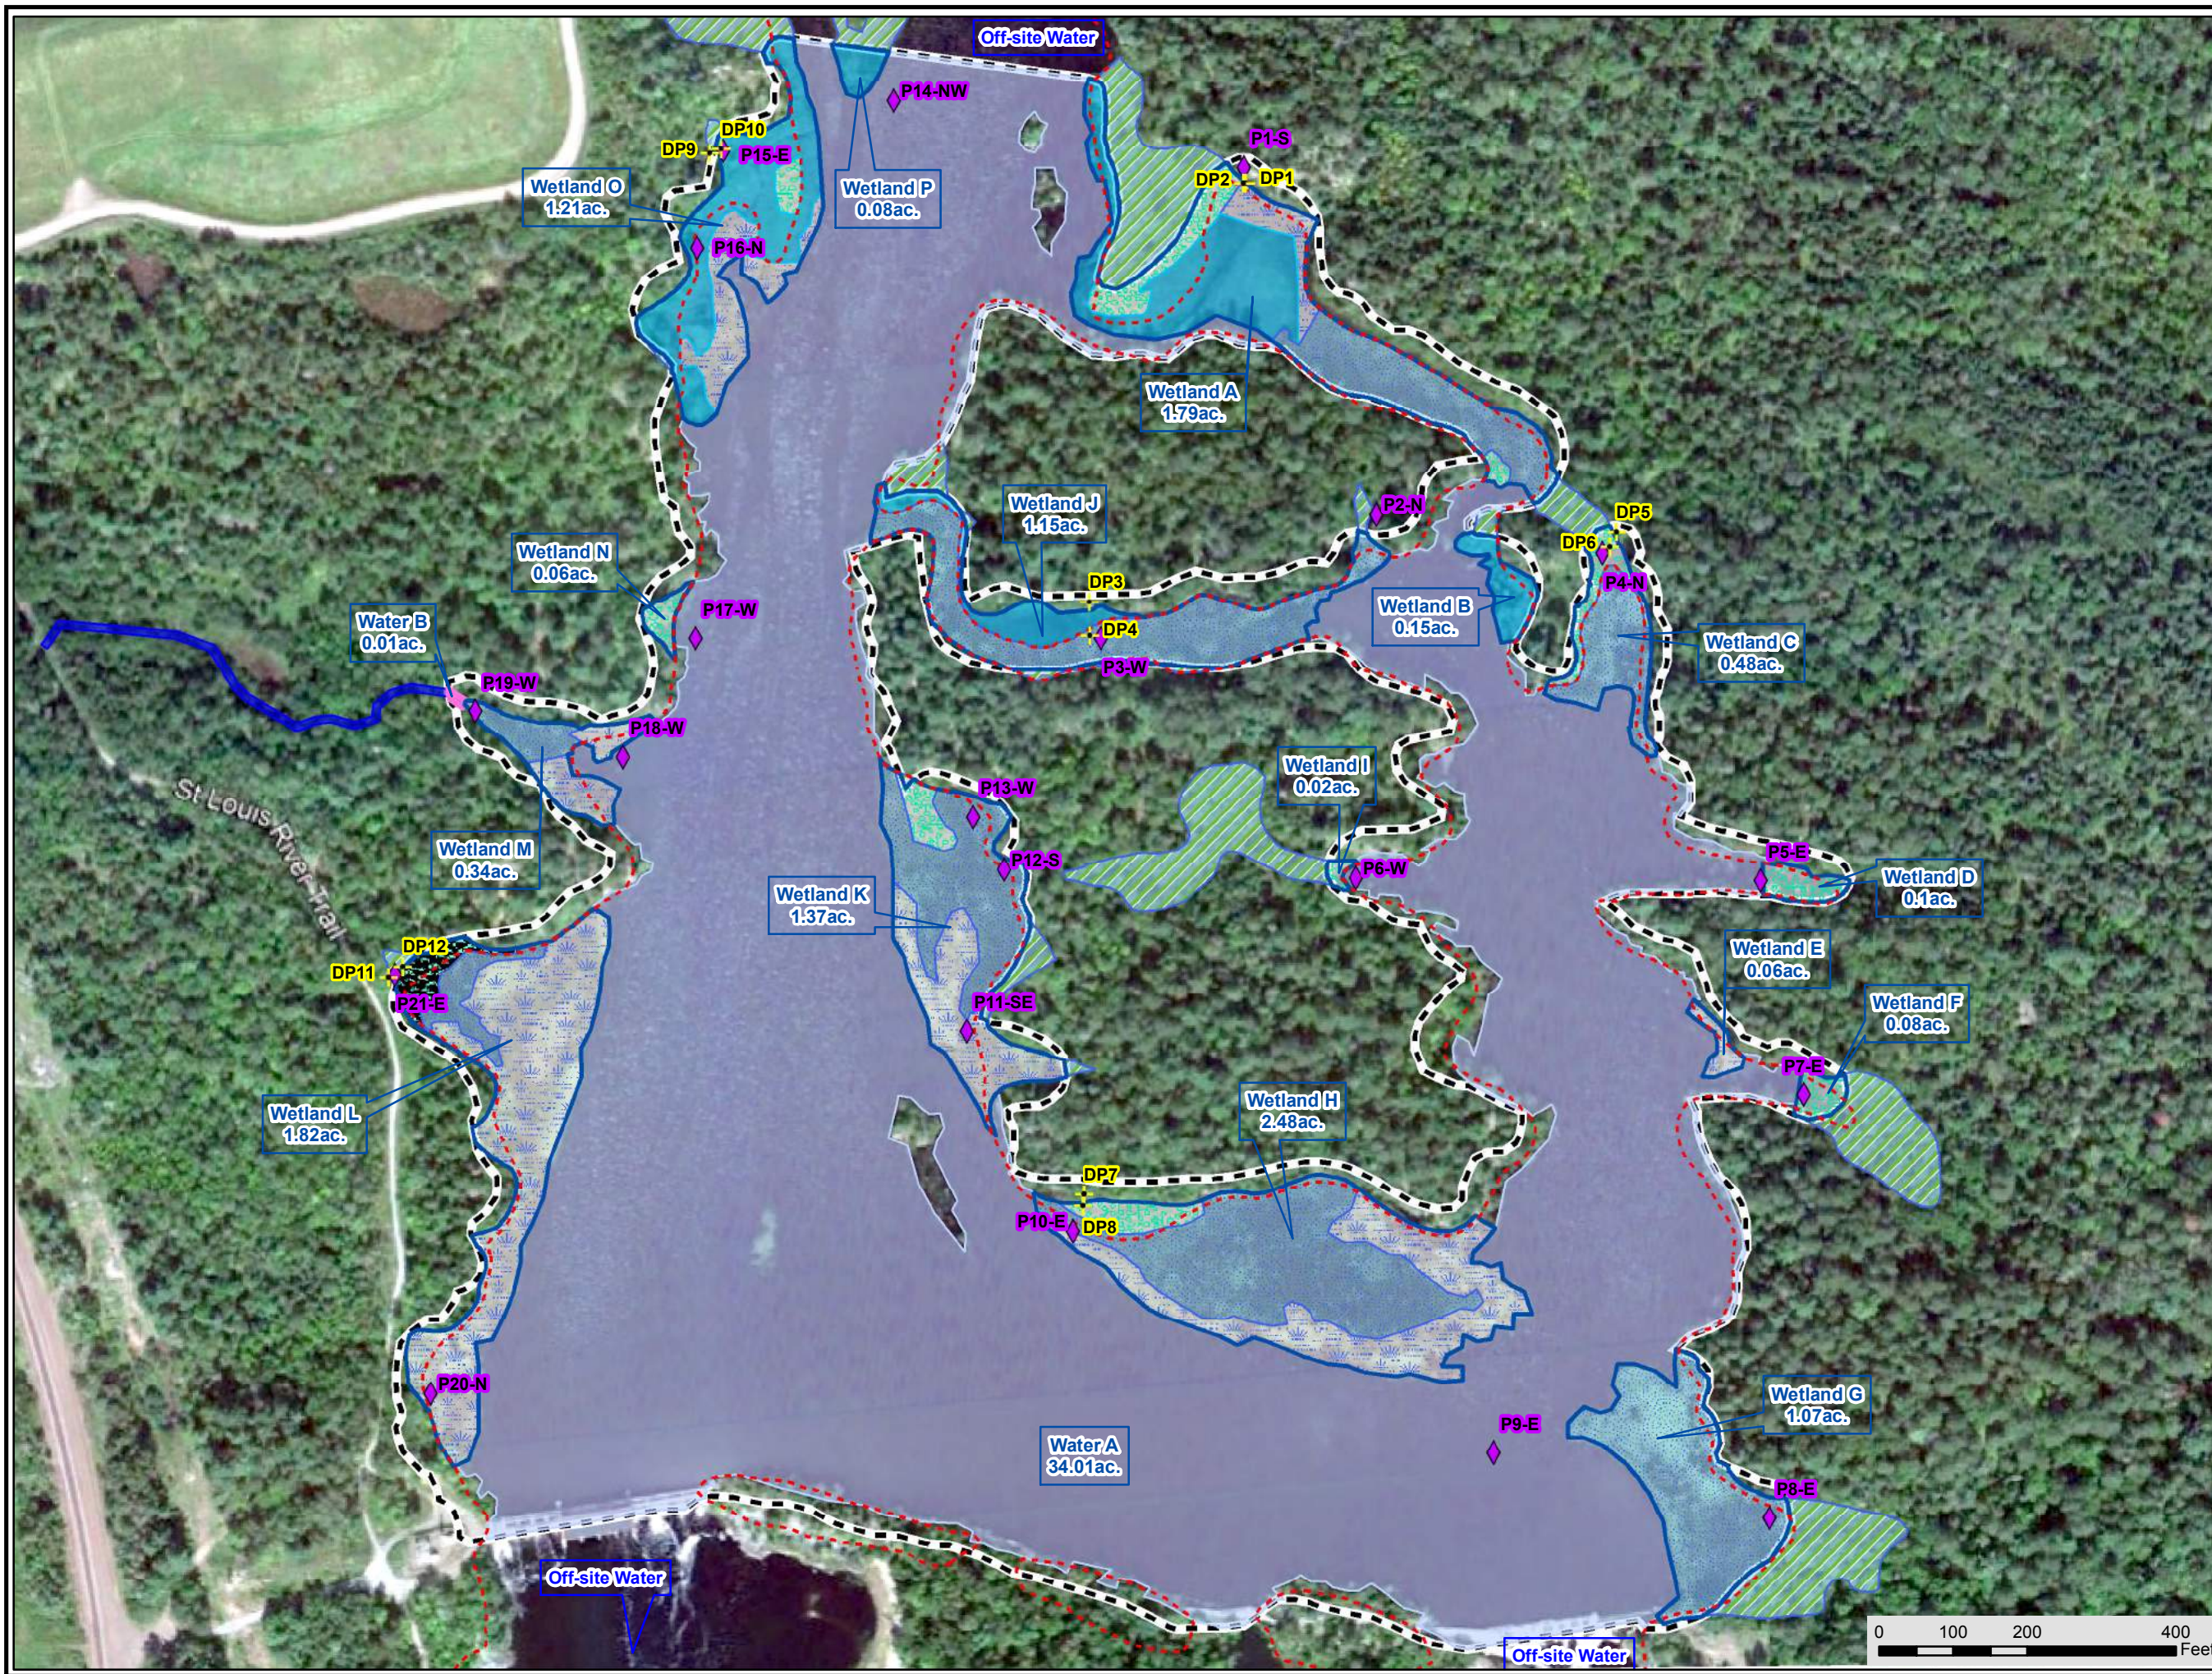
Figure 6. Wetland Delineation Map

- Area of Interest (AOI)
- Target Reservoir Elevation OHWL (1,120 Feet)
- Data Points With ID
- Photo Point # - Direction

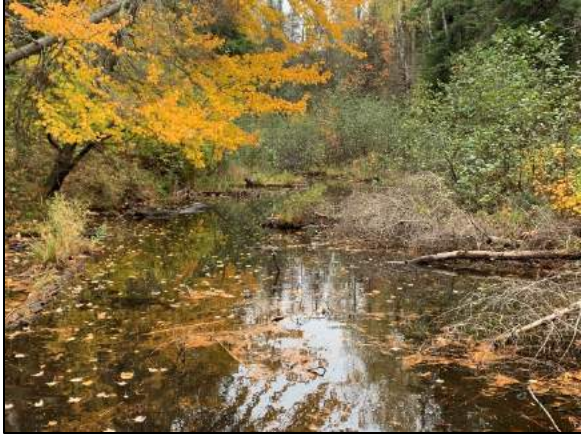
Photo 7. Photo Point 5 (P5) looking east at Wetland D (October 2, 2019)

Wetland D (Photo 7) is a small, approximately 0.10-acre Alder Thicket wetland in the eastern portion of the AOI. It is located almost entirely below the OHWL and is composed of the typical Alder Thicket species listed in Table 2.

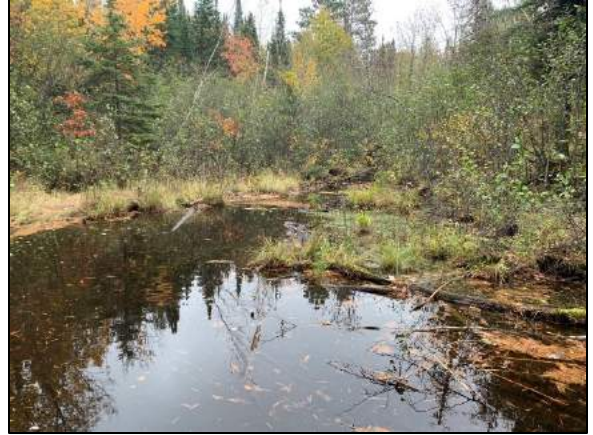
Photo 8. Photo Point 7 (P7) looking east at Wetland F (October 2, 2019)

Wetland F (Photo 8) is an approximately 0.08-acre Alder Thicket wetland located in a cove in the southeastern portion of the AOI. It is located almost entirely below the OHWL within the AOI but

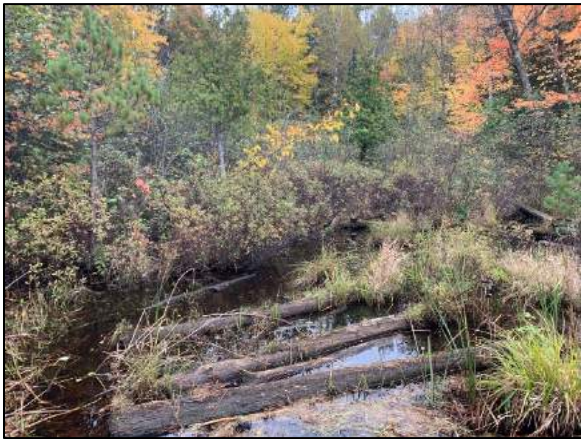
Photo 9. Photo Point 8 (P8) looking east at interior portion of Wetland G (October 2, 2019)

Wetland G (Photos 9 and 10) is an approximately 1.07-acre Shallow Open Water wetland located in the southeastern portion of the AOI. It is located almost entirely below the OHWL within the AOI but extends landward offsite in a low gradient area to the east where it transitions to Alder Thicket wetland. It is composed of the typical Shallow Open Water species listed in Table 2.

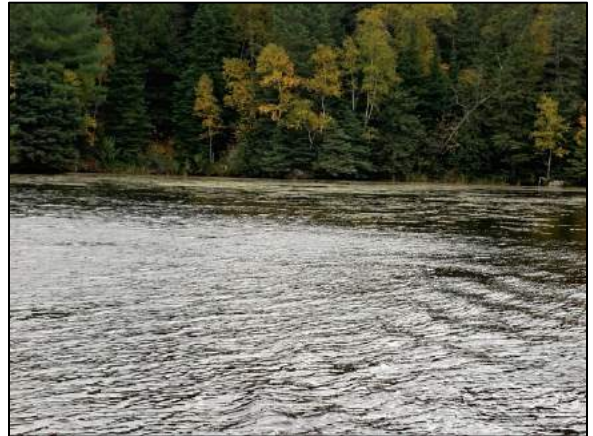
Photo 10. Photo Point 9 (P9) looking east towards Wetland G (October 2, 2019)

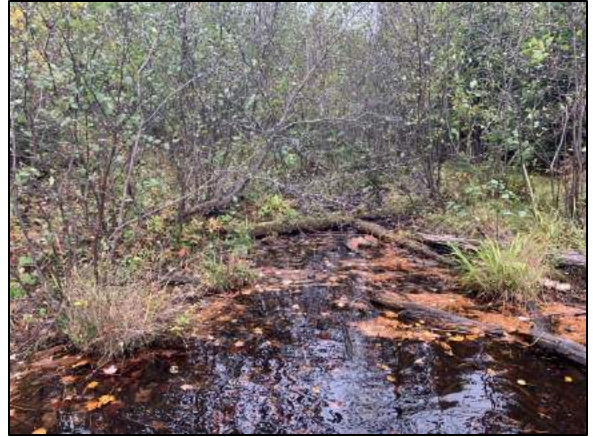
Photo 14. Photo Point 6 (P6) looking west at Wetland I (October 2, 2019)

Wetland I (Photo 14) is a small, approximately 0.02-acre Alder Thicket wetland located in a cove in the eastern portion of the south reservoir island. It is located entirely below the OHWL within the AOI but extends landward offsite in a low gradient portion of the island. It is composed of the typical Alder Thicket species listed in Table 2.

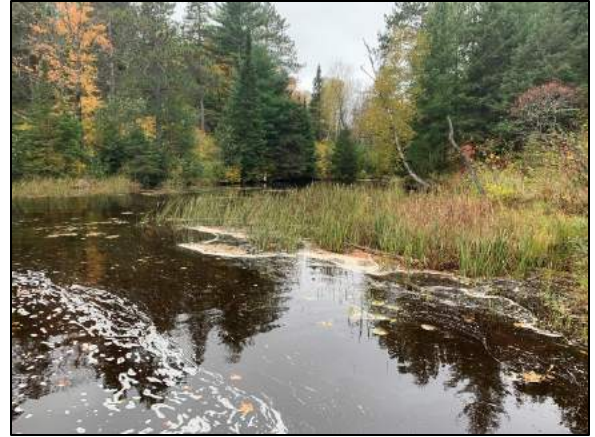
Photo 26. Photo Point 18 (P18) looking west at Wetland M (October 2, 2019)

Wetland M (Photo 26) is in a cove in the west-central portion of the AOI and is approximately 0.34 acres. It is composed of Deep Marsh and Shallow Open Water wetlands. Typical species associated with these wetland types are presented in Table 2.

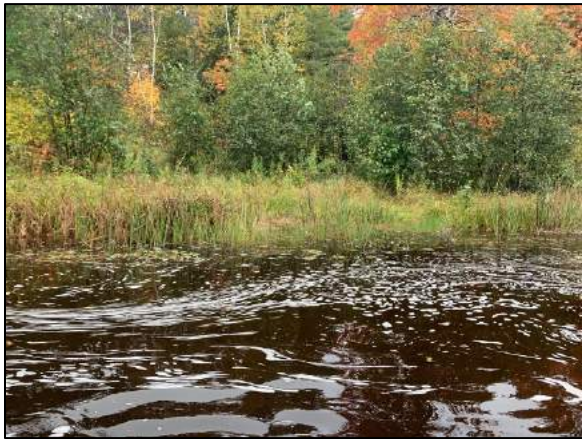
Photo 27. Photo Point 17 (P17) looking west at Wetland N (October 2, 2019)

Wetland N (Photo 27) is a small cove wetland immediately north of Wetland M. It is approximately 0.06 acres and is composed of Alder Thicket wetland. Typical species associated with this wetland type are presented in Table 2.

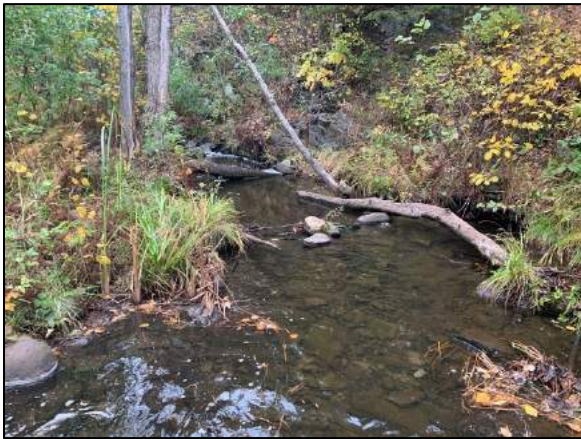
Photo 32. Photo Point 14 (P14) looking northwest at Wetland P (October 2, 2019)

Wetland P (Photo 32) in the northern portion of the AOI is approximately 0.08 acres and is composed of Shallow Marsh wetland. Typical species associated with this wetland type are presented in Table 2.
