# Remediation of the Black Lagoon Trenton, Michigan

## Great Lakes Legacy Program

October 2007

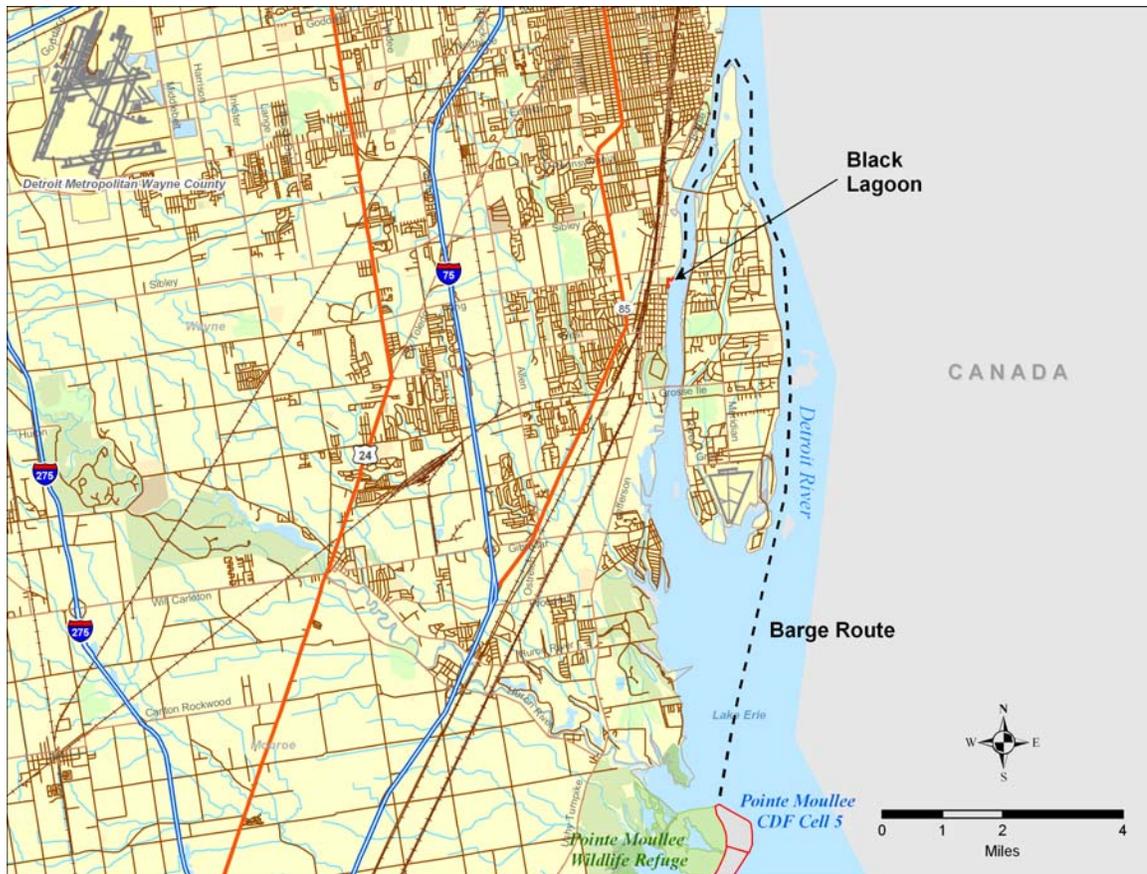
Figure 3-2 Map of Detroit Area With Barge Route From Black Lagoon to the Pointe Moullée CDF

Setup, preparation, and construction work was necessary to prepare Cell 5 of the facility for acceptance of the excavated sediments. Figure 3-2 provides a map of the barge route from the Black Lagoon to the Pointe Moullee CDF. Cell 5 is located in the northwest corner of the CDF. These CDF preparation activities involved:

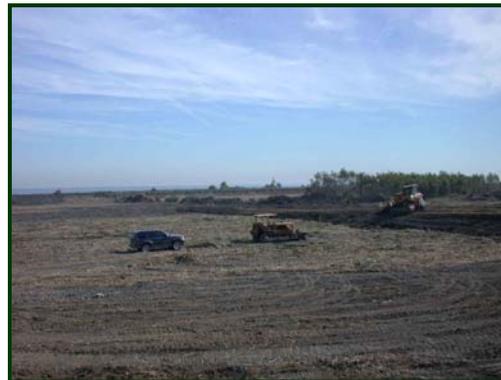
*Cross Dike Construction.* A new interior cross dike was installed along the southern end of the sub-cell between the existing perimeter dikes. The interior dike segregated and confined the dredge materials from existing and future materials in Cell 5. The dike was constructed in accordance with USACE drawings and specifications. Dike construction material was originally to be obtained from within Cell 5, in the borrow area shown on the USACE drawings. This material was inappropriate, due to water content and composition, therefore, material was conveyed from the offloading area to the cross dike location via 35-ton off-road articulated dump trucks. Placed borrow materials were shaped, graded, and compacted using a D6 LPG dozer. Soil material was placed in layers not more than 12 inches in loose thickness. Each layer was compacted by a minimum of 3 passes of the D6 LPG. Dike construction tolerances adhered to the required engineering specification of plus 0 and minus 6 inches.

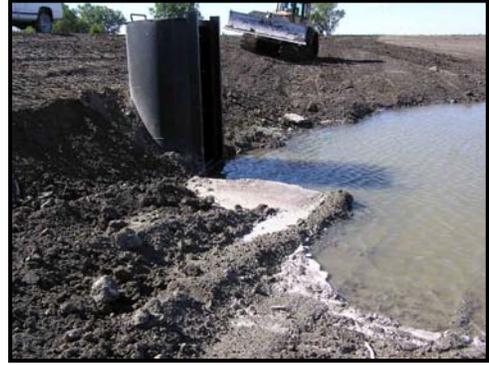
*Existing Dike Liner.* A 2-foot soil layer was placed over the interior of the existing dike to cover the riprap and to prepare the surface for placement of the synthetic liner. The soil materials were obtained from areas directly adjacent to the interior of the existing dike (i.e., the soil/dredge spoil material that is in the floor of Cell 5). The soil was placed in layers not more than 12 inches in loose thickness, and each layer was compacted by a minimum of 3 passes of the D6 LPG dozer. Woven fabric liner of polyethylene geotextile was installed along the interior slope of the existing perimeter dike to confine the solidified dredged material and to prevent any seepage through the dike wall into Lake Erie or the Pointe Mouillee Wildlife Refuge. Inspections were made prior to liner placement to ensure no protruding objects existed that could cause damage to the liner. The geotextile was placed with the long dimension parallel to the existing dike and laid smooth and free of tension, stress, folds, wrinkles, or creases. The strips were placed to provide a minimum 24 inches of overlap for each joint and each joint was sealed per the manufacturer's specifications. Geotextile installation did not exceed the placement of dredged material by more than 100 linear feet, per the USACE specifications.

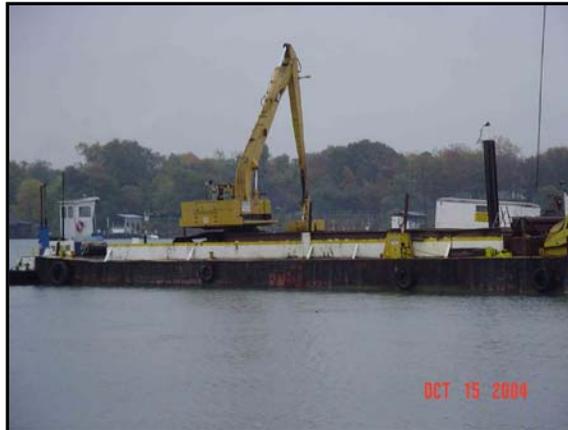
Phase I dredging was accomplished by mechanical means with a 320L long-reach excavator and a CAT 235DL excavator equipped with an environmental

clamshell. The excavators were mounted on two deck barges, 28'x111' (#744) and 33'x138' (#102), equipped with spuds. Dredged material was placed into a steel hopper located on the back of each dredge plant. The hoppers contained weep holes, which allowed necessary bulk dewatering of the sediment. Absorbent pads or sausage boom were placed on and around the hoppers to contain any oil. A silt fence and filter fabric panels were attached on the inside of the hoppers in front of the weep holes. This allowed the material to shed water, yet prevented as much re-suspension of the sediments as possible.

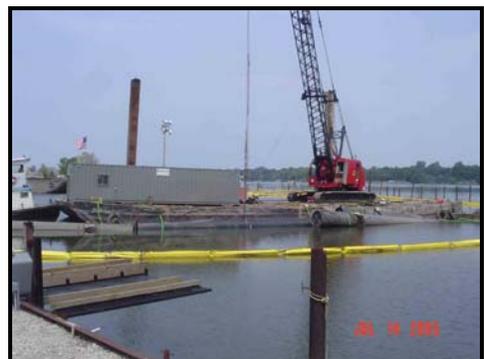
*Additional Environmental Controls.* An additional turbidity curtain was strategically placed perpendicular to the inner permeable curtain (i.e., east to west). The curtains were bolted together from surface to sediment and prevented recontamination as each cell was completed. In

addition to the turbidity curtains, a barrier consisting of 3 to 7 pieces of 4-foot by 50-foot HDPE pipe was also used to prevent sediment migration along the bottom of the lagoon. Each section of barrier pipe was floated into position prior to dredging a cell and located approximately 25 feet beyond each curtain placement location. The pipe was flooded and weighted with pipe saddles to overcome neutral buoyancy and each end was marked with buoys.

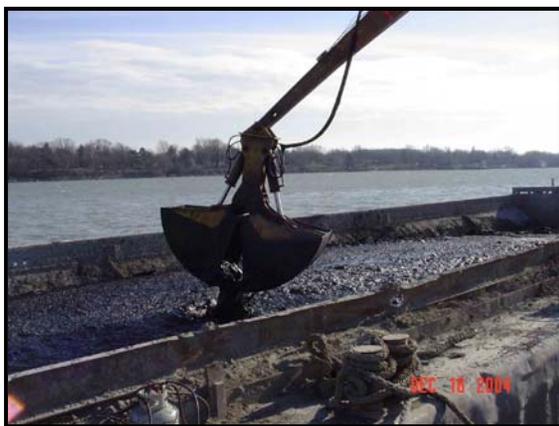
Transport barges were loaded outside of the silt curtain. This was accomplished by

locating the transport barges immediately adjacent to the outside perimeter of the curtain, and then loading them by extending the excavator boom over the curtain from the dredge plant and dumping the material into the transport barges. Various engineering controls and careful operator practices were used to prevent removed

sediment from being released into the river channel. The primary control was a “spill prevention plate,” which consisted of a steel plate that overlapped the transport barge and the silt curtain and lead back to the dredge plant. This plate was welded to 6 of the steel pipe pilings that anchored the turbidity curtain and was hinged to allow it to adjust to the varying height of the transport barge as it was loaded.

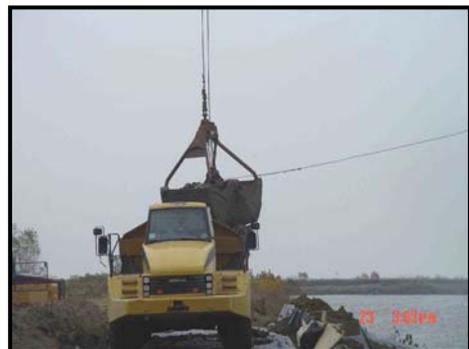
Dredged sediment from the Black Lagoon was received at the transfer/offloading area of the CDF. The tug and barges entered the CDF through the Southeast Interior Channel, where a smaller harbor tugboat (e.g., 35 foot, 300 HP) was used to maneuver the barges and place them at the transfer site. The barges were moored next to the H piles and the working deck barge at the temporary, contractor-installed, transfer site.

barges with a CAT 330 long-reach excavator positioned on shore and an 85-ton Manitowoc crane positioned on the adjacent working deck barge. The sediments were offloaded from the barges directly into the storage/solidification pit and then into 35-ton off-road articulated dump trucks. Sediment was transported from the offloading area to the Cell 5 placement area using four articulated dump trucks.

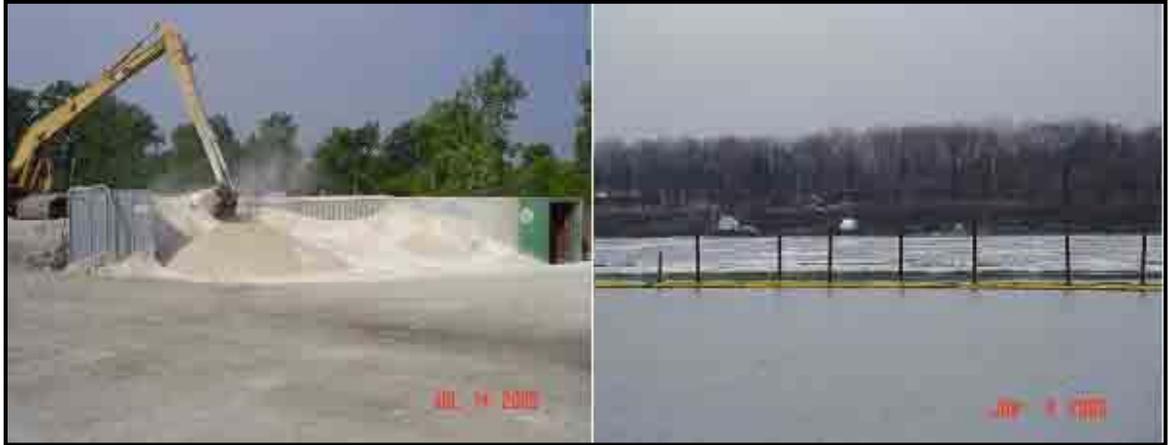
A loading platform was constructed to offload the barge into trucks, using approximately 60 linear feet of sheet piling to create a wall at the shoreline. Limestone aggregate was used to raise the grade behind the sheet piling wall from the existing grade of 576.5 feet to an elevation of 583.5 feet. Placement of the GTB2 barge immediately adjacent to the shoreline/sheet piling prevented inadvertent spillage of dredged material into the lagoon during the offloading process. Once all dredging operations were complete, the sheet piling was removed and the area restored.

The solidification agent (Calciment) was staged directly west of, and adjacent to, the raised aggregate landing. Calciment was added into the barge and mixed in place prior to direct loading into trucks. Mixing operations were closely monitored to ensure that no free liquid existed prior to loading the dredged material into trucks for transportation over the road. Calciment was stored in a secure area surrounded on 3 sides, to protect it from prevailing winds and minimize dust migration. This same equipment also was used to load the transport trucks. The existing air/dust monitoring methods and frequency proved to be adequate to ensure compliance with the original work plan. However, 2 to 3 additional monitoring points were added to encompass the area of new operations.

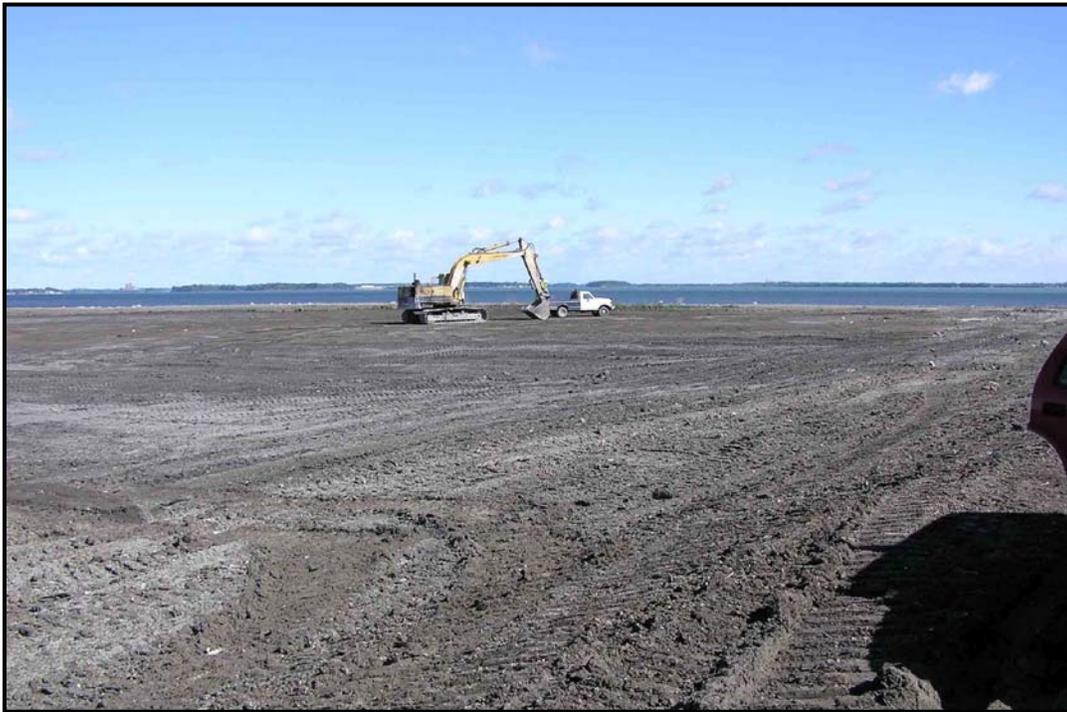
A minimum 2-foot cap was placed on top of the dredged materials. Cap material was obtained from areas adjacent to the offloading site within Cell 5. The material was excavated with a CAT 330 excavator and spread in 1-foot lifts, then compacted with a D6 LGP dozer. At least 3 passes were made with the D6 LGP dozer over all placed cap material. The top of the cap did not exceed an elevation of 581.0 feet.

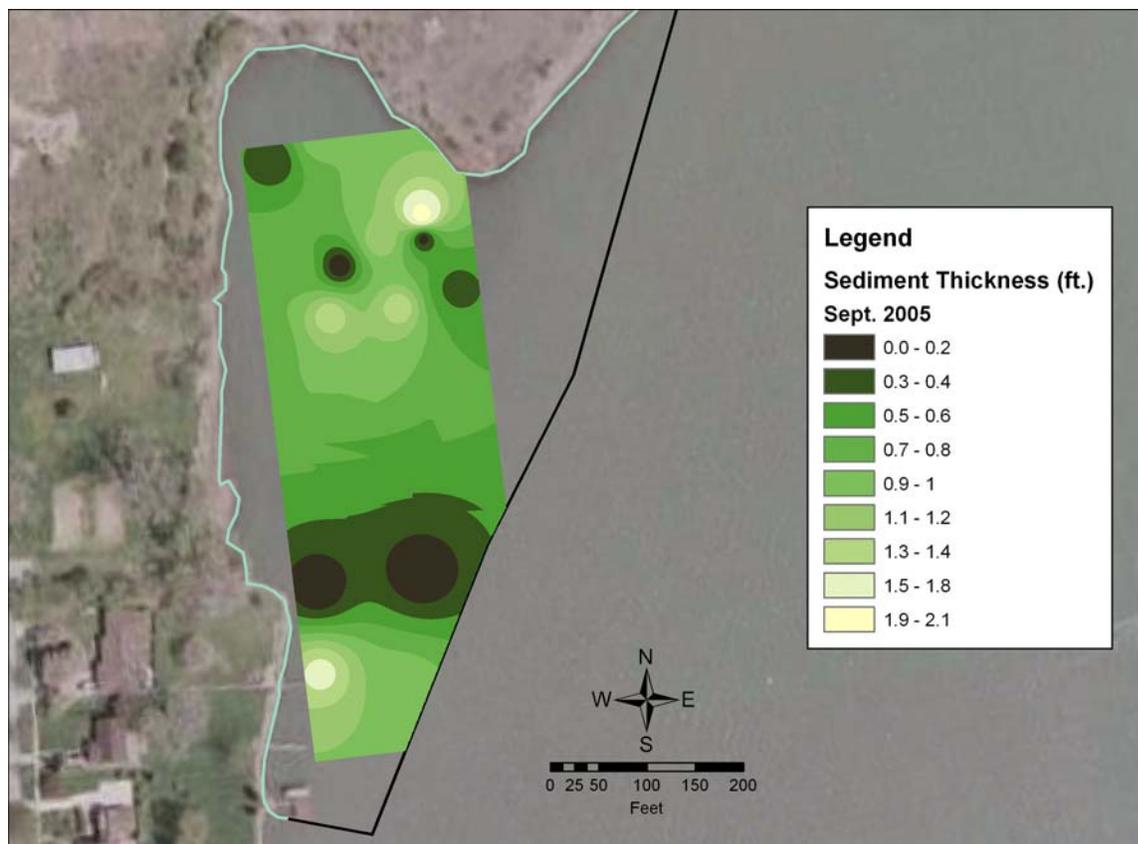
Figure 6-2 Black Lagoon Sediment Thickness After Completion Of Phase II Dredging (based on data collected in August and September 2005)

Results suggest that, although the Phase II dredging activities did not completely reduce contaminant concentrations to the levels targeted, the second round of dredging was successful in reducing both the overall concentration and the distribution of those contaminants. Figures 6-3 and 6-4 illustrate this by showing the estimated concentration and distribution of oil and grease before and after contaminated sediments were removed in Phase II. Figures 6-5 and 6-6 present similar information for total PCB distributions. A similar pair of figures could not be presented for mercury due to the lack of confirmation samples in the southern half of the lagoon because of the decision to halt the sample analysis when results reported for oil and grease showed all samples exceeded the target levels (see Table 6-1). As can be seen from these figures, dredging efforts in the Black Lagoon dramatically reduced the levels of contamination across the site. See Section 6.3 for final sediment confirmation results after placement of the residual cover.

The accuracy of the revised calculations was substantiated by the estimates obtained from the kriging maps presented in Figures 6-1 and 6-2. A three-dimensional view of both surfaces is provided in Figure 6-8 to show the difference in the estimated sediment thickness before and after Phase II dredging activities. Figure 6-9 provides a cut-and-fill report to show the three-dimensional surface of the estimated sediment removed from the site during Phase II. The cut-and-fill surface, calculated area, and volume were developed by subtracting the estimated sediment thickness surface of August/September of 2005 from the May 2005 surface (Figure 6.8). Even though all estimates are based on sediment thickness  $\pm 0.5$  feet, the cut-and-fill report provides fairly accurate account of the sediment removed from the site (approximately 11,000 cubic yards, which agrees within 10% with the calculated figure of 12,122 cubic yards).

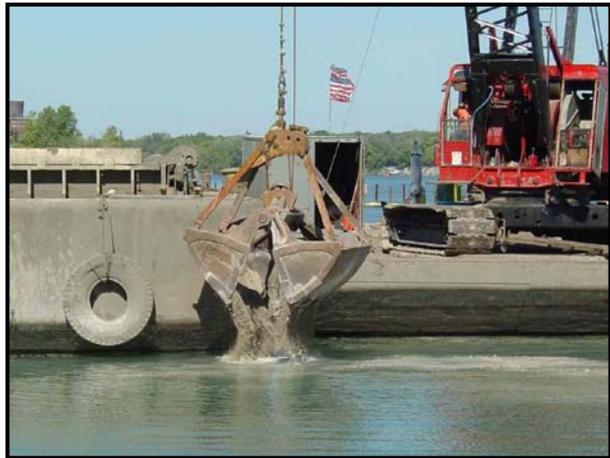
The sand cover was spread using an 85-ton crane with a 3-cubic yard bucket, utilizing Dredge Pack to log the exact GPS location where each bucket was released. Each bucket was released by progressively opening the bucket wider as the material was released. Materials were released from a height of approximately 2 feet above the surface

of the water to achieve a greater rate of dispersion and to reduce mounding. The cover materials were shuttled from the north end of the lagoon by hopper barge and tugboat, and the progression of cover material was from south to north. An additional 1,500 cubic yards of sand were approved for placement in the northern half of the lagoon to increase cover thickness. Because of variables outside the control of the operator, such as the topography of the bottom of the lagoon and the strength of the current within the lagoon that could have affected the rate of descent and dispersion of material, the sand layer of some areas fluctuated in thickness by up to 20%. Prior to stone placement, the sand layer thickness was tested and verified by taking a predetermined number of core samples.
