**Removal Recommendation  
Loss of Fish and Wildlife Habitat  
Degradation of Fish and Wildlife Populations  
River Raisin Area of Concern**

Michigan Office of the Great Lakes  
Great Lakes Management Unit  
Michigan Department of Environmental Quality  
May 29, 2015

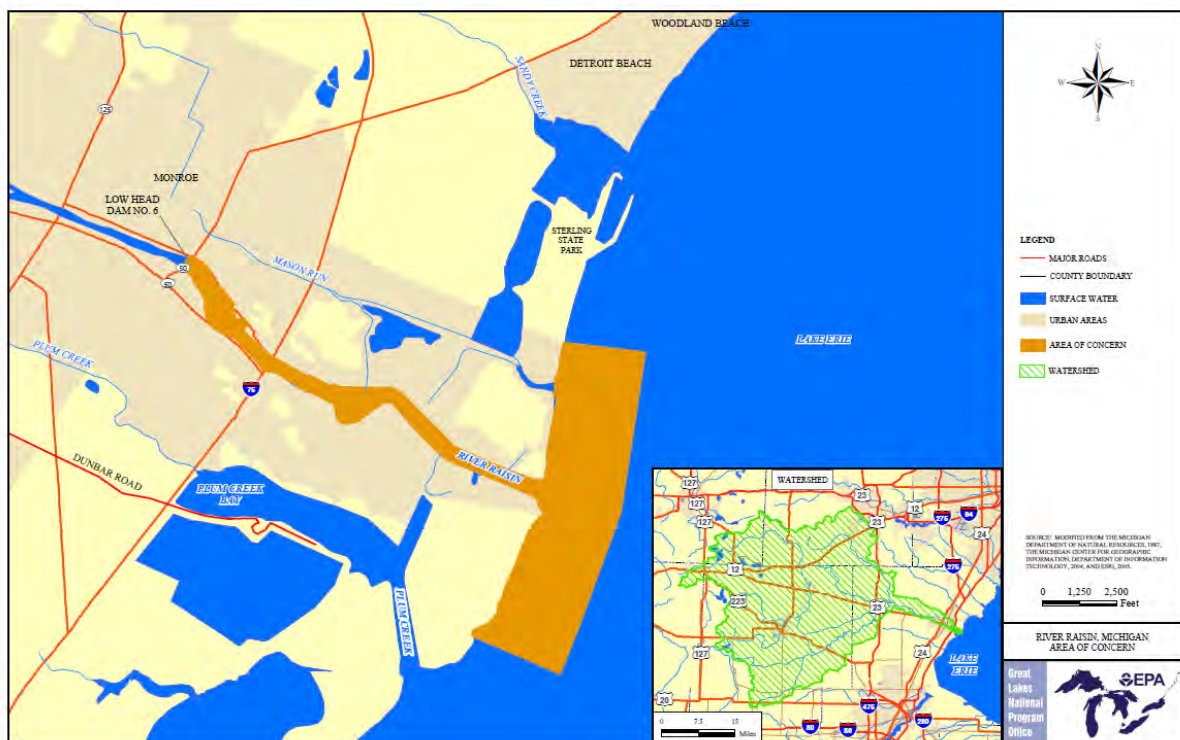
Figure 1: Boundary of the River Raisin Area of Concern

The boundary of the River Raisin AOC is defined as “the lower (2.6 miles) portion of the River Raisin, downstream from Dam No. 6 at Winchester Bridge in the City of Monroe, extending one-half mile out into Lake Erie following the Federal Navigation Channel and along the nearshore zone of Lake Erie, both north and south, for one mile” (MDNR 1987) (Figure 1). The River Raisin was identified as an AOC primarily due to “heavy metals contamination of the sediments and PCB contamination of the fish and sediments” with the major impaired beneficial uses related to “toxic and physical impacts on the biota, toxic impacts on human health due to PCB contamination of fish and sedimentation effects on navigation” (MDNR 1987).

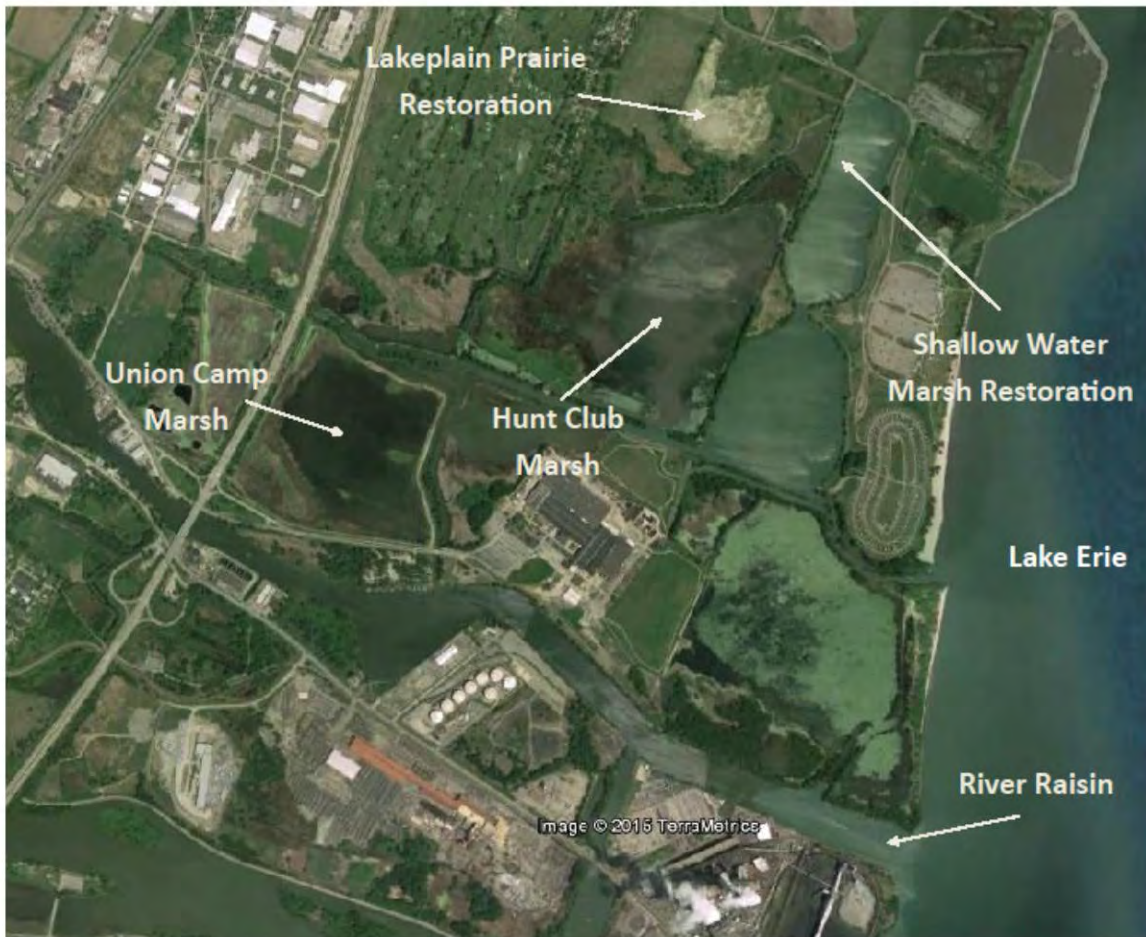
Figure 2: Location of North River Raisin Wetland Enhancements

The North River Raisin Wetland Enhancements was a very large-scale project with four major components: Lakeplain Prairie Restoration, Shallow Water Marsh Restoration, Hunt Club Marsh Restoration, and Union Camp Marsh Restoration (Figure 2). Completion of the project resulted in the restoration of a total of 383 acres of habitat restoration. All four areas of restoration were within the boundary of the William C. Sterling State Park (Sterling State Park) and were implemented by the Michigan Department of Natural Resources Parks and Recreation Division (MDNR PRD).

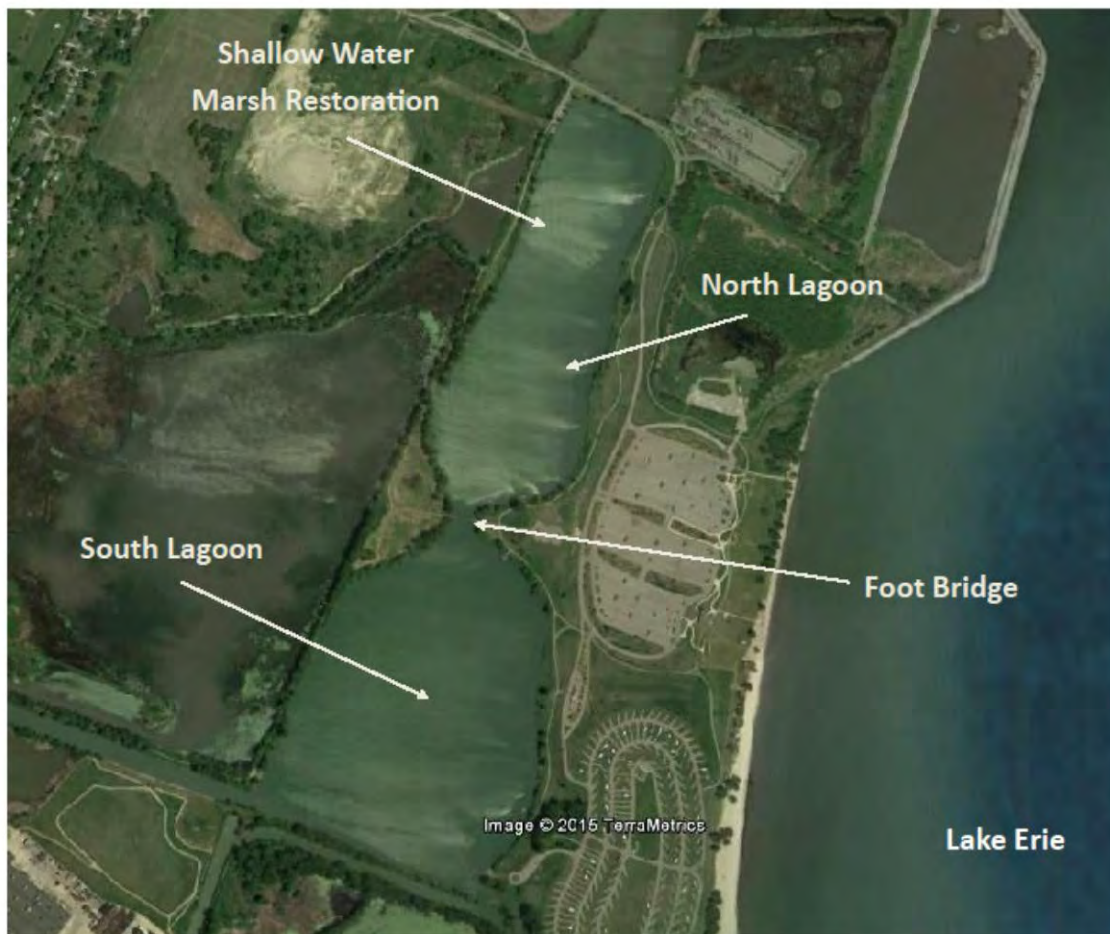
Figure 3: Location of the North and South Lagoons at Sterling State Park

In the 1950s, within the boundary of Sterling State Park, areas of Great Lakes marsh were dredged in order to obtain soils used to create upland for the park day-use and campground areas. One of these areas of impact is two lagoons in the shape of an hourglass, and referred to as the North and South Lagoon (Figure 3). The North Lagoon is the location of the shallow water marsh restoration project and is connected to the South Lagoon under a footbridge approximately 140 feet in length.

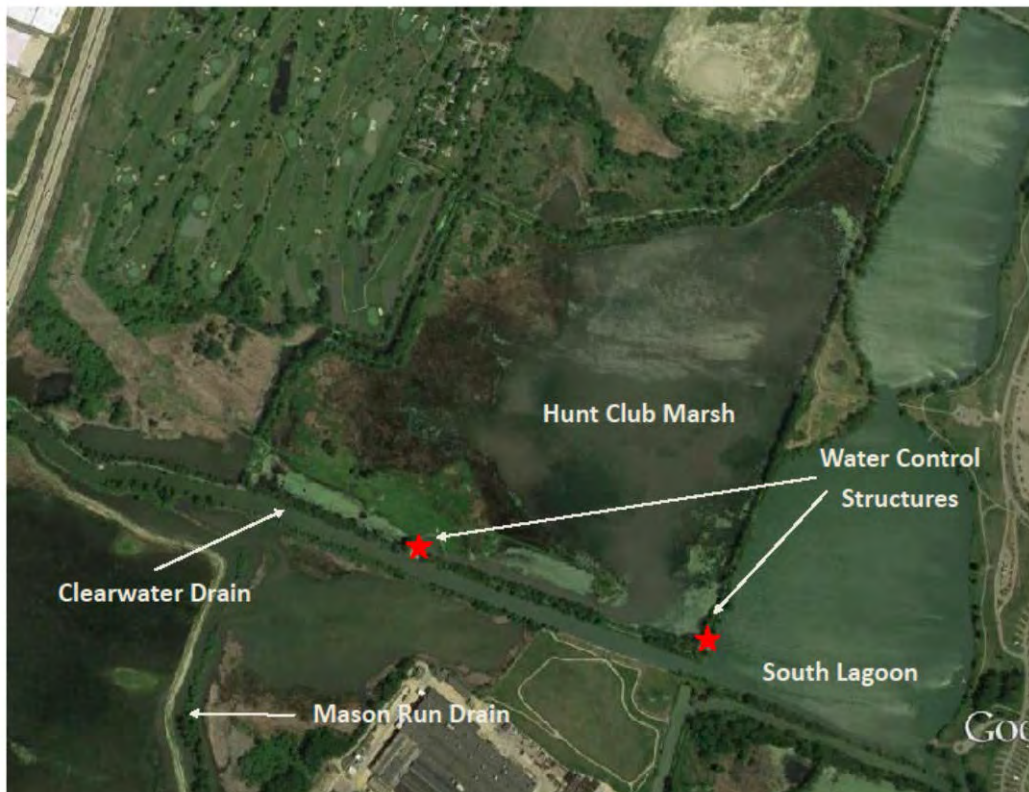
Figure 5: Location of the Hunt Club Marsh and Associated Water Control Structures

Construction in both marshes took place in 2012. The project goals were accomplished at the Hunt Club Marsh by repairing a 250 foot breach in the dike on the south side of the wetland and installation of two new water control structures: one to connect the Hunt Club marsh to the South Lagoon and one to connect the marsh to the Clearwater Drain (Figure 5). In the Union Camp marsh, at least five breaches in the dike were repaired, one water control structure was installed connecting the marsh to the Mason Run drain, and a second connection was made by creating a break in the dike separating the Mason Run Drain and the Clearwater Drain to allow fish passage between the two drains (Figure 6).

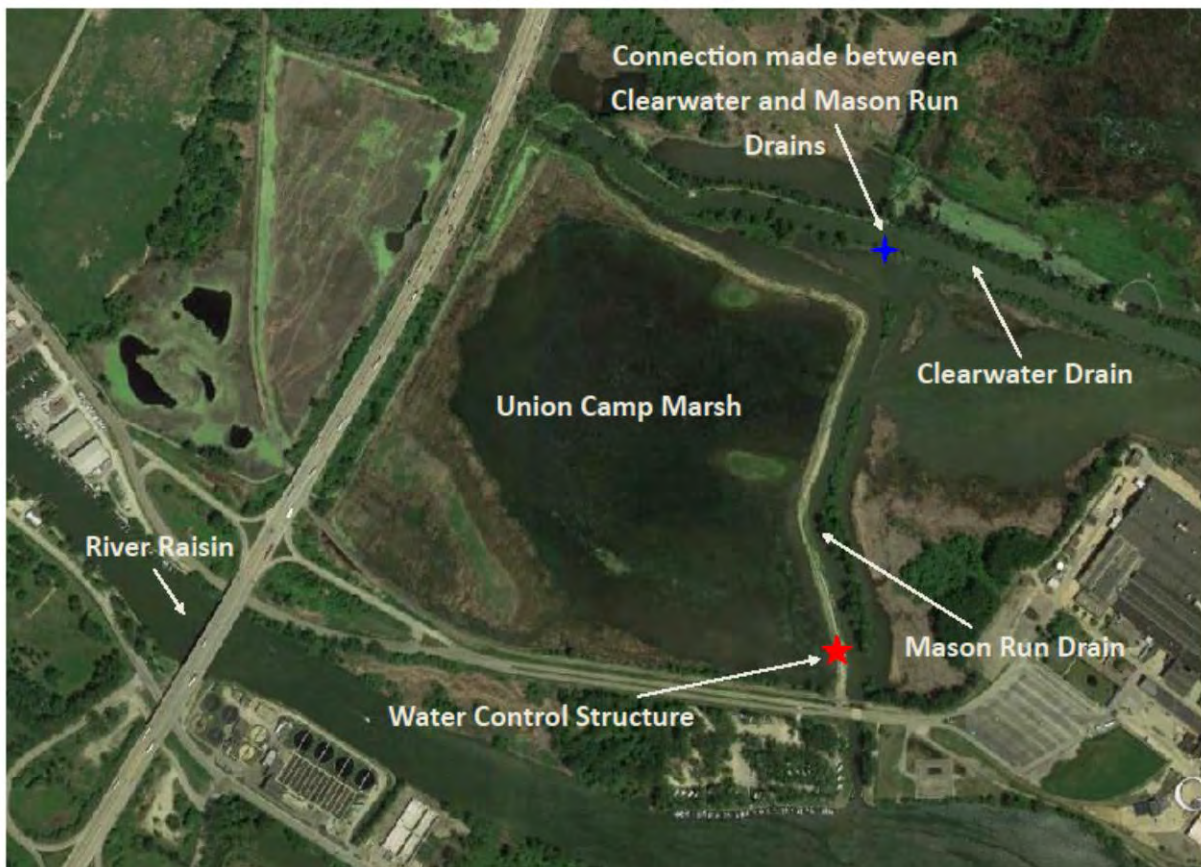
Figure 6: Location of Union Camp Marsh and Associated Water Control Structures

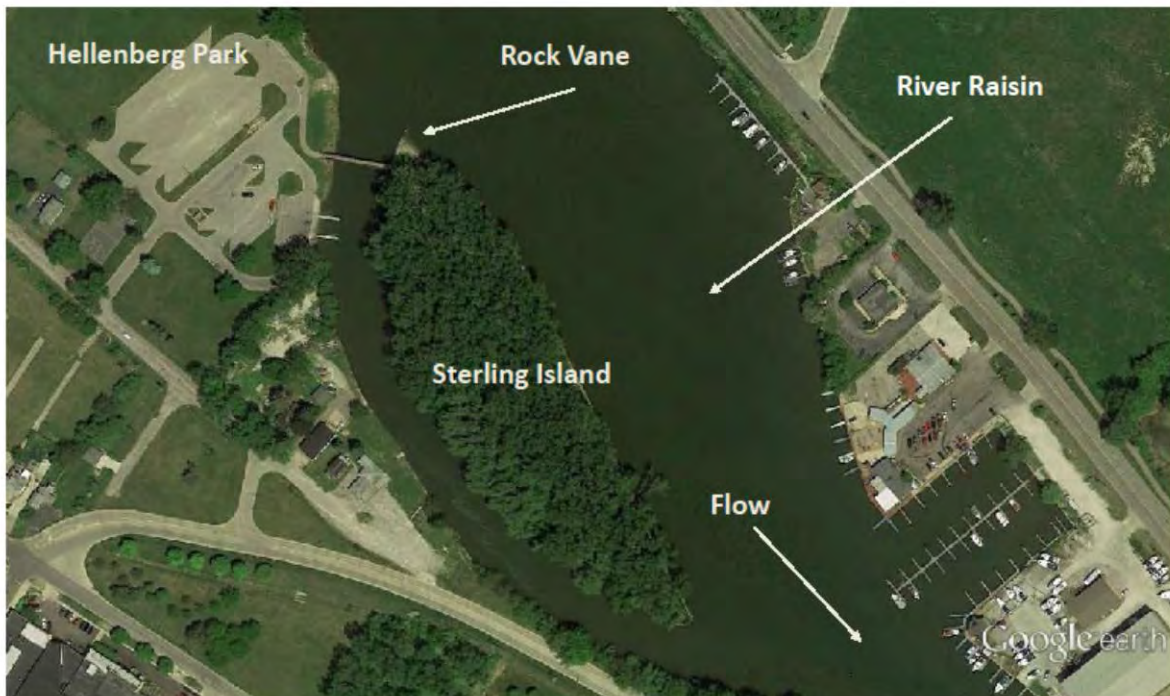
Figure 7: Location of Sterling Island in the River Raisin

Sterling Island is a man-made island located near Hellenberg Park in the City of Monroe and approximately 2.5 miles upstream from the mouth of the River Raisin (Figure 7). The island had been experiencing erosion due to ice scour and boat traffic causing downstream sedimentation. In 2012, a shoreline stabilization project was undertaken by the City of Monroe.

To stabilize the island, rock riprap was placed along 1,020 linear feet of shoreline and planted with native shrubs. In addition, a rock deflector (rock vane) was constructed at the northwest side of the island to further protect the shoreline by deflecting flow, debris, and ice away from the island while also providing a protected area ideal for waterfowl, reptiles and amphibians. By stabilizing the shoreline of Sterling Island, it was anticipated that it would provide benefit both to the immediate area surrounding the island, but also to improve fish habitat throughout the lower River Raisin by reducing sediment.

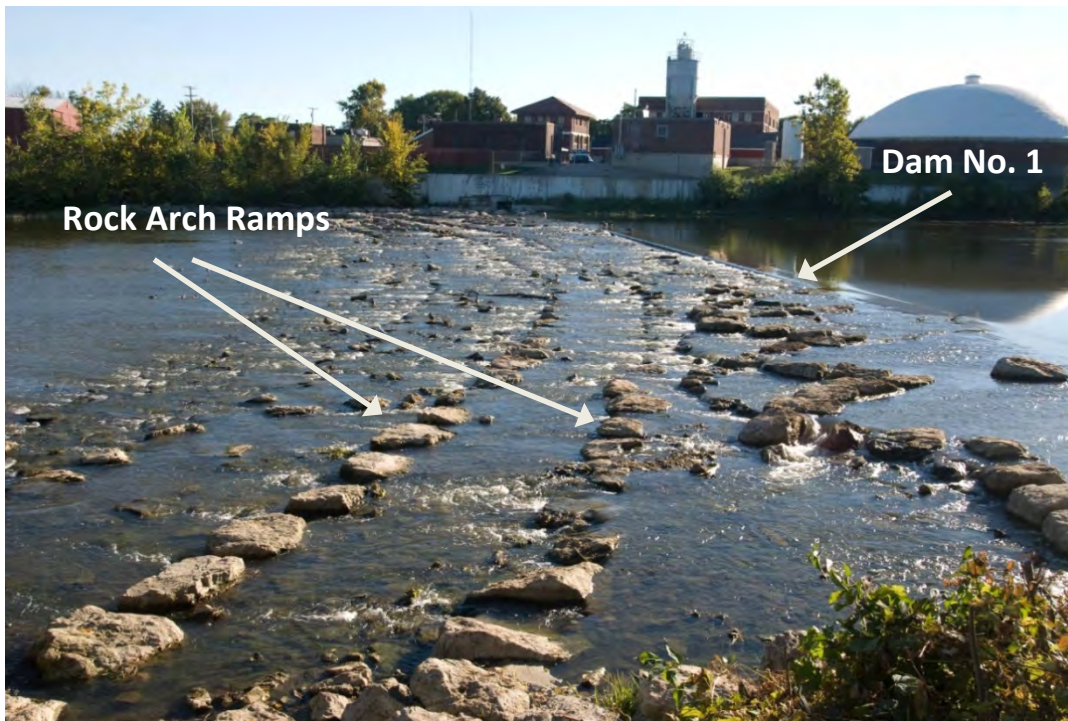
Figure 9: Rock Arch Ramps at Dam No. 1

Two of the six low head dams (Dam 2 and 3) no longer had active sewer lines and in 2012 were removed completely. The remaining four low head dams (Dam 1, 4, 5, and 6) still have active sewer lines in them and an alternative to removal was necessary. These dams were retrofitted to provide fish passage by creating a series of rock arch ramps (Figure 9).

The eight dam projects were constructed in two different phases. During Phase 1 in 2012, Dams 2 and 3 were removed and rock arch ramps were constructed at Dams 1 and 6. During Phase 2 in 2013, rock arch ramps were constructed at Dams 4 and 5 while the bypass channel was constructed around the Waterloo Dam and the millrace was enhanced at the Grape Dam. Following the winter of 2013-2014, the ice caused some damage to the rock arch ramps at Dams 4 and 5 and they were repaired in the summer of 2014.

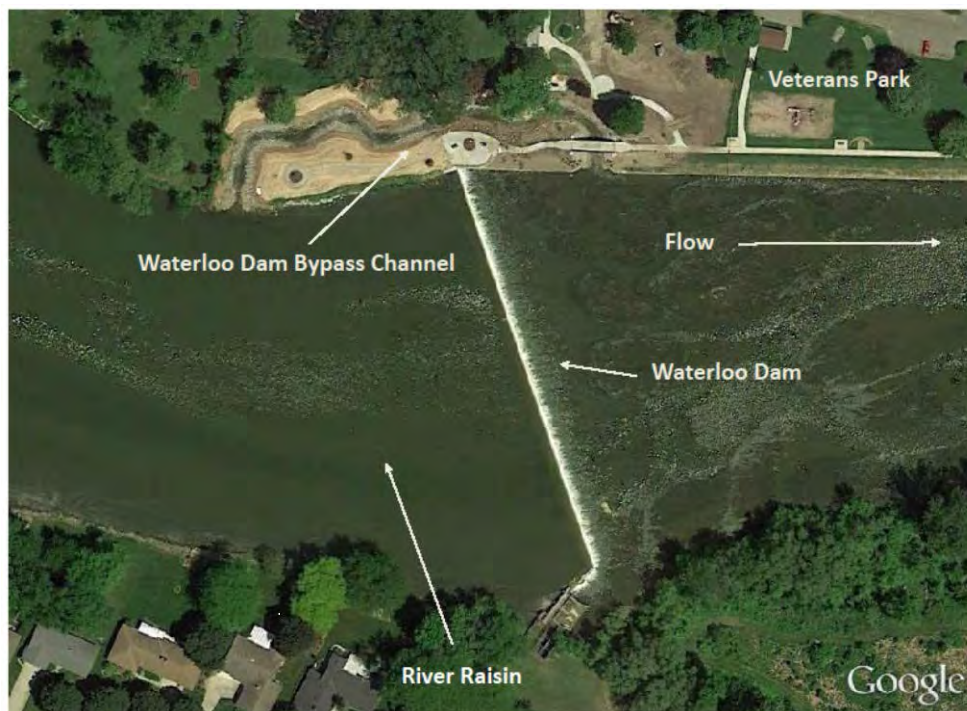
Figure 10: Low Flow Bypass Channel at the Waterloo Dam at Veterans Park

There was an excessive amount of sediment upstream of the Waterloo Dam which would have been prohibitively expensive to remove, so again an alternative was sought to provide fish passage but at a lower cost. The alternative was to build a low flow bypass channel around the Waterloo Dam (Figure 10).

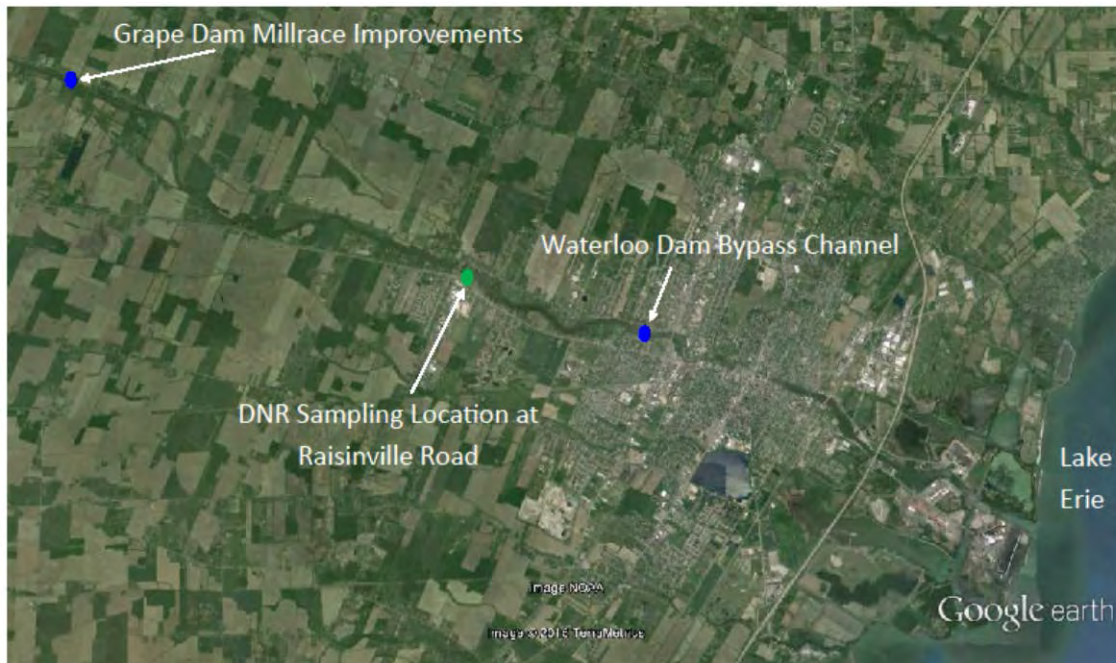
Figure 11: Michigan DNR Fish Division Sampling Location in the River Raisin

In addition to the pre and post construction assessment conducted by Cardno JFNew, the Michigan DNR Fisheries Division (MDNR FD) also conducted monitoring in 2014. Since 2002, the MDNR FD has sampled between the Waterloo and Grape Dams at Raisinville Road (Figure 11). During July of 2014, the DNR FD surveyed this area and found two species never before encountered at this location, gizzard shad and blackside dace (J. Braunscheidel, personal communication, November 26, 2014). Of particular note is the presence of gizzard shad, a migratory species and a strong indication that the Waterloo Dam bypass channel is functioning and providing a means for Great Lakes fish to migrate into the upper River Raisin.

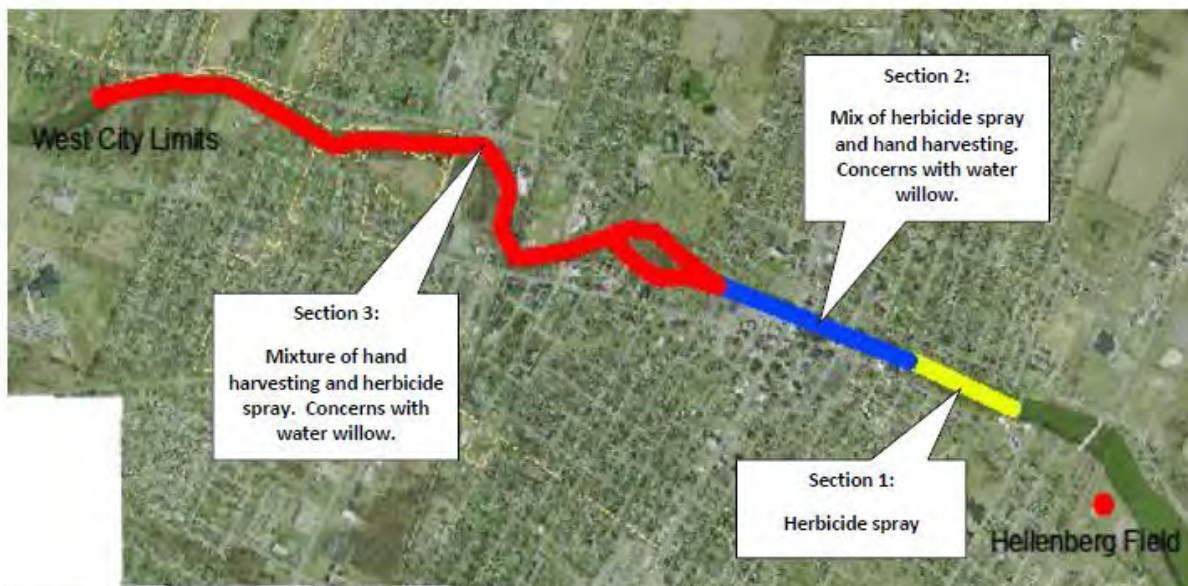
Figure 14: Locations of Upcoming Flowering Rush Invasive Species Treatment

Following the aforementioned fish passage projects throughout the River Raisin, the City of Monroe through their River Raisin Commission on the Environment (COTE) decided to resume the work on control of flowering rush in the river. Currently the City is partnering with the Detroit-Western Lake Erie Cooperative Weed Management Area (CWMA) for monitoring and treatment of flowering rush in several locations of the River Raisin (Figure 14). The project to treat these areas is due to commence in the summer of 2015.

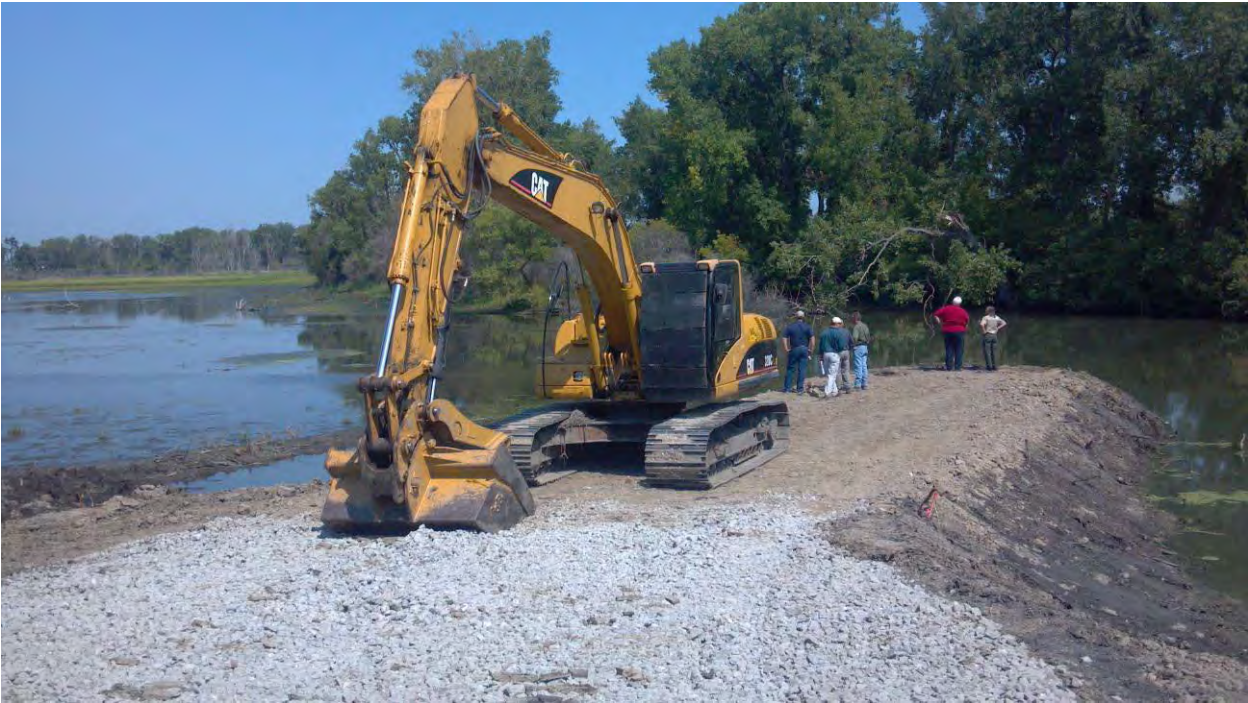
Construction of Union Camp Marsh Dike

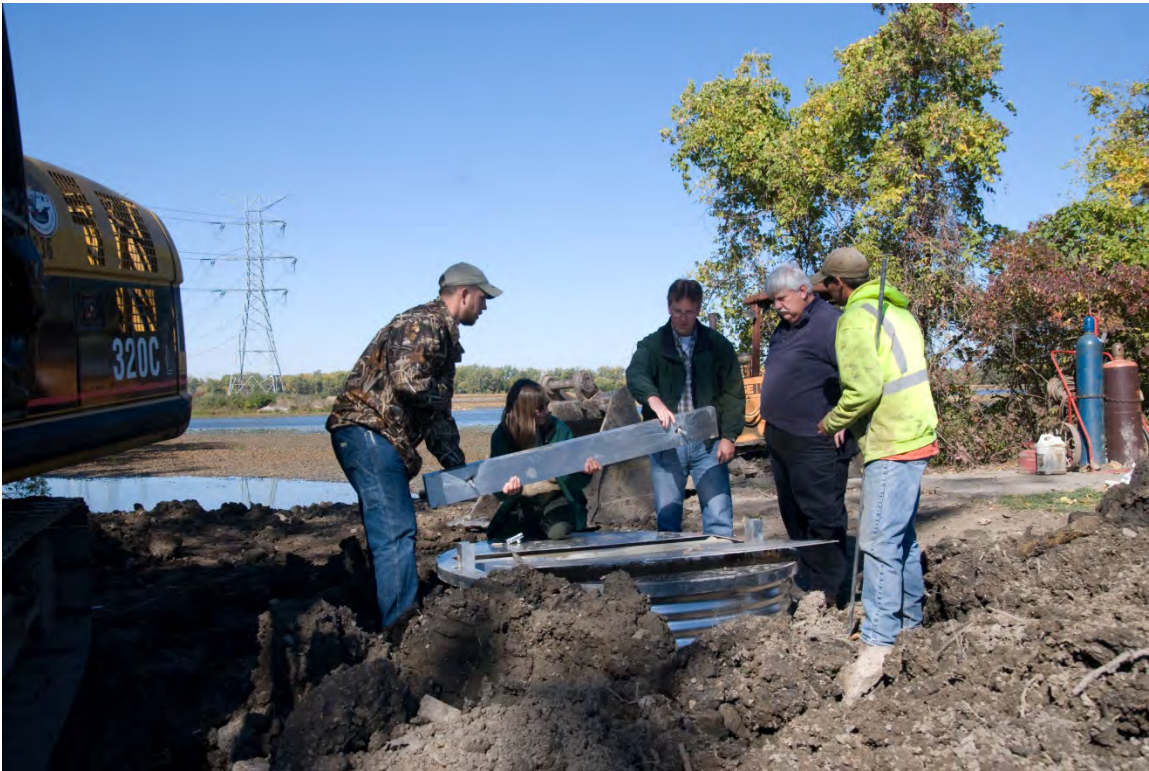
Installation of “Stop-Log” at Water Control Structure

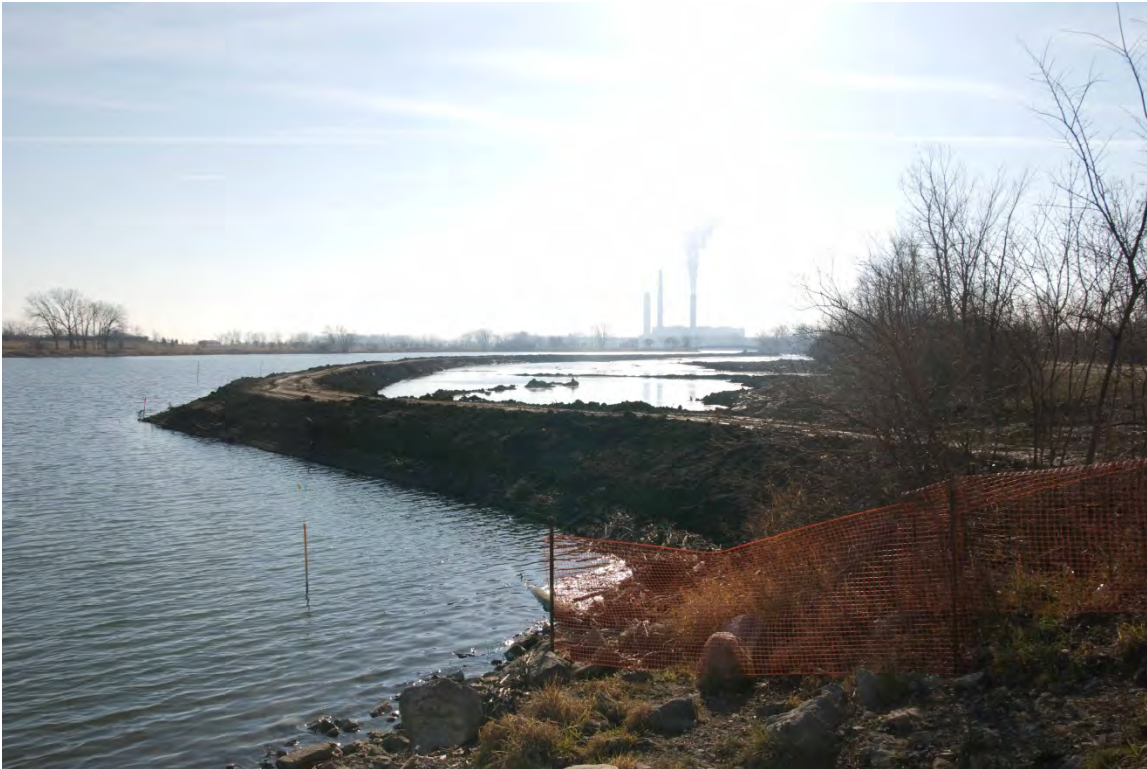
Looking South at the Temporary Dike/Haul Road at the Shallow Water Restoration at Sterling State Park

To construct the project, a temporary dike/haul road was created surrounding the area of restoration. Following completion of the dike/haul road, the area inside the dike was dewatered allowing the construction to be completed on dry ground. After construction on the inside area of the dike was completed, the dike/haul road was demolished by placing that amount of fill also within the area of wetland restoration.

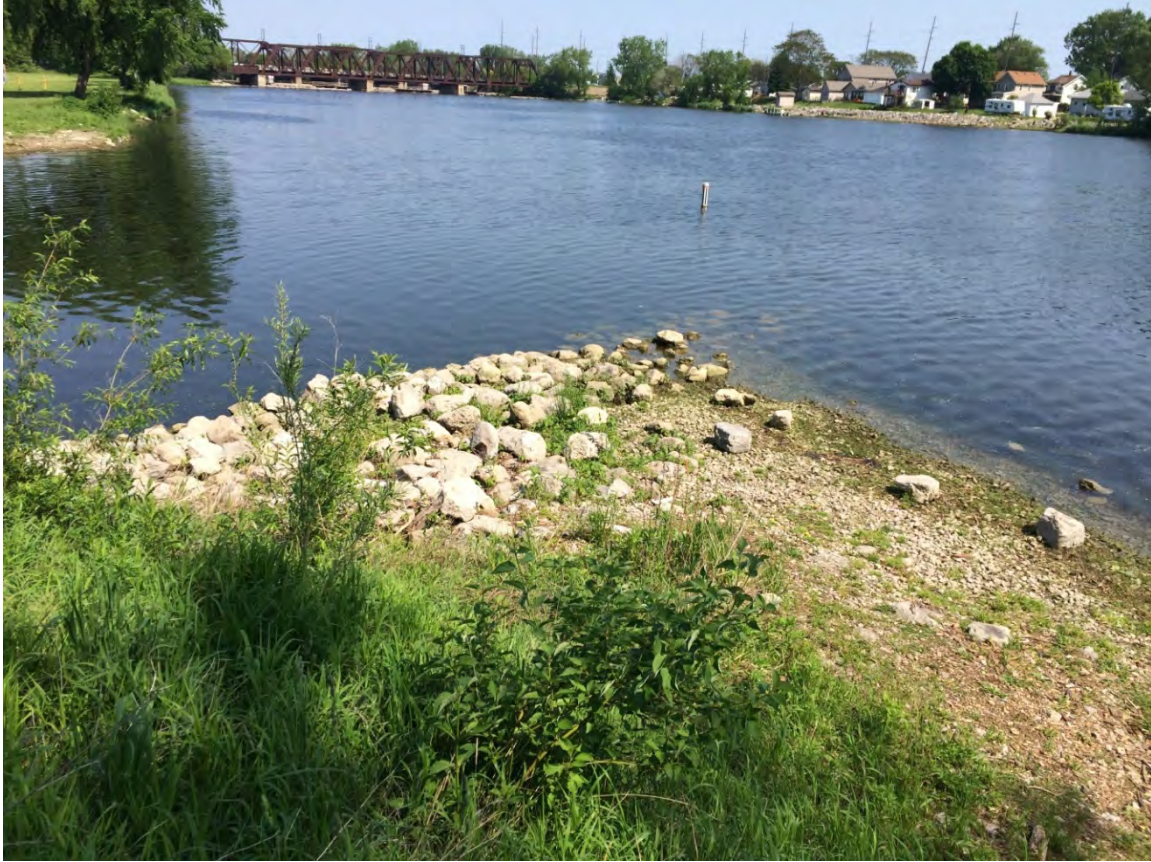
Rock Vane at Sterling Island

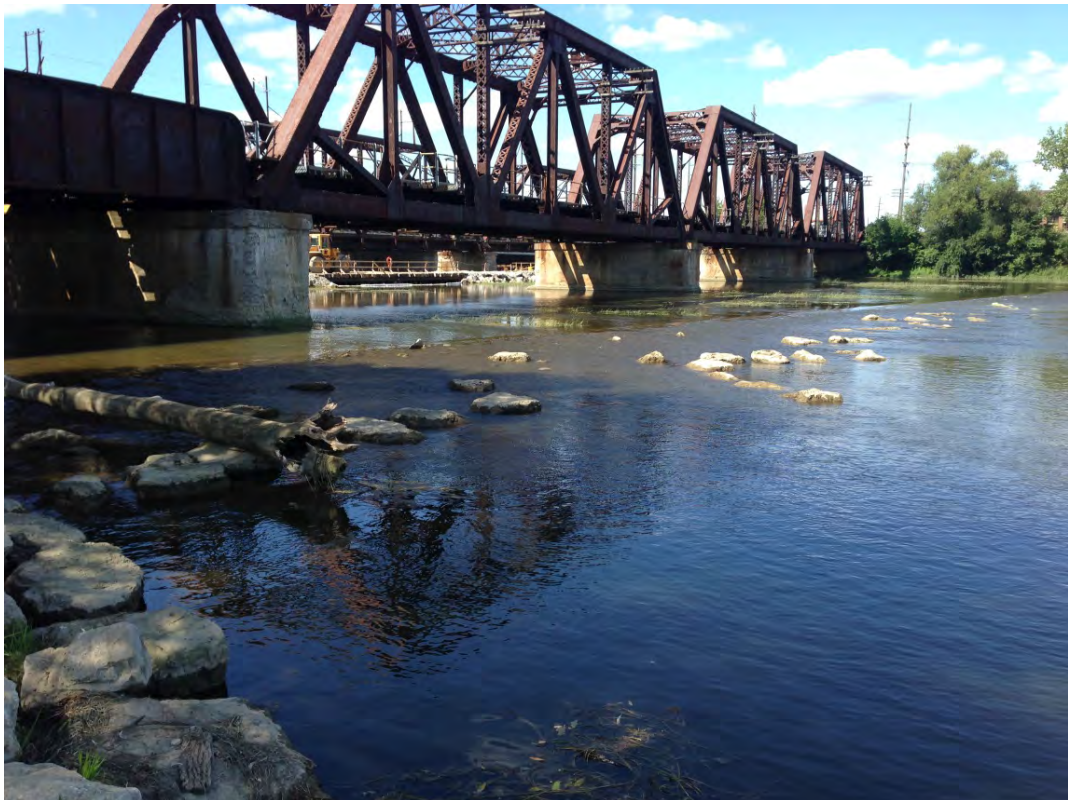
Looking West (Upstream) at Rock Arch Ramp at Dam No. 6

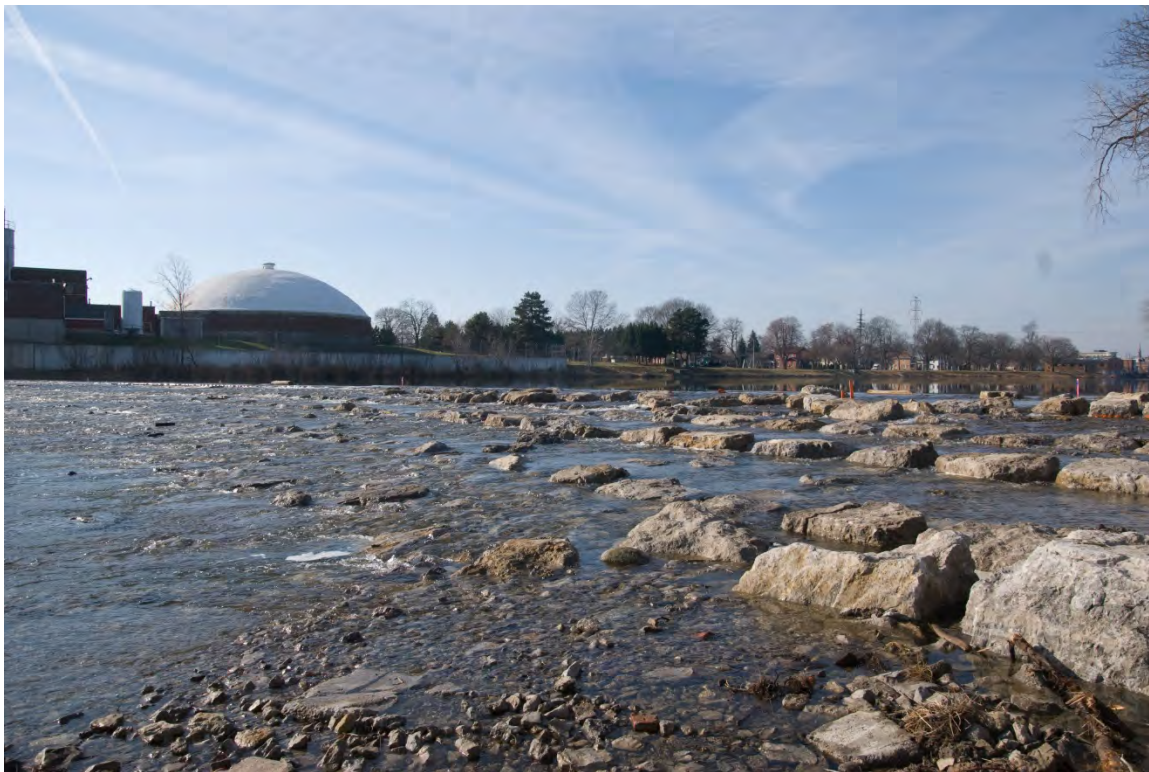
Looking South (and Upstream) at Rock Arch Ramp at Dam No. 1

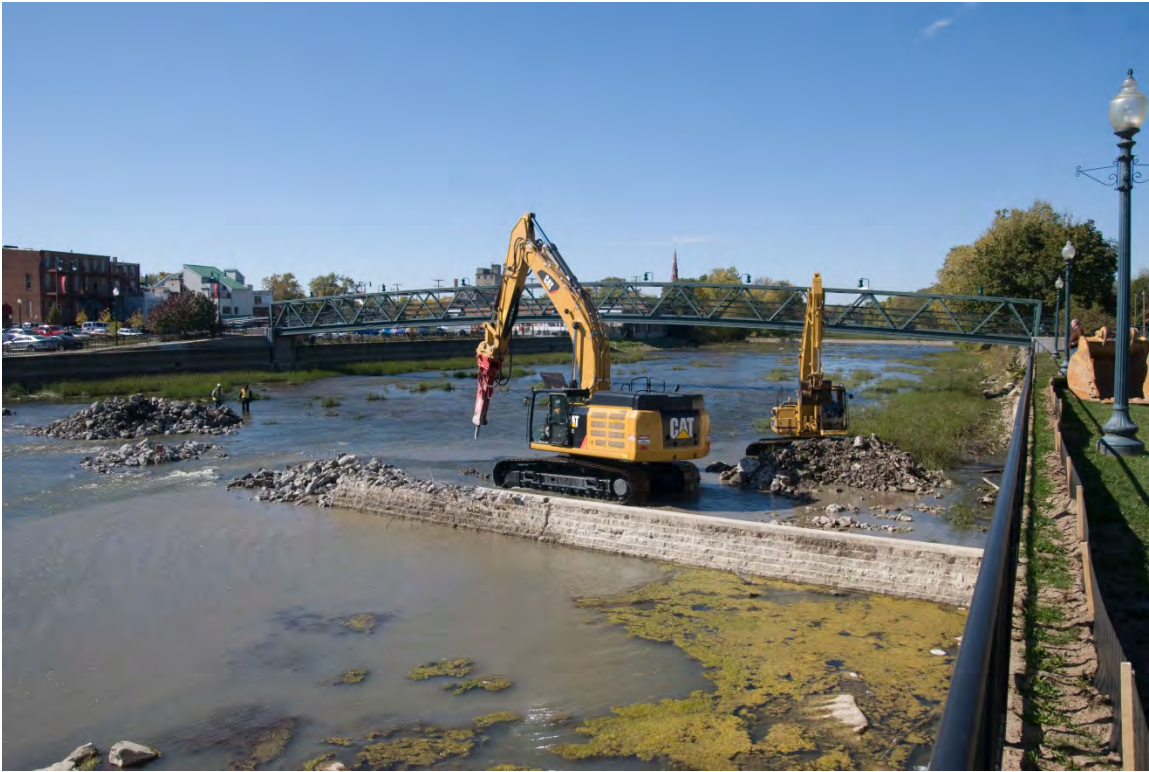
Dam No. 3 during Demolition

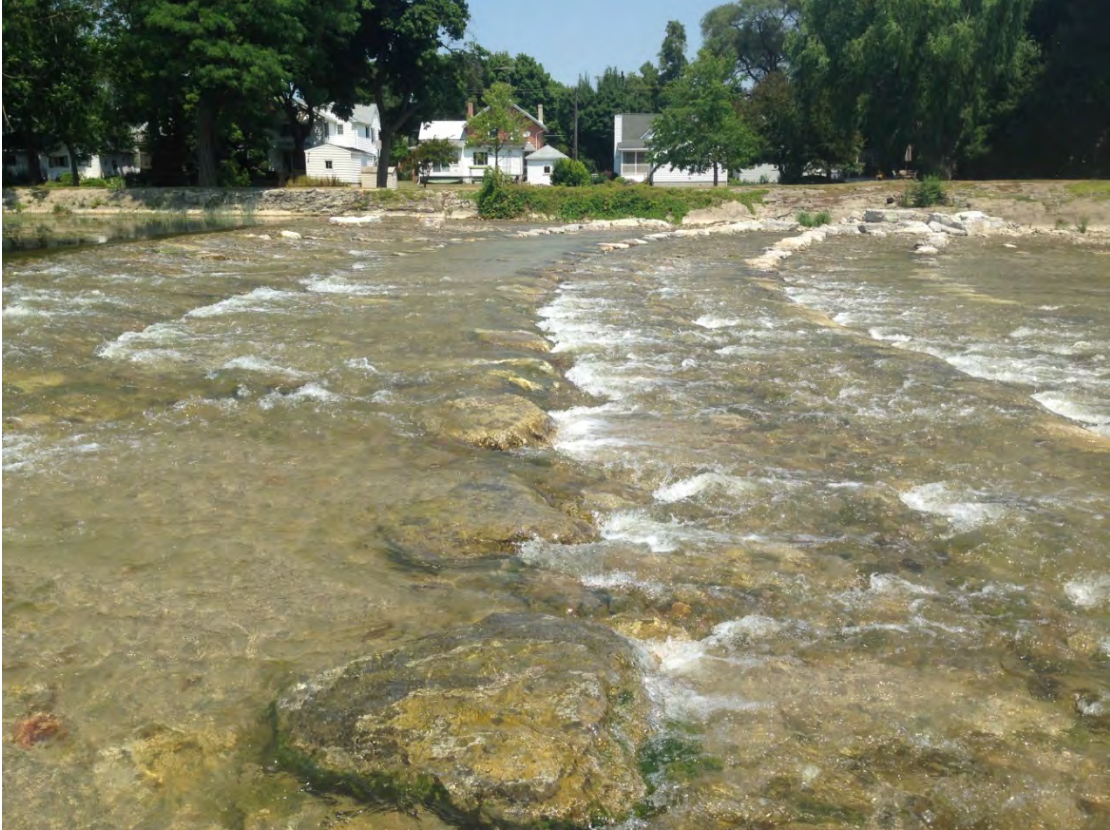
Rock Arch Ramps at Dam No. 4

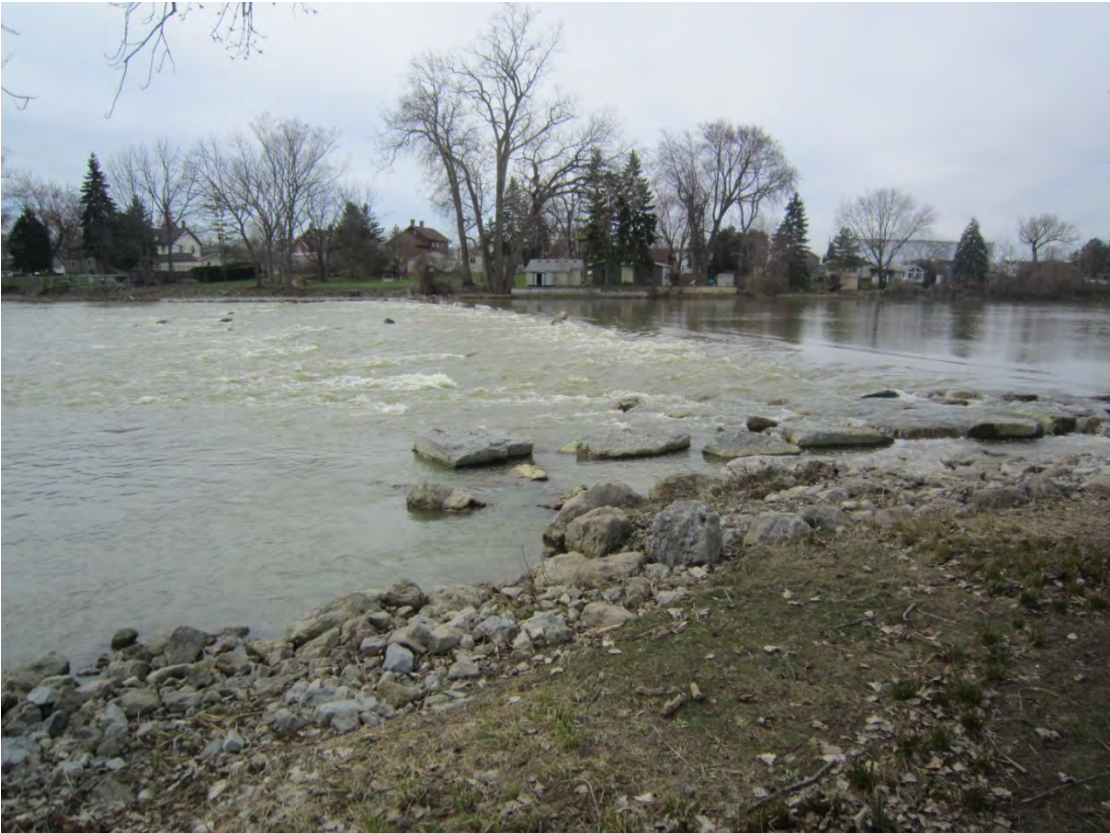
Rock Arch Ramps at Dam No. 5

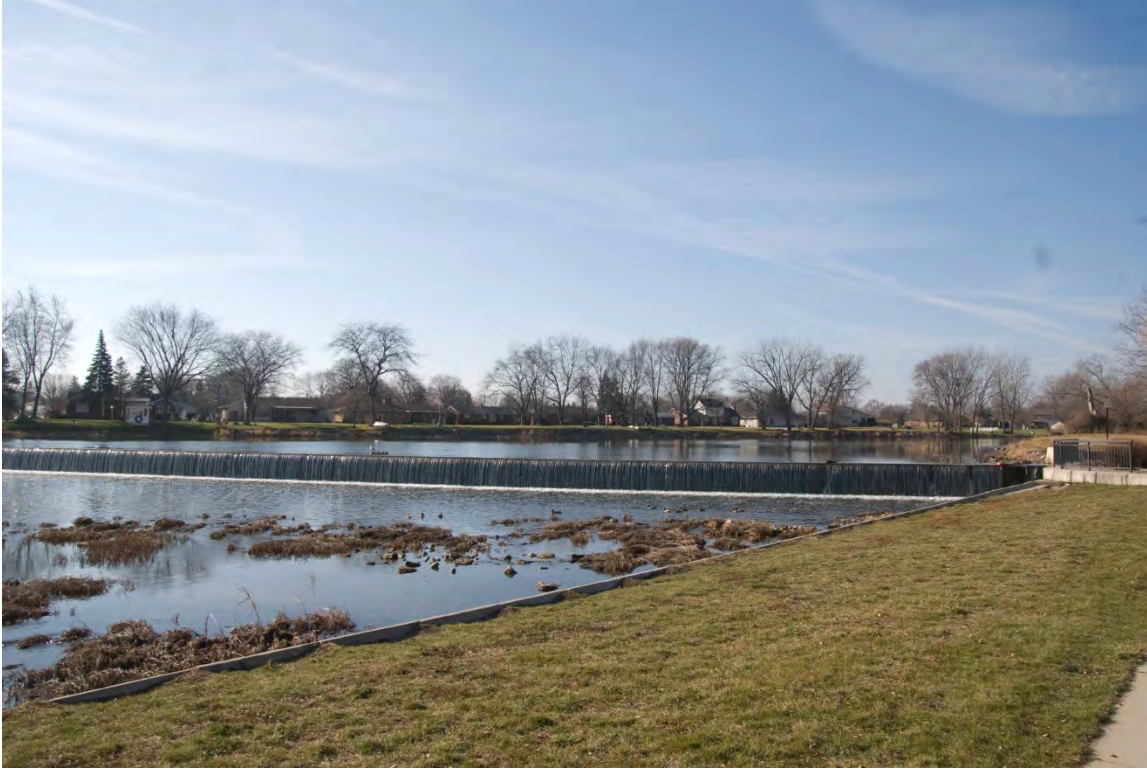
Looking West (Upstream) at the Waterloo Dam (Bypass Channel is to the right of Dam)

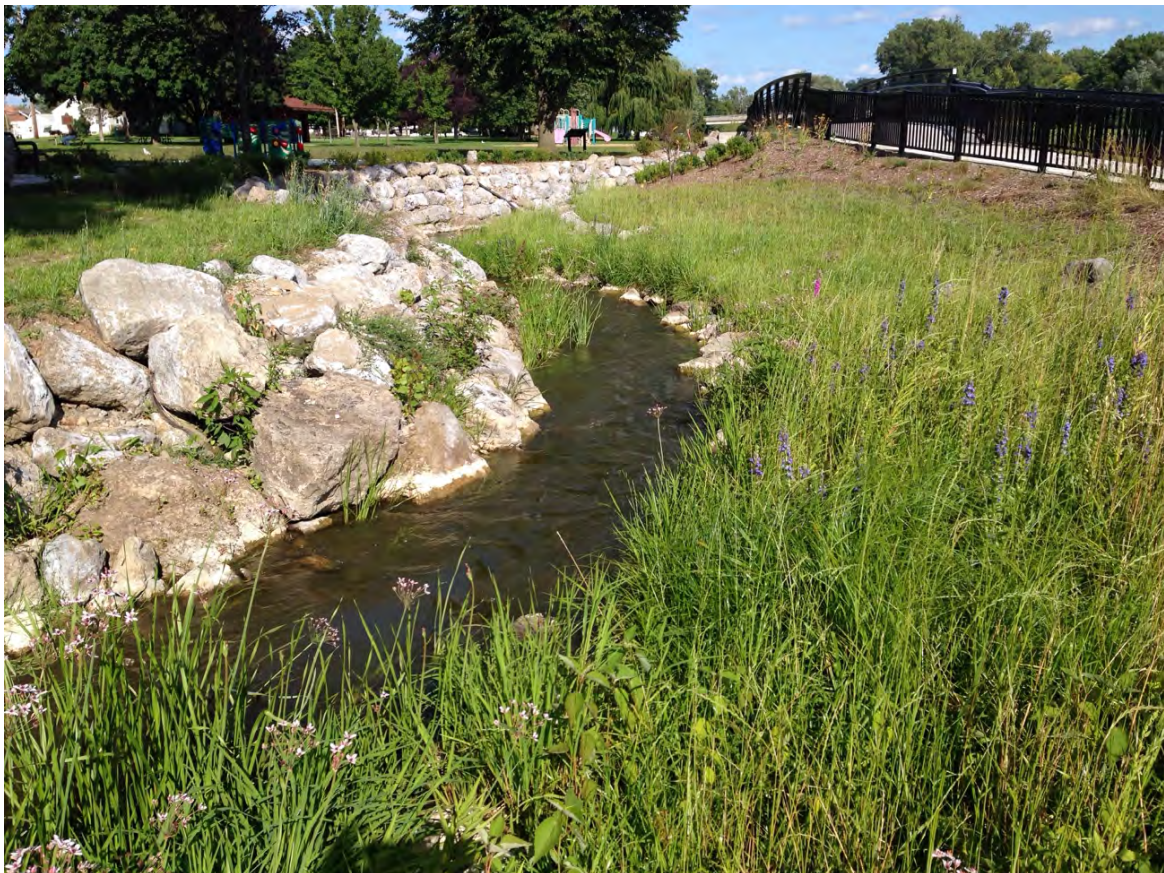
Looking East (Downstream) at the Waterloo Dam Bypass Channel at Veterans Park

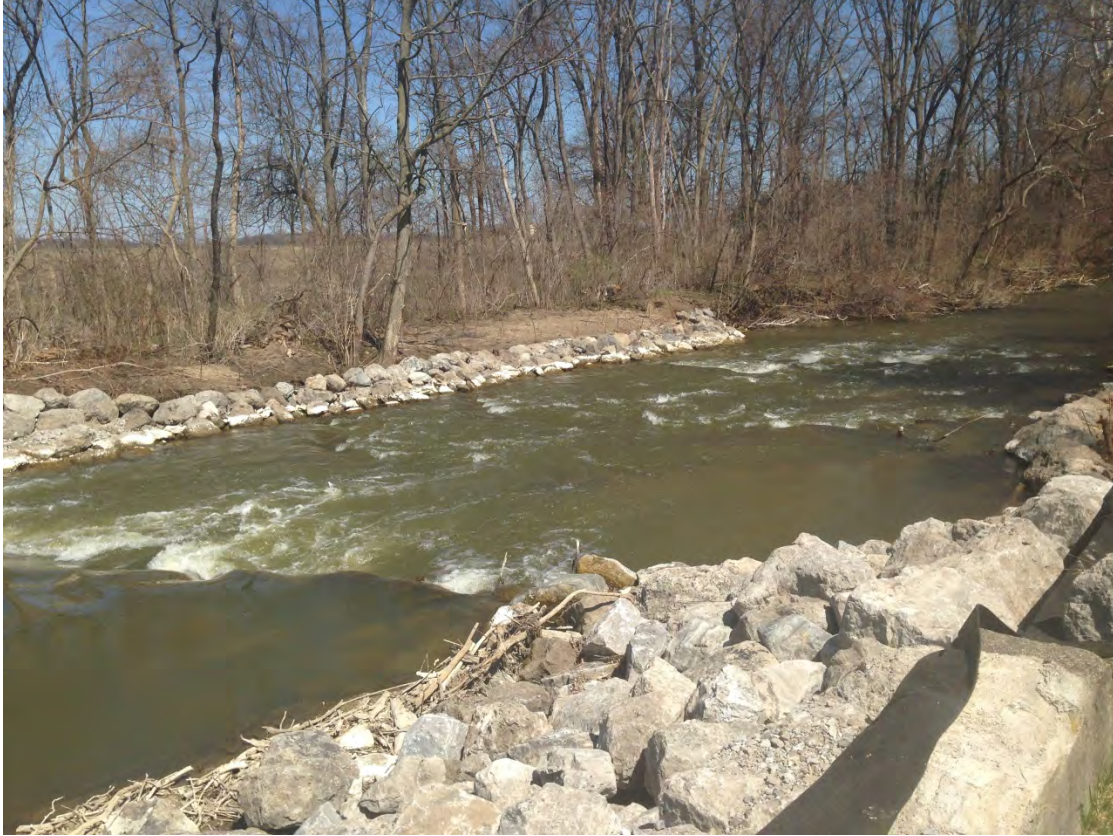
Looking East (Downstream) at the Grape Dam Millrace Improvements

The Grape Dam, the most upstream dam is privately owned and was unable to be completely removed. However, the existing millrace channel was enhanced to provide fish passage around the dam.
