Monitored Natural Recovery (MNR)

Enhanced Natural Recovery (ENR)

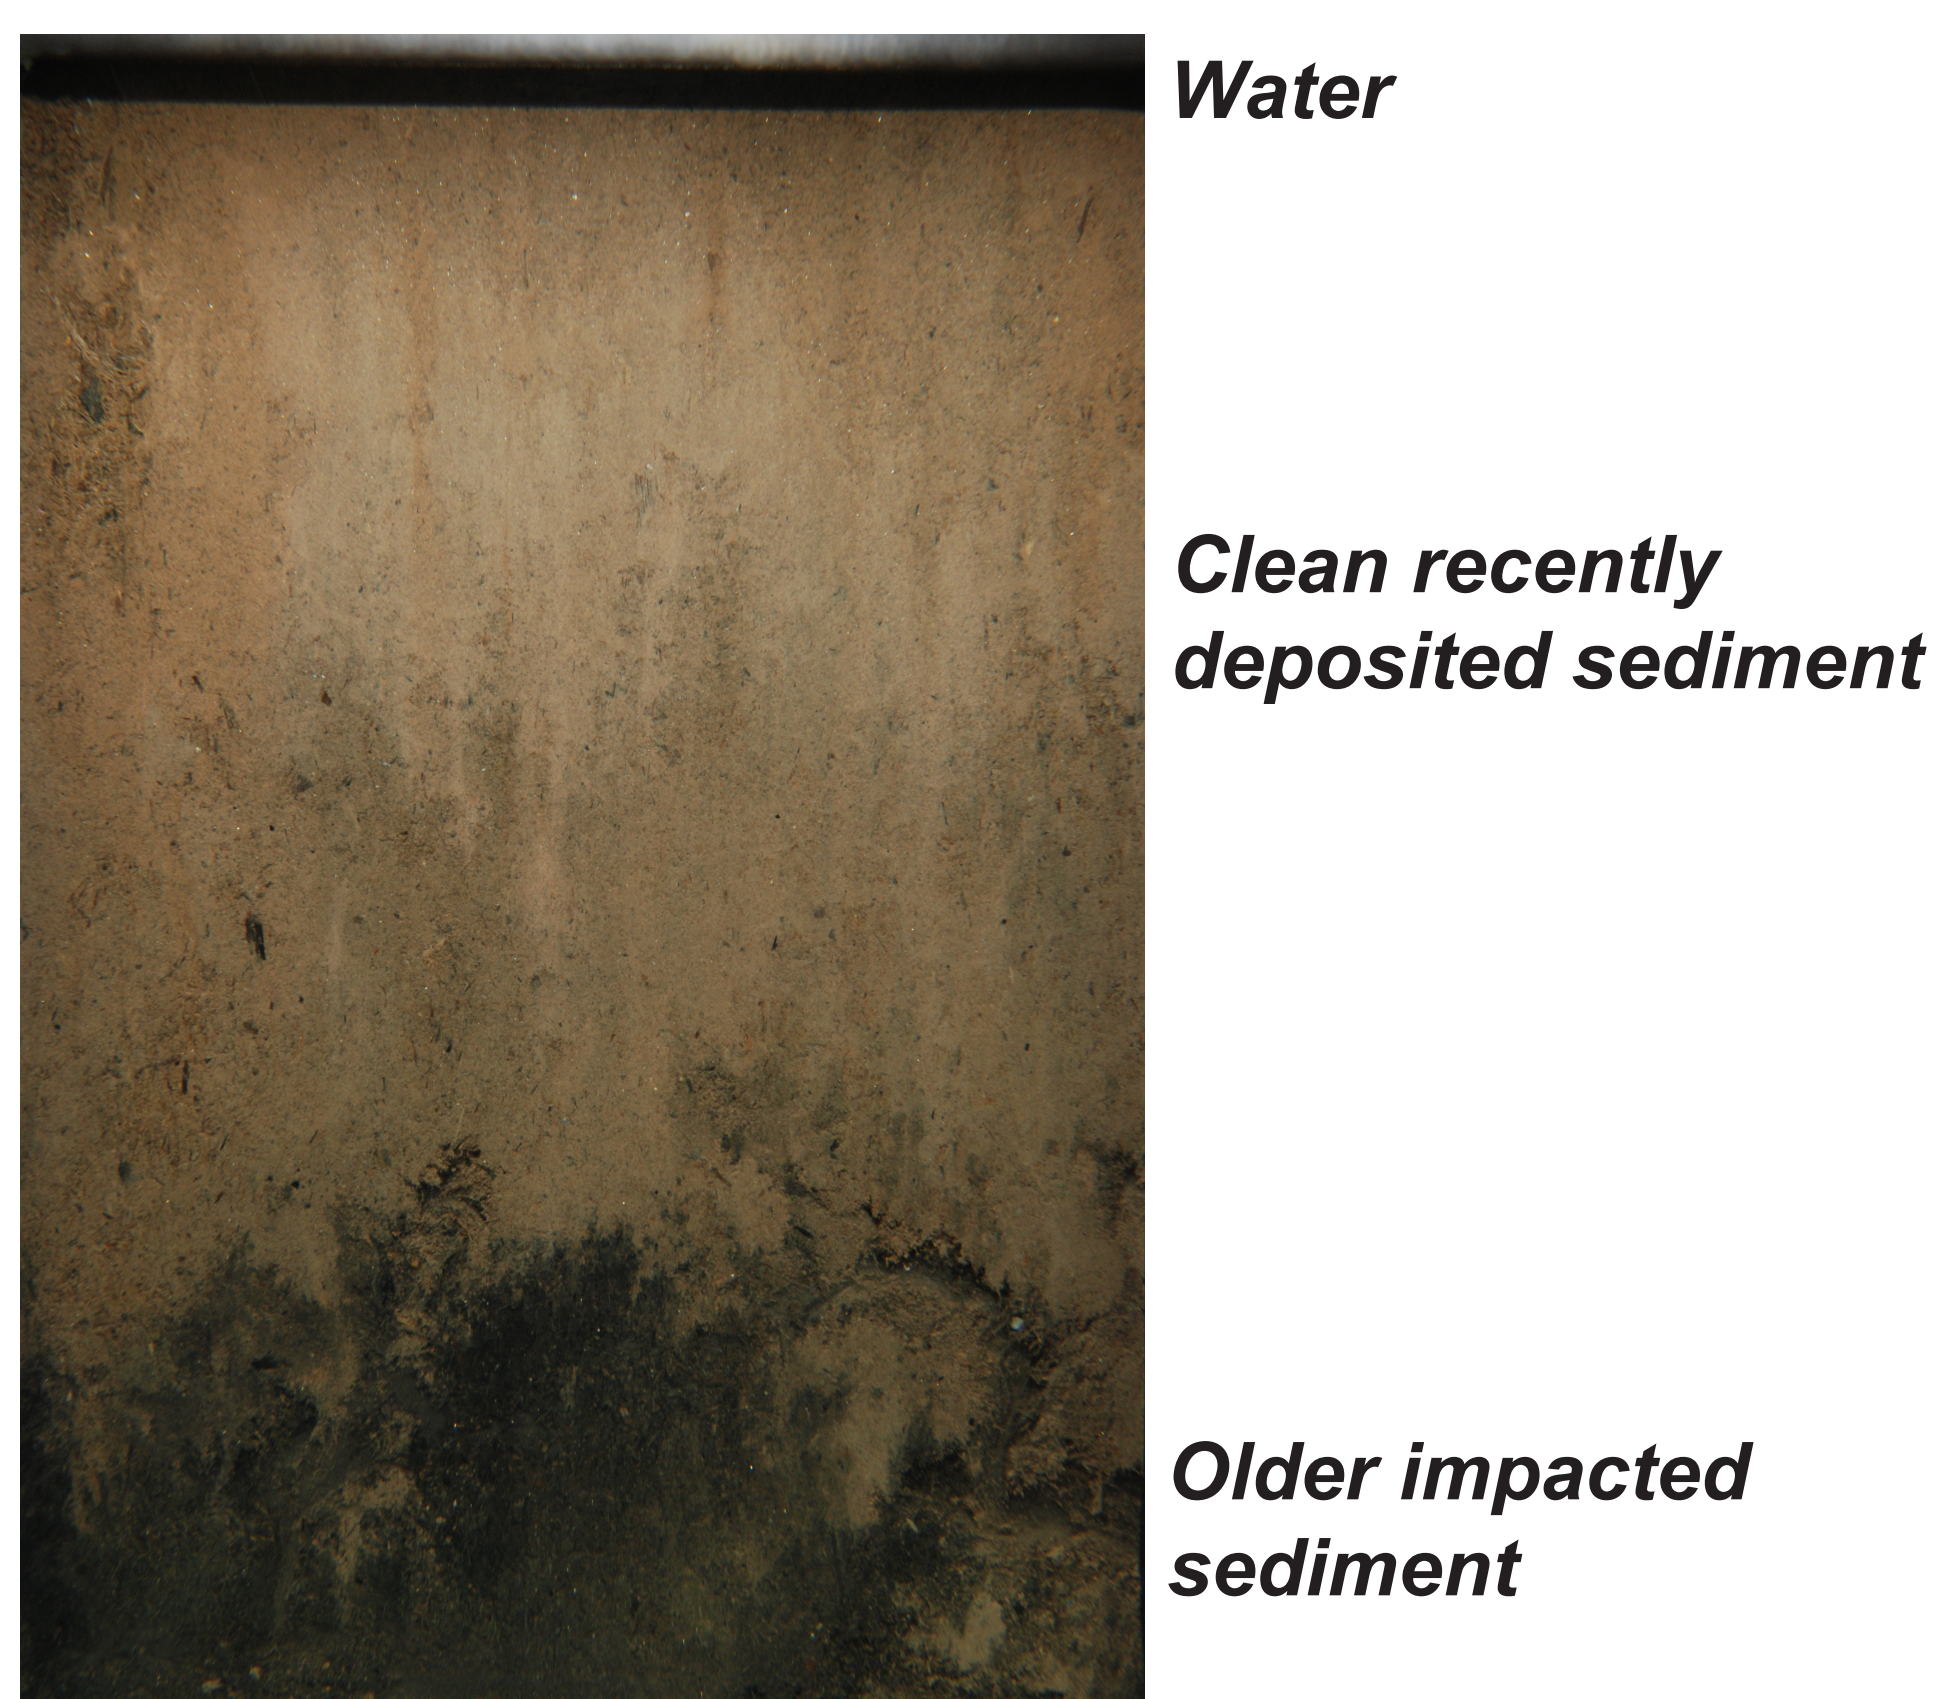
- Sampling at Spirit Lake shows that clean sediment is naturally covering impacted sediment.
- Photographs of the sediment layers confirm that clean sediment has buried impacted sediment in many areas. Recovery will be monitored over time.

Spirit Lake sediment photograph.

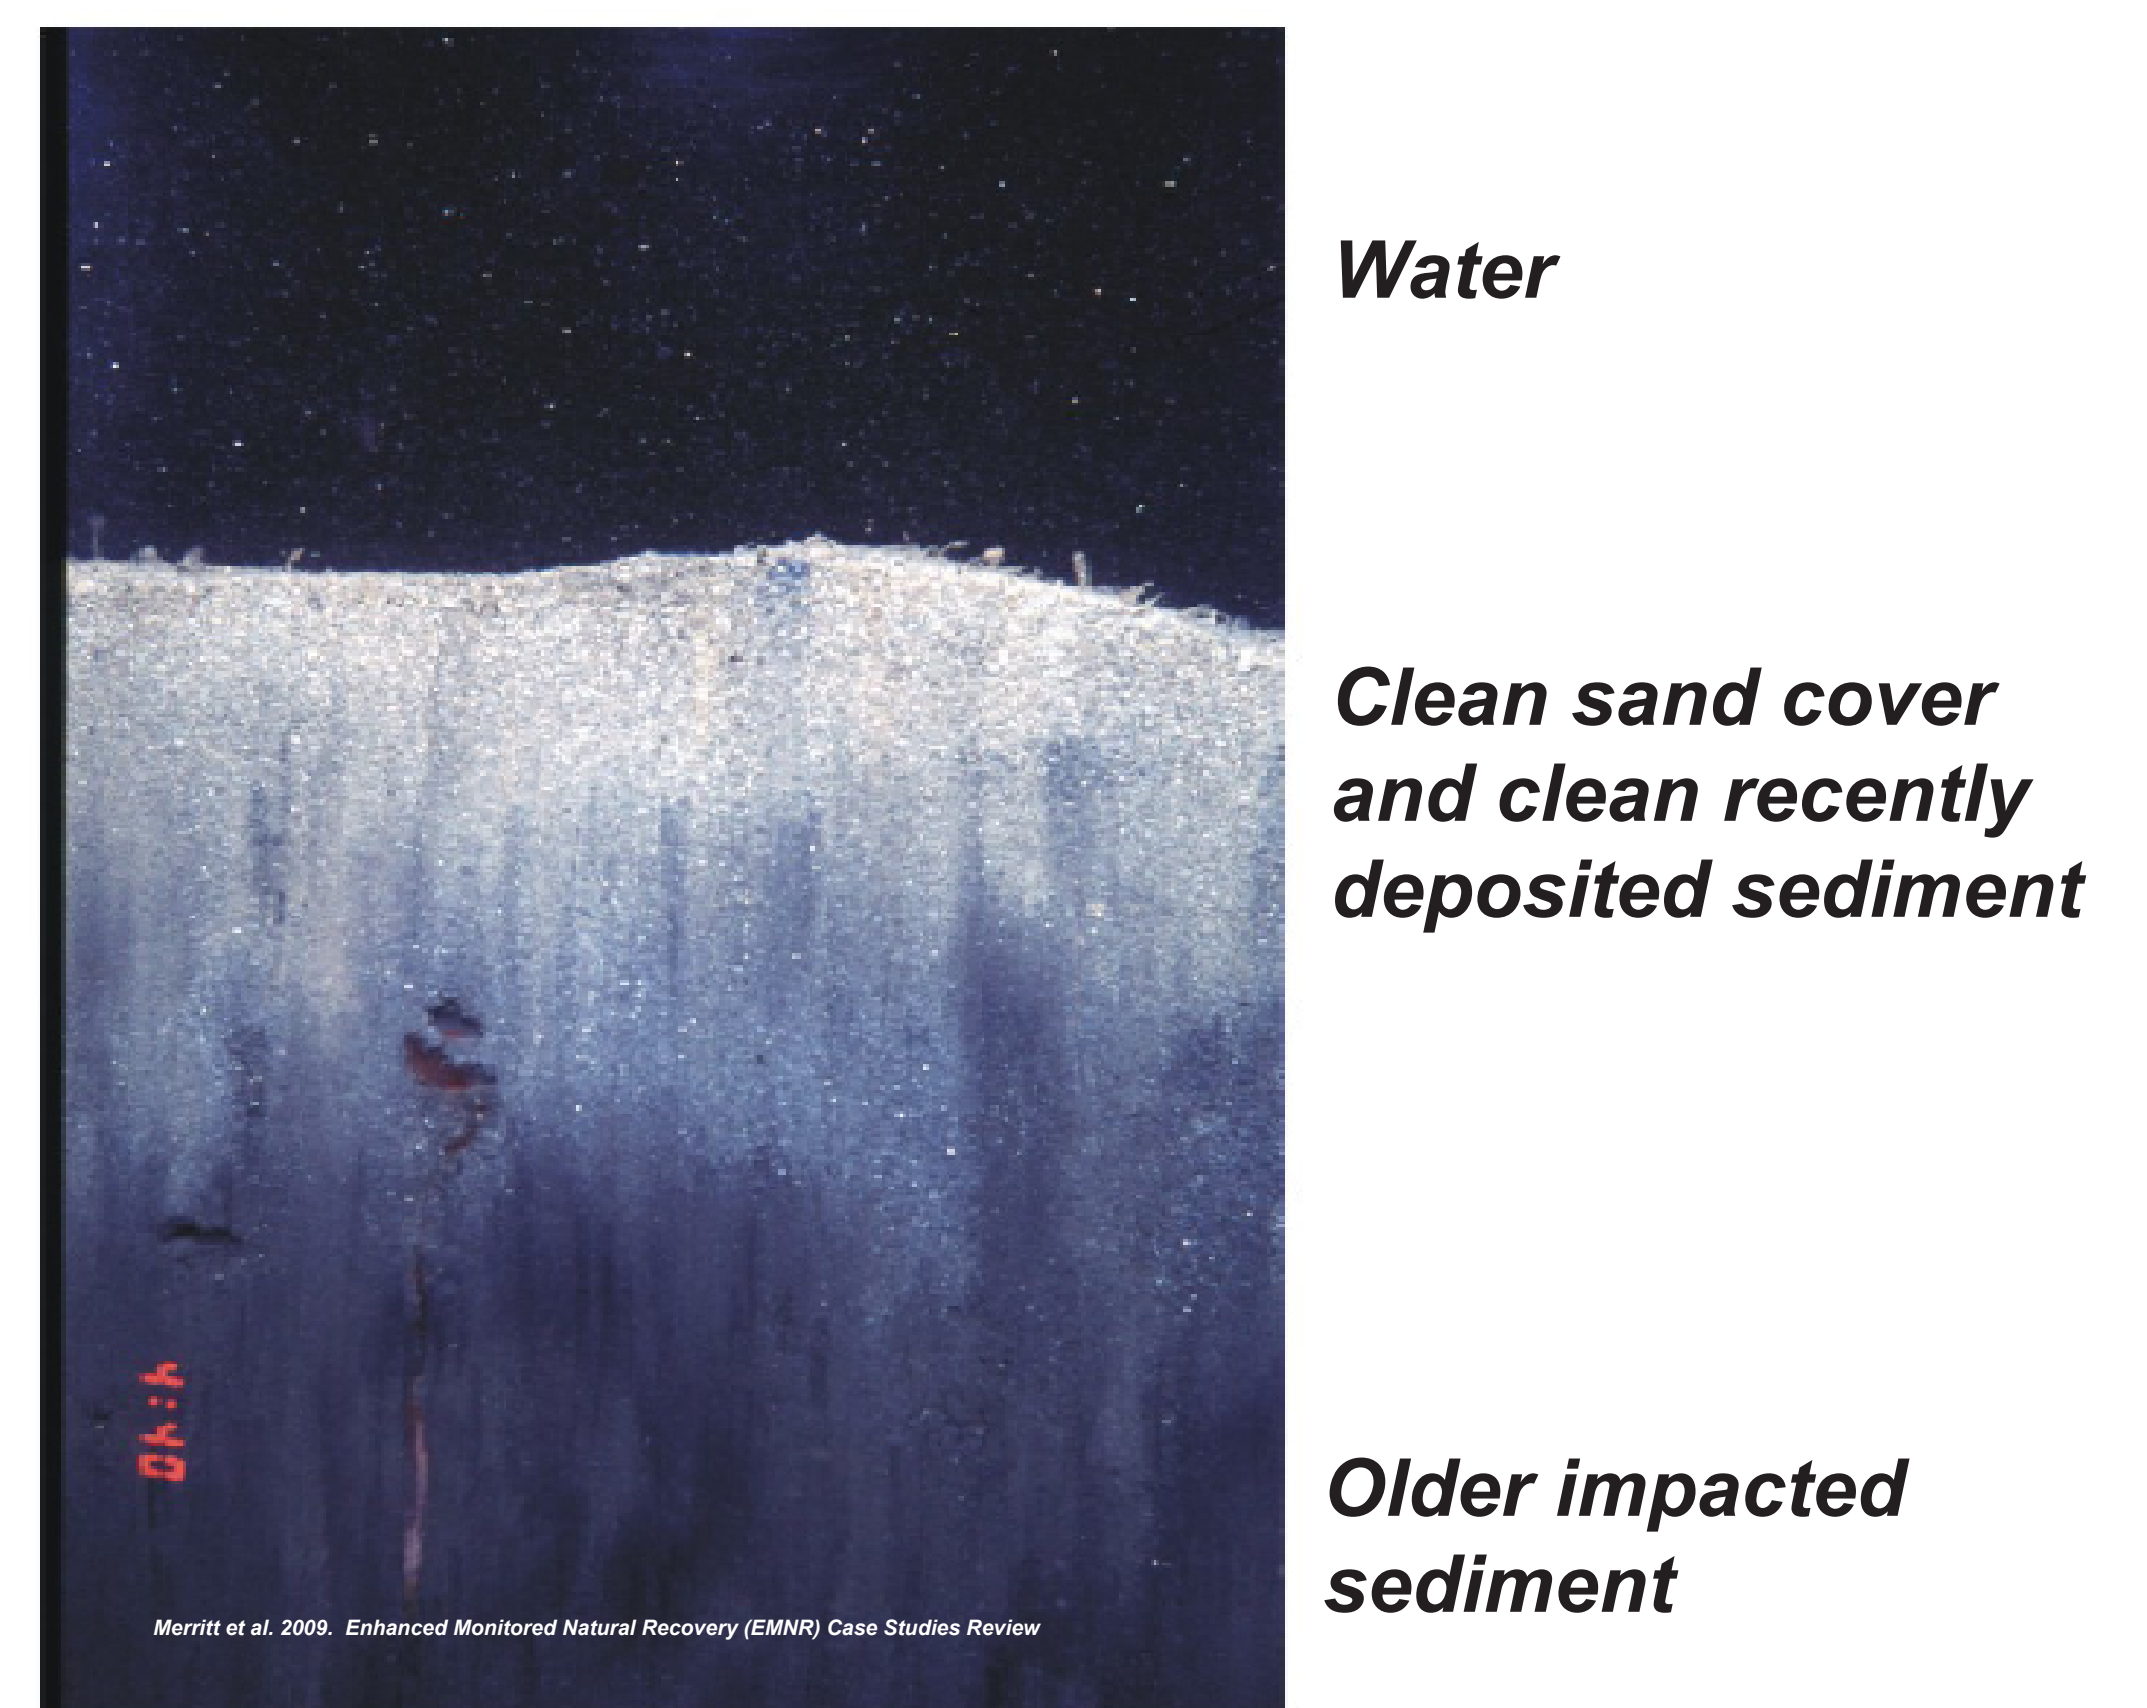
- Natural recovery can be enhanced by placing a thin layer of 6 inches of clean sand to speed up burial while preserving the plants and wildlife that are present already.
- ENR areas will be monitored over time.

Conceptual example of ENR sediment cover.
